University of Idaho Administration Building

Entry Foyer & Main Stair Renovation
North Entry Mosaic Tile Restoration

Condition Survey

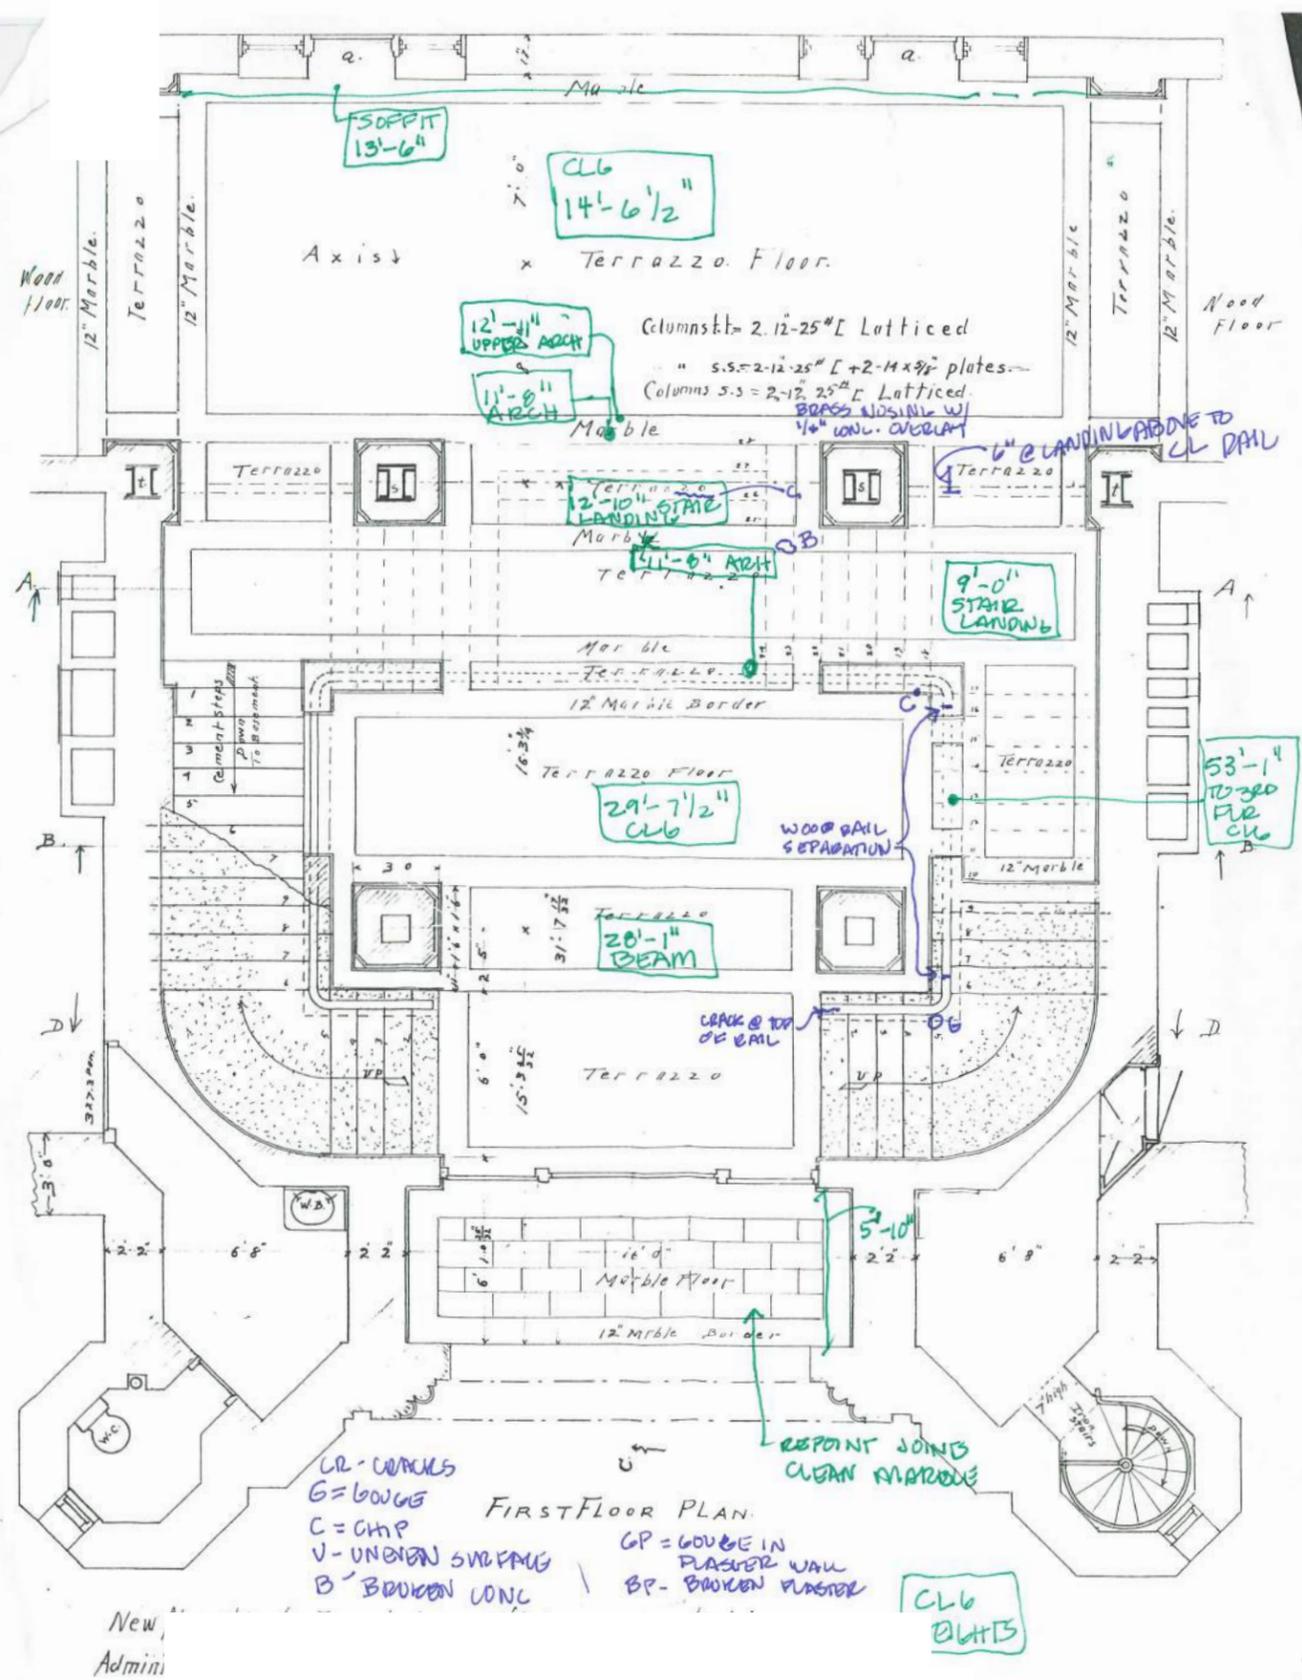
First Floor Plan

Findings:

1. Cracks in plaster walls
2. Gouges and chips in plaster walls
3. Broken and delaminating paint and plaster on walls
4. Cracks and gaps at wood railings
5. Non-original stair nosings

1. Cracks, gouges, and chips in plaster walls
 - a. Structural Cracks: Remove base coat on either side of crack. Rout out crack 1/4" wide x 3/8" deep. Do not straighten or deviate from crack more than 1/8". Clean and prime as required. Inject epoxy grout appropriate for plaster wall repair to stabilize crack. Install surface applied fiberglass sheet per manufacturer's recommendations. Re-coat with 3-coat plaster system to feather in to match existing adjacent surfaces.

- b. Surface cracking, gouges and chips: Where entire wall surface is cracked or damaged, a wall restoration system (Nu-Wal Restoration System or equivalent) may be utilized. Prepare surfaces in accordance with manufacturer's recommendations. Sand ridges of cracks gouges and chips to even plane. Fill cracks, gouges and chips greater than 1/16". Repair large holes with patching plaster or drywall compound. Prime all bare plaster and patched areas. Seal chalky surfaces with penetrating surface conditioner in accordance with manufacturer's instructions. Apply plaster restoration system in accordance with manufacturer's instructions. Ensure completed application forms a seamless, monolithic surface, leaves no differing textures, and covers cracks and holes.

2. Broken and delaminating paint and plaster on walls
 - a. Remove unsound material as required. Fill/replaster as required to blend and match existing adjacent surfaces.

3. Cracks and gaps at wood railings
 - a. Carefully hand rub scratches and minor surface imperfections with a fine grit sandpaper. Match patina of unscratched wood by selective staining. Do not remove more than 1/16" thickness of the material. Maintain levelness of surface over entire width or length of wood piece.

- b. Small gouges and holes can be filled using linseed oil putty. Stain the putty to match using the sediment from the bottom of the stain can, or universal tints.

- c. For large holes and gaps, use a sandable filler. Stain to match.
4. Non-original stair nosings
 - a. Remove non-original stair nosing, and replace with decorative cast iron plates with 3/8" rounded nosings to match historic treads.

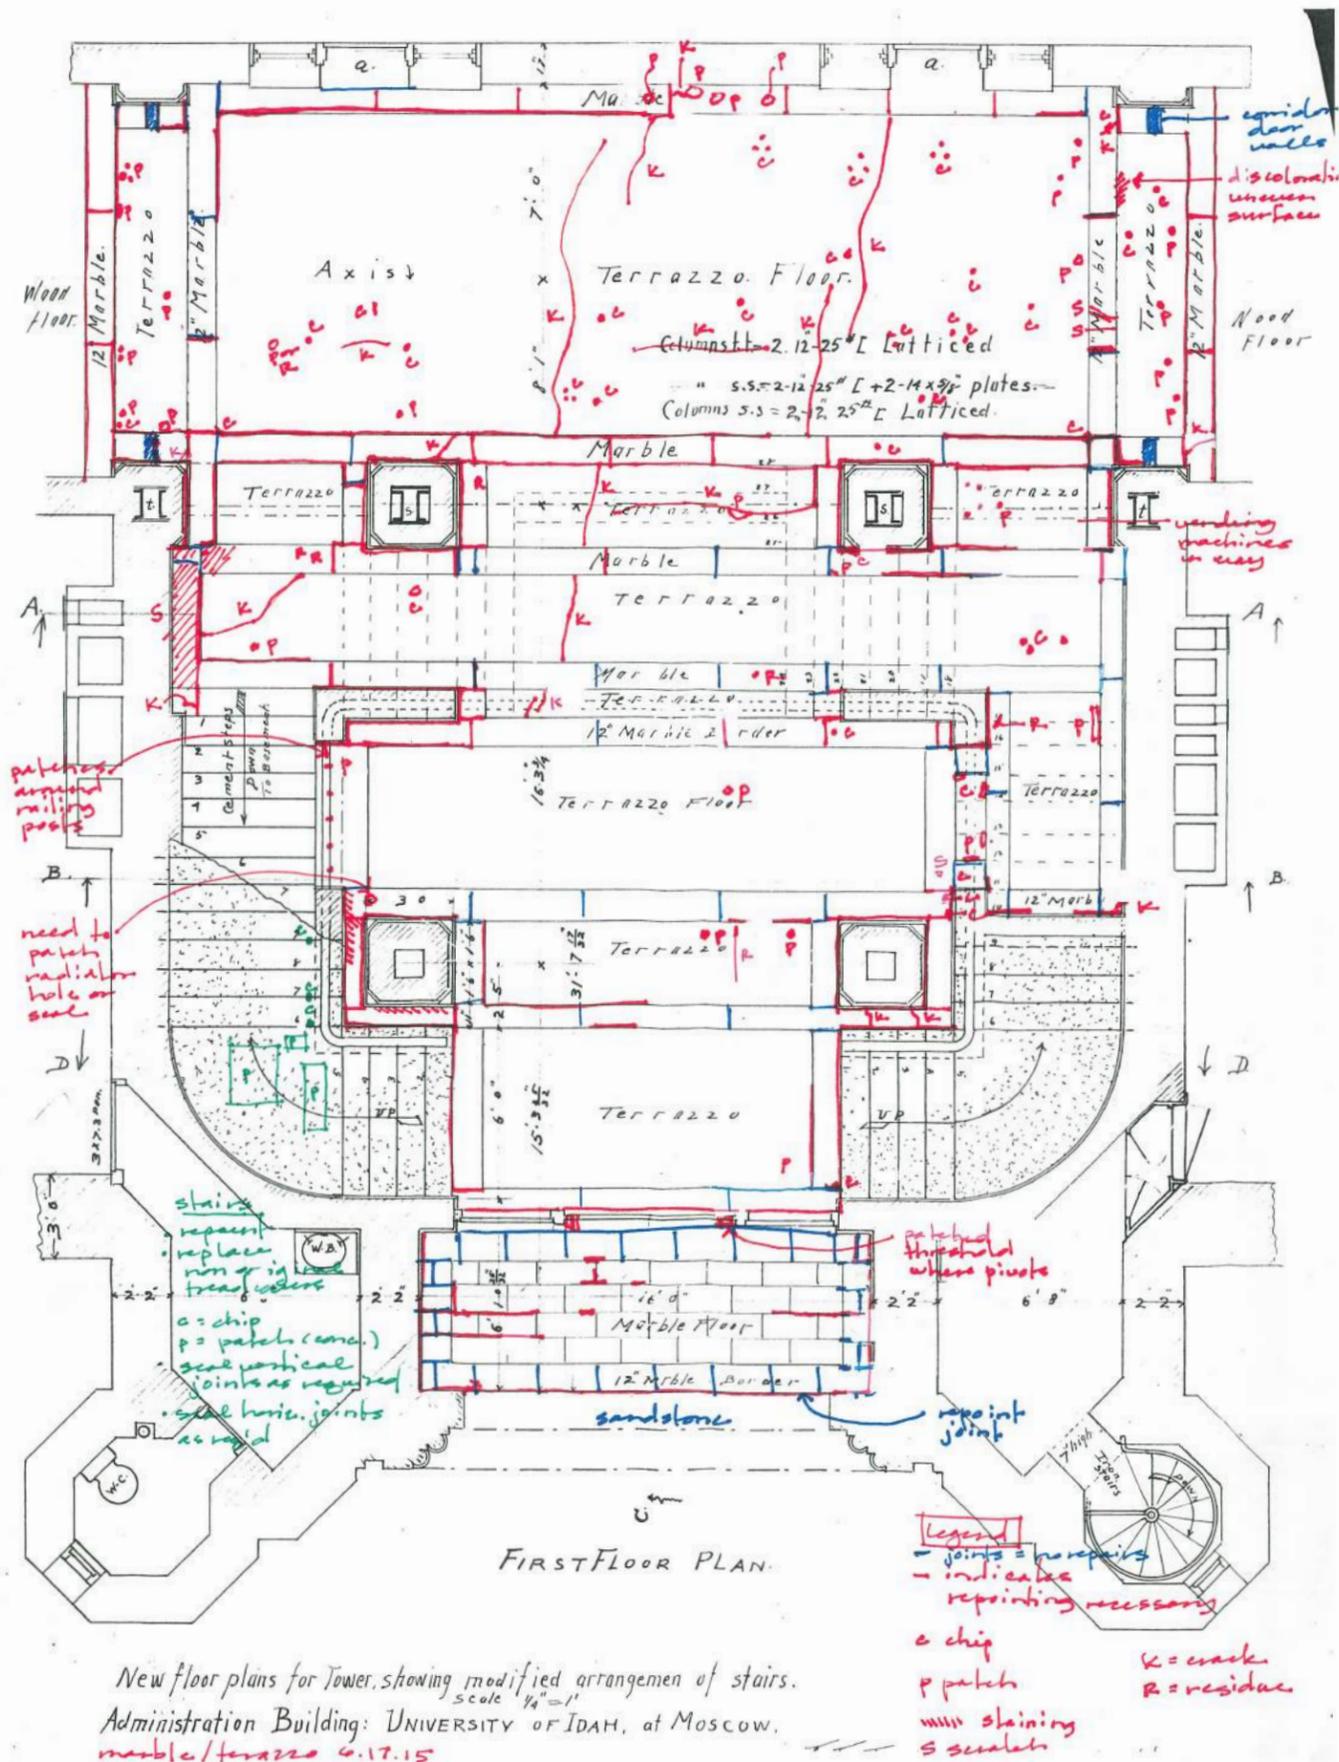
1. Non-original marble or terrazzo floor finish
2. Missing or loose grout in marble joints.
3. Chip in marble or terrazzo.
4. Non-original patch in marble or terrazzo.
5. Stained marble or terrazzo.
6. Scratches in marble or terrazzo.
7. Crack in marble or terrazzo.
8. Residue on marble or terrazzo.
9. Chip in concrete stair.
10. Non-original patch in concrete stair.
11. Non-original stair nosing.

2. Minor cracks, chips, scratches and spalls in marble or terrazzo.
 - a. No work required.
3. Minor wear in joint material.
 - a. No work required.
4. Missing or loose grout in marble joints.

- a. Remove any accumulated dirt, grease, wax, etc. from joint. Remove any loose grout back to stable grout. Rout out remaining joint with a bladed tool to a minimum depth of 1/4". Repoint with a polyurethane joint filler tinted to match existing mortar.

5. Chips or spalls in marble or terrazzo.
 - a. For chips or spalls larger than 3/4", remove accumulated dirt, grease, wax, etc. from depression. Cut a dove tail into bottom of hole to create a ledge for patch to anchor. Patch to match existing marble or terrazzo.

7. Stained marble or terrazzo.
 - a. Cover entire stain with a poultice, and seal with plastic sheeting for at least 24 hours. Rinse and reapply as required.

8. Cracks in marble or terrazzo.
 - a. Remove accumulated dirt, grease, wax, etc. from crack. Where required remove existing patching material and loose marble or terrazzo. Inject mortar into remaining crack to 1/8" of top of crack. Hand sand patch, and fill to top with a polyurethane patch tinted to match existing grout at marble, and with cement grout or epoxy resin at terrazzo.

9. Chip in concrete stair
 - a. For chips and spalls greater than 3/4", remove accumulated dirt, grease, wax, etc. from depression. Where required remove existing patching material. Fill with concrete patching compound mixed to match existing stair concrete color. Trowel smooth

10. Non-original stair nosings.
 - a. Remove non-original stair nosing, and replace with decorative cast iron plates with 3/8" rounded nosings to match historic treads.

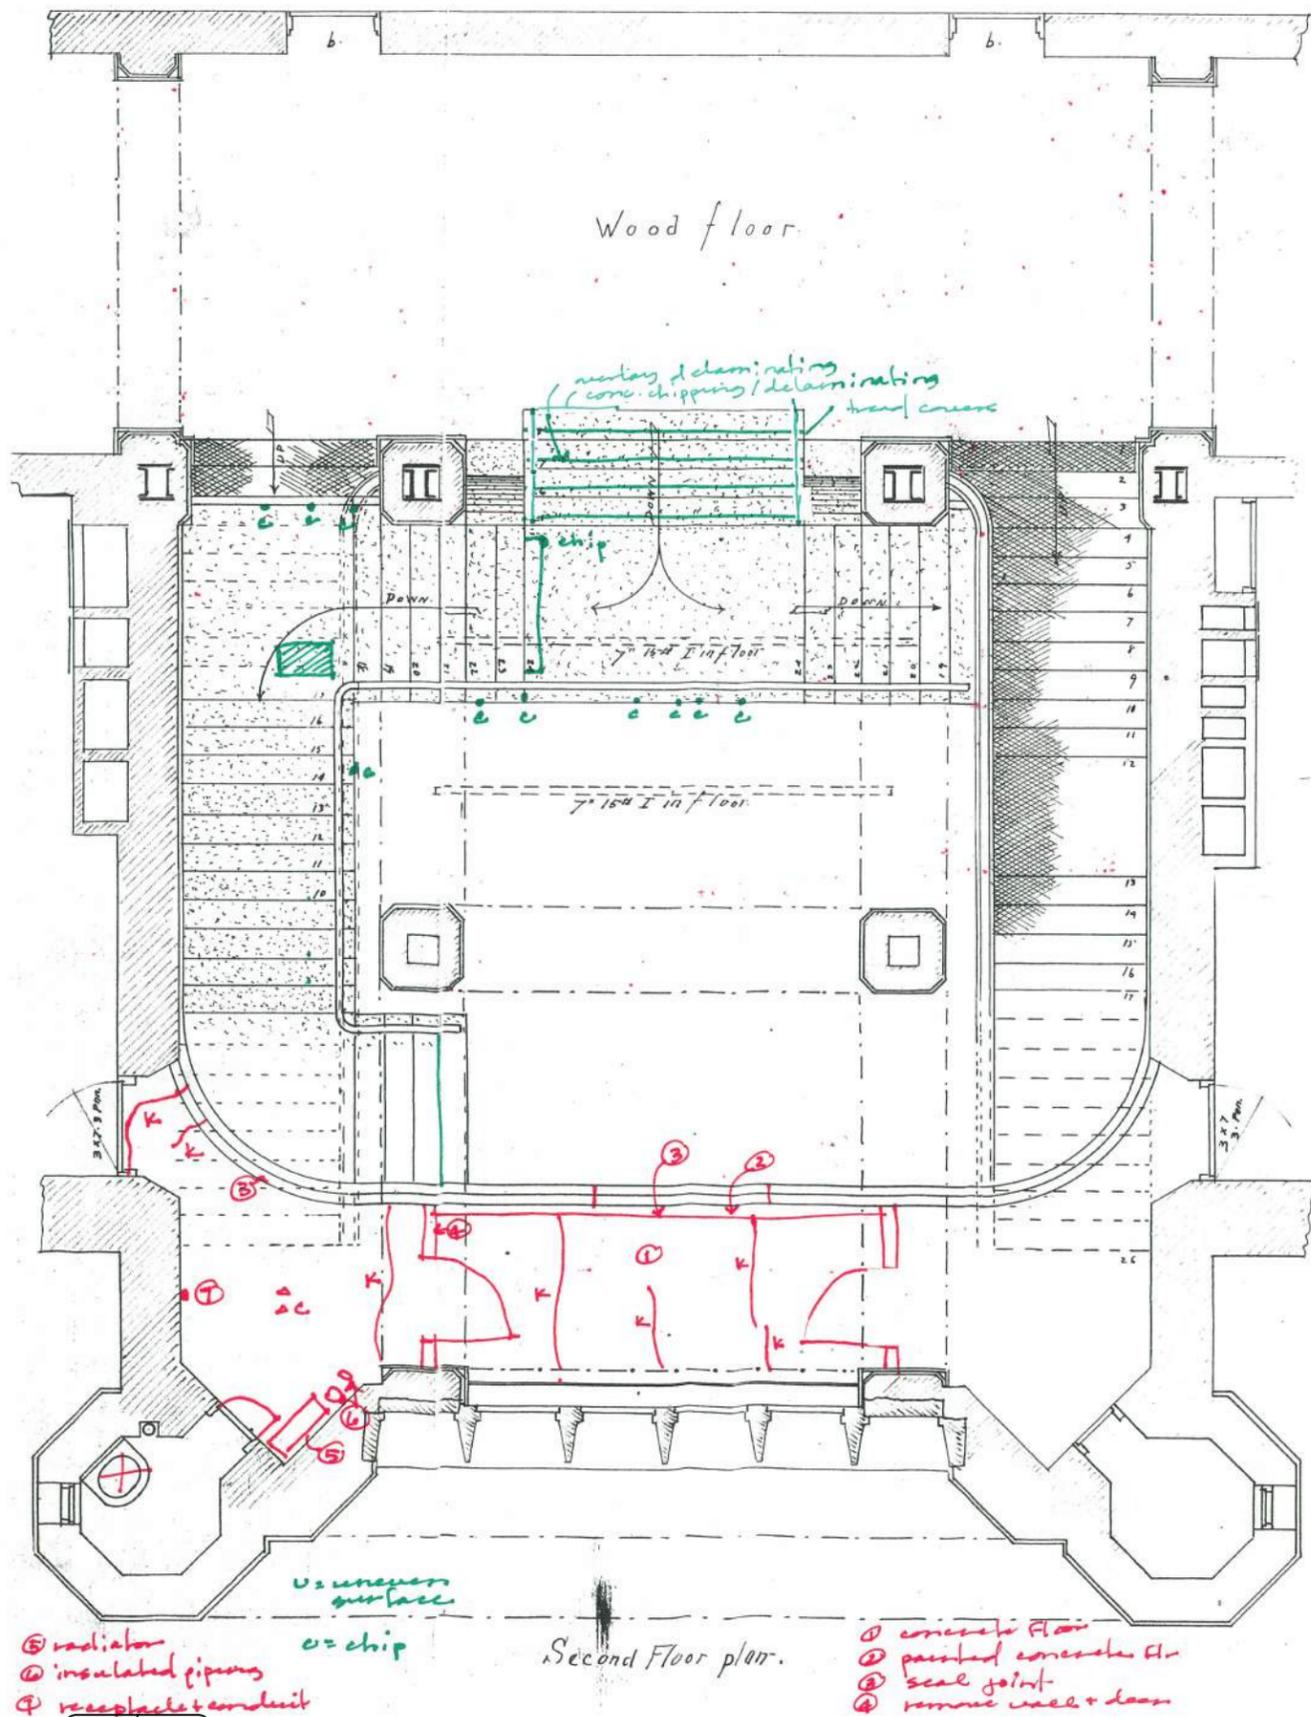
1. Chips and spalls in concrete stairs and landings.
2. Delaminating concrete on treads.
3. Open concrete joints.

1. Chips and spalls in concrete stairs and landings:
 - a. Small chips that are structurally stable will not be repaired.
 - b. For chips and spalls greater than 3/4", remove accumulated dirt, grease, wax, etc. from depression. Where required remove existing patching material. Fill with concrete patching compound mixed to match existing stair concrete color. Trowel smooth
2. Delaminating concrete:
 - a. Either remove delaminating surface back to sound concrete, and patch to match existing concrete, or inject void under delaminating concrete with a polyurethane bonding agent.
3. Open concrete joints:
 - a. Remove loose and deteriorating material along entire length of joint and repoint.

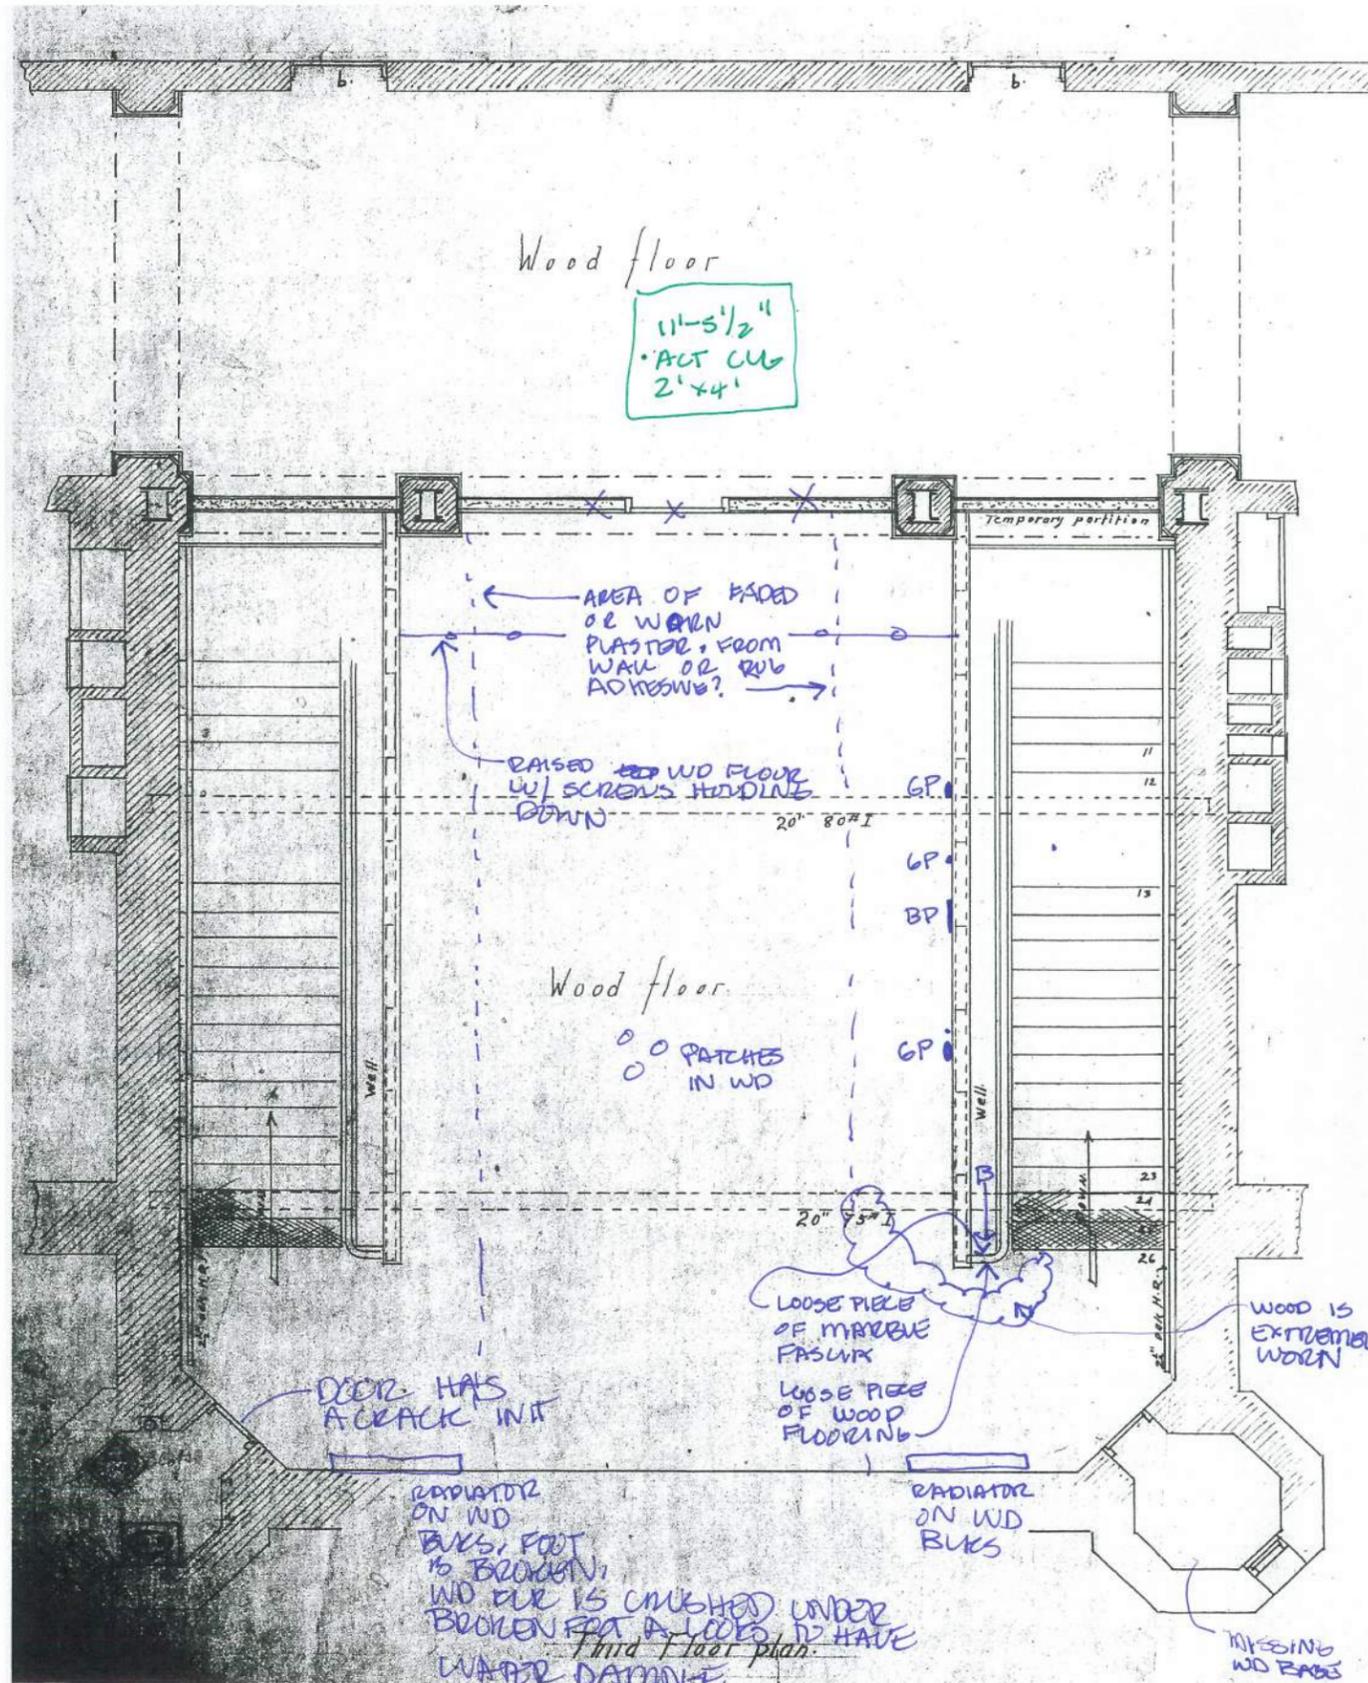
1. Faded and worn wood floor.
2. Areas of patched and screwed down floor.
3. Creaky wood floor.
4. Broken and delaminating plaster.
6. Gouges and chips in plaster walls
6. Areas of missing wood base.
7. Loose marble fascia at stair.
8. Crack in original wood door.
9. Misaligned original steam radiators.

1. Refinish entire wood floor.
2. Areas of patched and screwed down floor.
 - a. Evaluate patched areas to verify if patches are of similar species of wood. Either replace or refinish in place.

- b. Remove screws and review condition of supports. Realign or replace supports for a flush finish, nail to supports and refinish.
3. Creaky wood floors.

- a. Locate the creaky areas.
 - b. Reduce squeak through lubricate, glazier points, or finish nails.
4. Broken and delaminating paint and plaster on walls.

5. Cracks, gouges and chips in plaster walls.
 - a. Structural Cracks: Remove base coat on either side of crack. Rout out crack 1/4" wide x 3/8" deep. Do not straighten or deviate from crack more than 1/8". Clean and prime as required. Inject epoxy grout appropriate for plaster wall repair to stabilize crack. Install surface applied fiberglass sheet per manufacturer's recommendations. Re-coat with 3-coat plaster system to feather in to match existing adjacent surfaces.

- b. Surface cracking, gouges and chips: Where entire wall surface is cracked or damaged, a wall restoration system (Nu-Wal Restoration System or equivalent) may be utilized. Prepare surfaces in accordance with manufacturer's recommendations. Sand ridges of cracks gouges and chips to even plane. Fill cracks, gouges and chips greater than 1/16". Repair large holes with patching plaster or drywall compound. Prime all bare plaster and patched areas. Seal chalky surfaces with penetrating surface conditioner in accordance with manufacturer's instructions. Apply plaster restoration system in accordance with manufacturer's instructions. Ensure completed application forms a seamless, monolithic surface, leaves no differing textures, and covers cracks and holes.

6. Replace missing or damaged wood base to match existing
7. Secure loose marble.
8. Crack in original wood door
 - a. Fill crack in door with wood putty or shellac stick. Sand flush and refinish door.

9. Misaligned steam radiators.
 - a. Remove existing radiators and realign piping. Replace damaged wood floor and increase underfloor support for relocation of radiator to original location on wood floor.

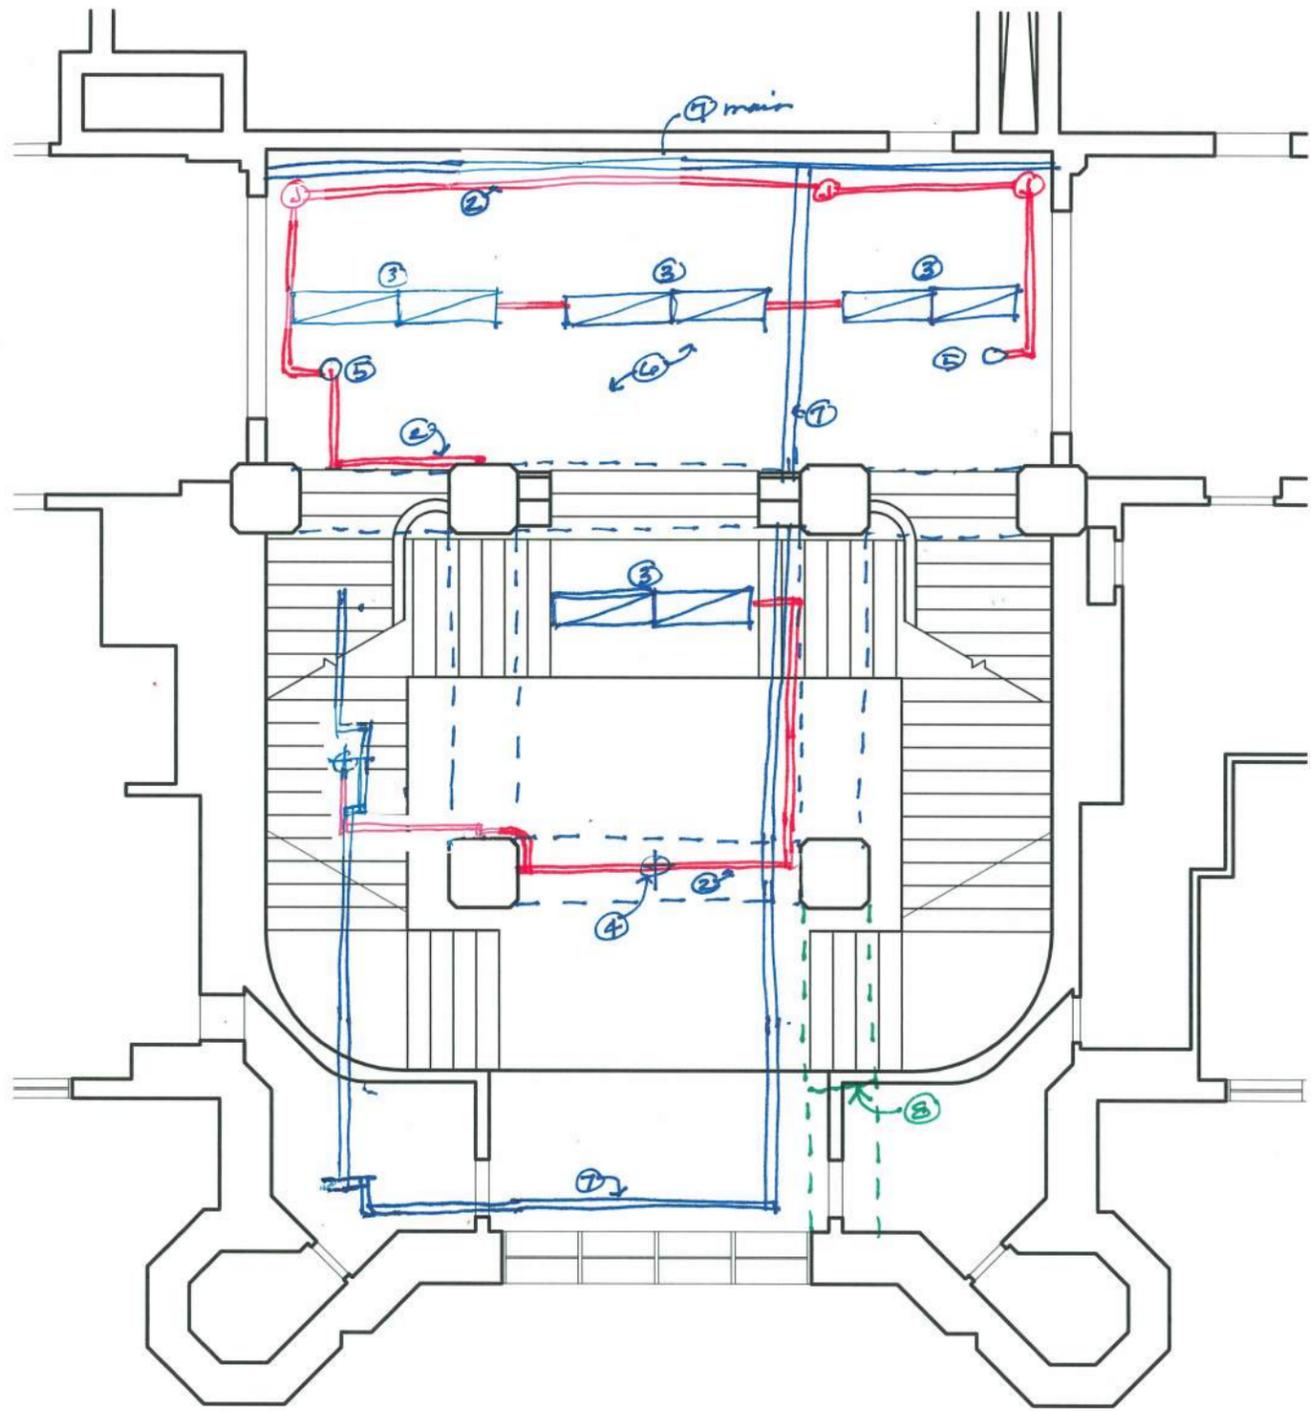
Second Floor Reflected Ceiling Plan
Scale: 1/8" = 1'-0"

① fire sprinkler piping
⑥ crack in arch

1. Non-historic light fixtures.
2. Exposed sprinkler piping.
3. Non-historic glued-on acoustic ceiling tiles.
4. Exposed conduit.
5. Crack in plaster arch.

1. Replace non-historic light fixtures with historically accurate fixtures (refer to electrical narrative).
2. Remove fire sprinkler piping and conceal in walls and ceilings (refer to mechanical narrative).

5. Crack in plaster arch:
 - a. Structural Cracks: Remove base coat on either side of crack. Rout out crack 1/4" wide x 3/8" deep. Do not straighten or deviate from crack more than 1/8". Clean and prime as required. Inject epoxy grout appropriate for plaster wall repair to stabilize crack. Install surface applied fiberglass sheet per manufacturer's recommendations. Re-coat with 3-coat plaster system to feather in to match existing adjacent surfaces.

- b. Surface cracking, gouges and chips: Where entire wall surface is cracked or damaged, a wall restoration system (Nu-Wal Restoration System or equivalent) may be utilized. Prepare surfaces in accordance with manufacturer's recommendations. Sand ridges of cracks gouges and chips to even plane. Fill cracks, gouges and chips greater than 1/16". Repair large holes with patching plaster or drywall compound. Prime all bare plaster and patched areas. Seal chalky surfaces with penetrating surface conditioner in accordance with manufacturer's instructions. Apply plaster restoration system in accordance with manufacturer's instructions. Ensure completed application forms a seamless, monolithic surface, leaves no differing textures, and covers cracks and holes.

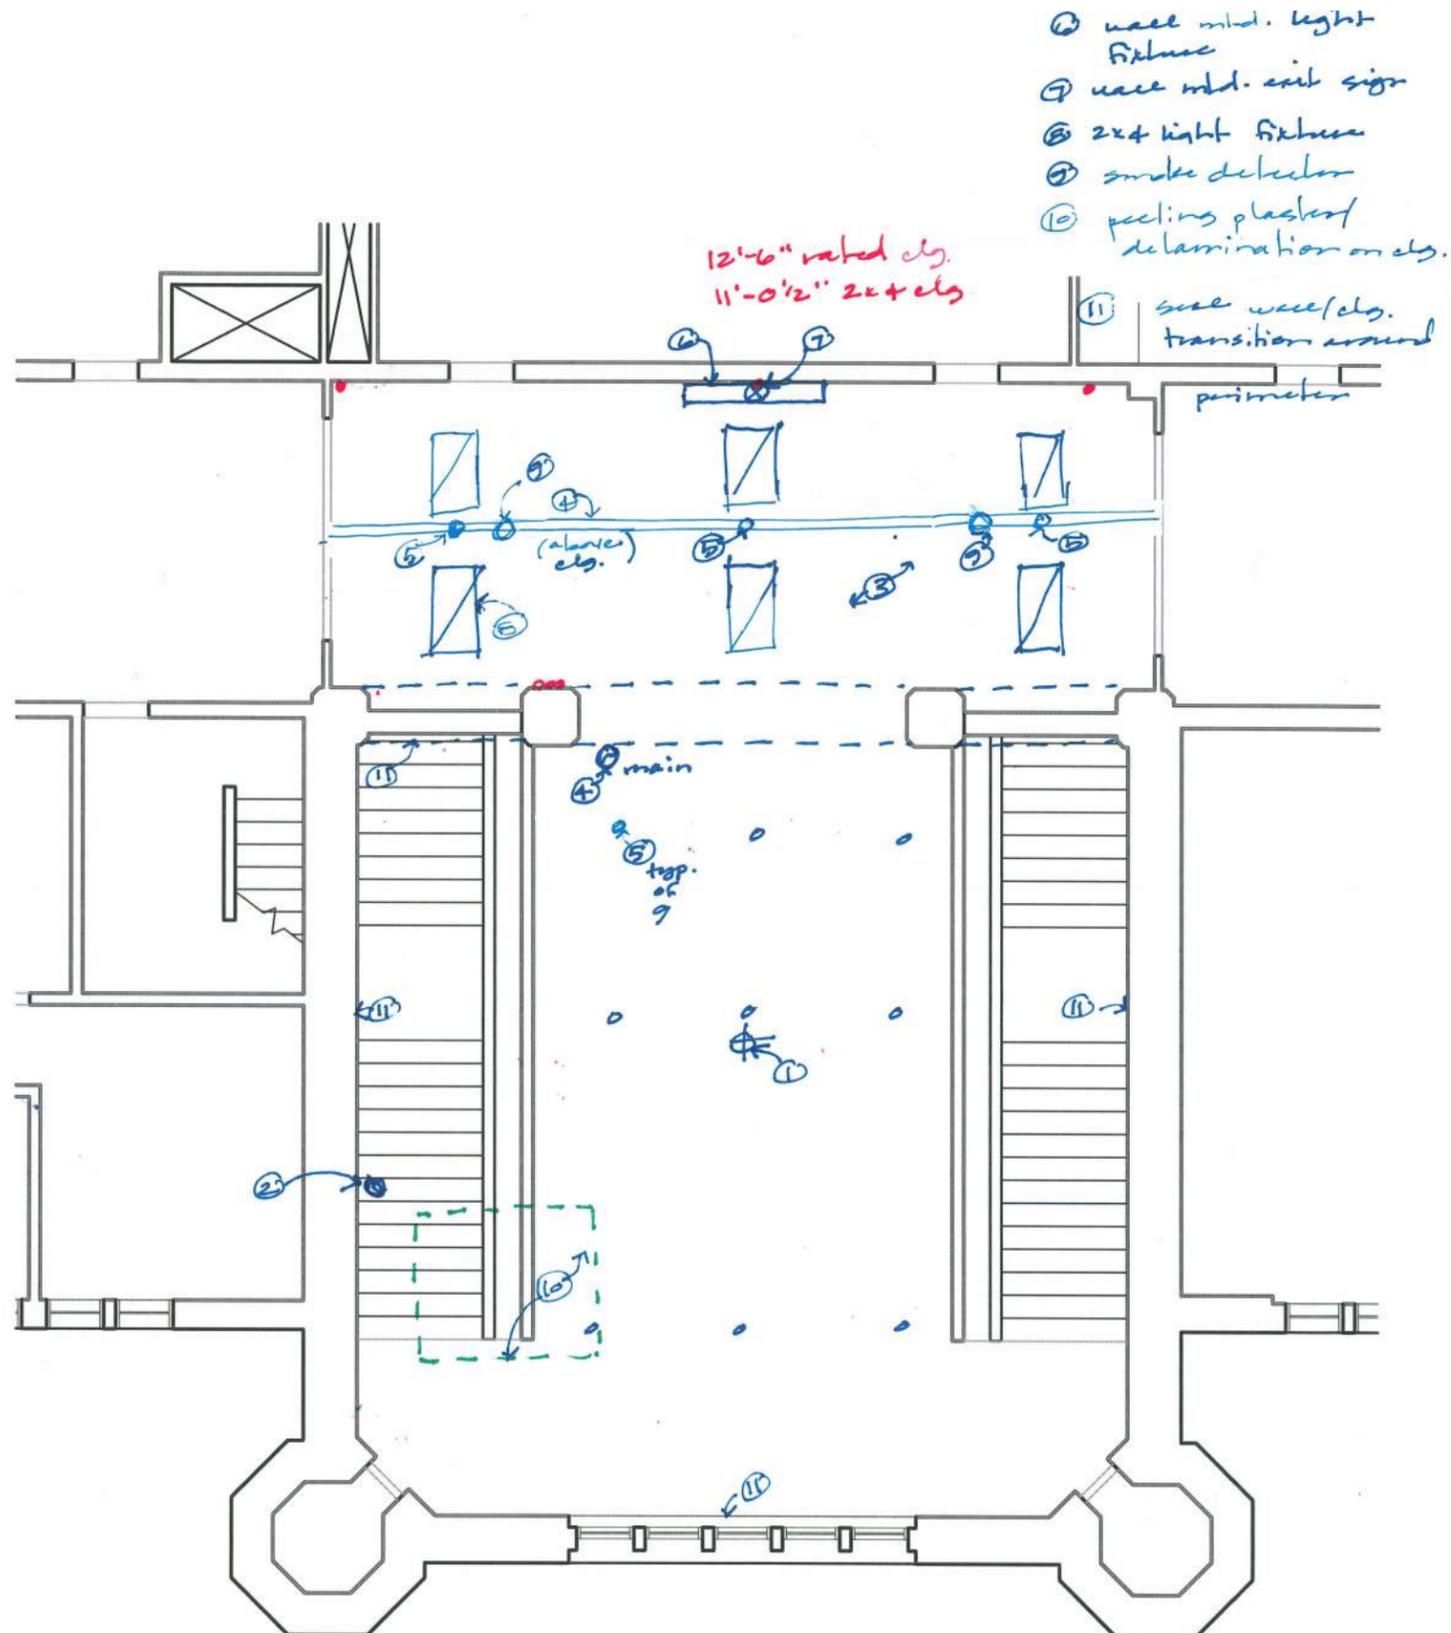
Third Floor Reflected Ceiling Plan
Scale: 1/8" = 1'-0"

1. Non-historic light fixtures.
2. Exposed sprinkler piping.
3. Non-historic 2x4 lay-in ceiling.
4. Exposed conduit.
5. Cracks in plaster walls.
6. Pendant mounted historic chandelier.
7. Delaminating plaster

1. Replace non-historic light fixtures with historically accurate fixtures (refer to electrical narrative).
2. Remove fire sprinkler piping and conceal in walls and ceilings (refer to mechanical narrative).

5. Crack in plaster arch:
 - a. Structural Cracks: Remove base coat on either side of crack. Rout out crack 1/4" wide x 3/8" deep. Do not straighten or deviate from crack more than 1/8". Clean and prime as required. Inject epoxy grout appropriate for plaster wall repair to stabilize crack. Install surface applied fiberglass sheet per manufacturer's recommendations. Re-coat with 3-coat plaster system to feather in to match existing adjacent surfaces.

- b. Surface cracking, gouges and chips: Where entire wall surface is cracked or damaged, a wall restoration system (Nu-Wal Restoration System or equivalent) may be utilized. Prepare surfaces in accordance with manufacturer's recommendations. Sand ridges of cracks gouges and chips to even plane. Fill cracks, gouges and chips greater than 1/16". Repair large holes with patching plaster or drywall compound. Prime all bare plaster and patched areas. Seal chalky surfaces with penetrating surface conditioner in accordance with manufacturer's instructions. Apply plaster restoration system in accordance with manufacturer's instructions. Ensure completed application forms a seamless, monolithic surface, leaves no differing textures, and covers cracks and holes.

6. Refinish existing chandelier.
7. Delaminating plaster:
 - a. Remove unsound material as required. Fill/replaster as required to blend and match existing adjacent surfaces.

- b. Delaminated base coats: Remove unsound material as required back to solid material. Fill/replaster as required to blend and match existing adjacent surfaces

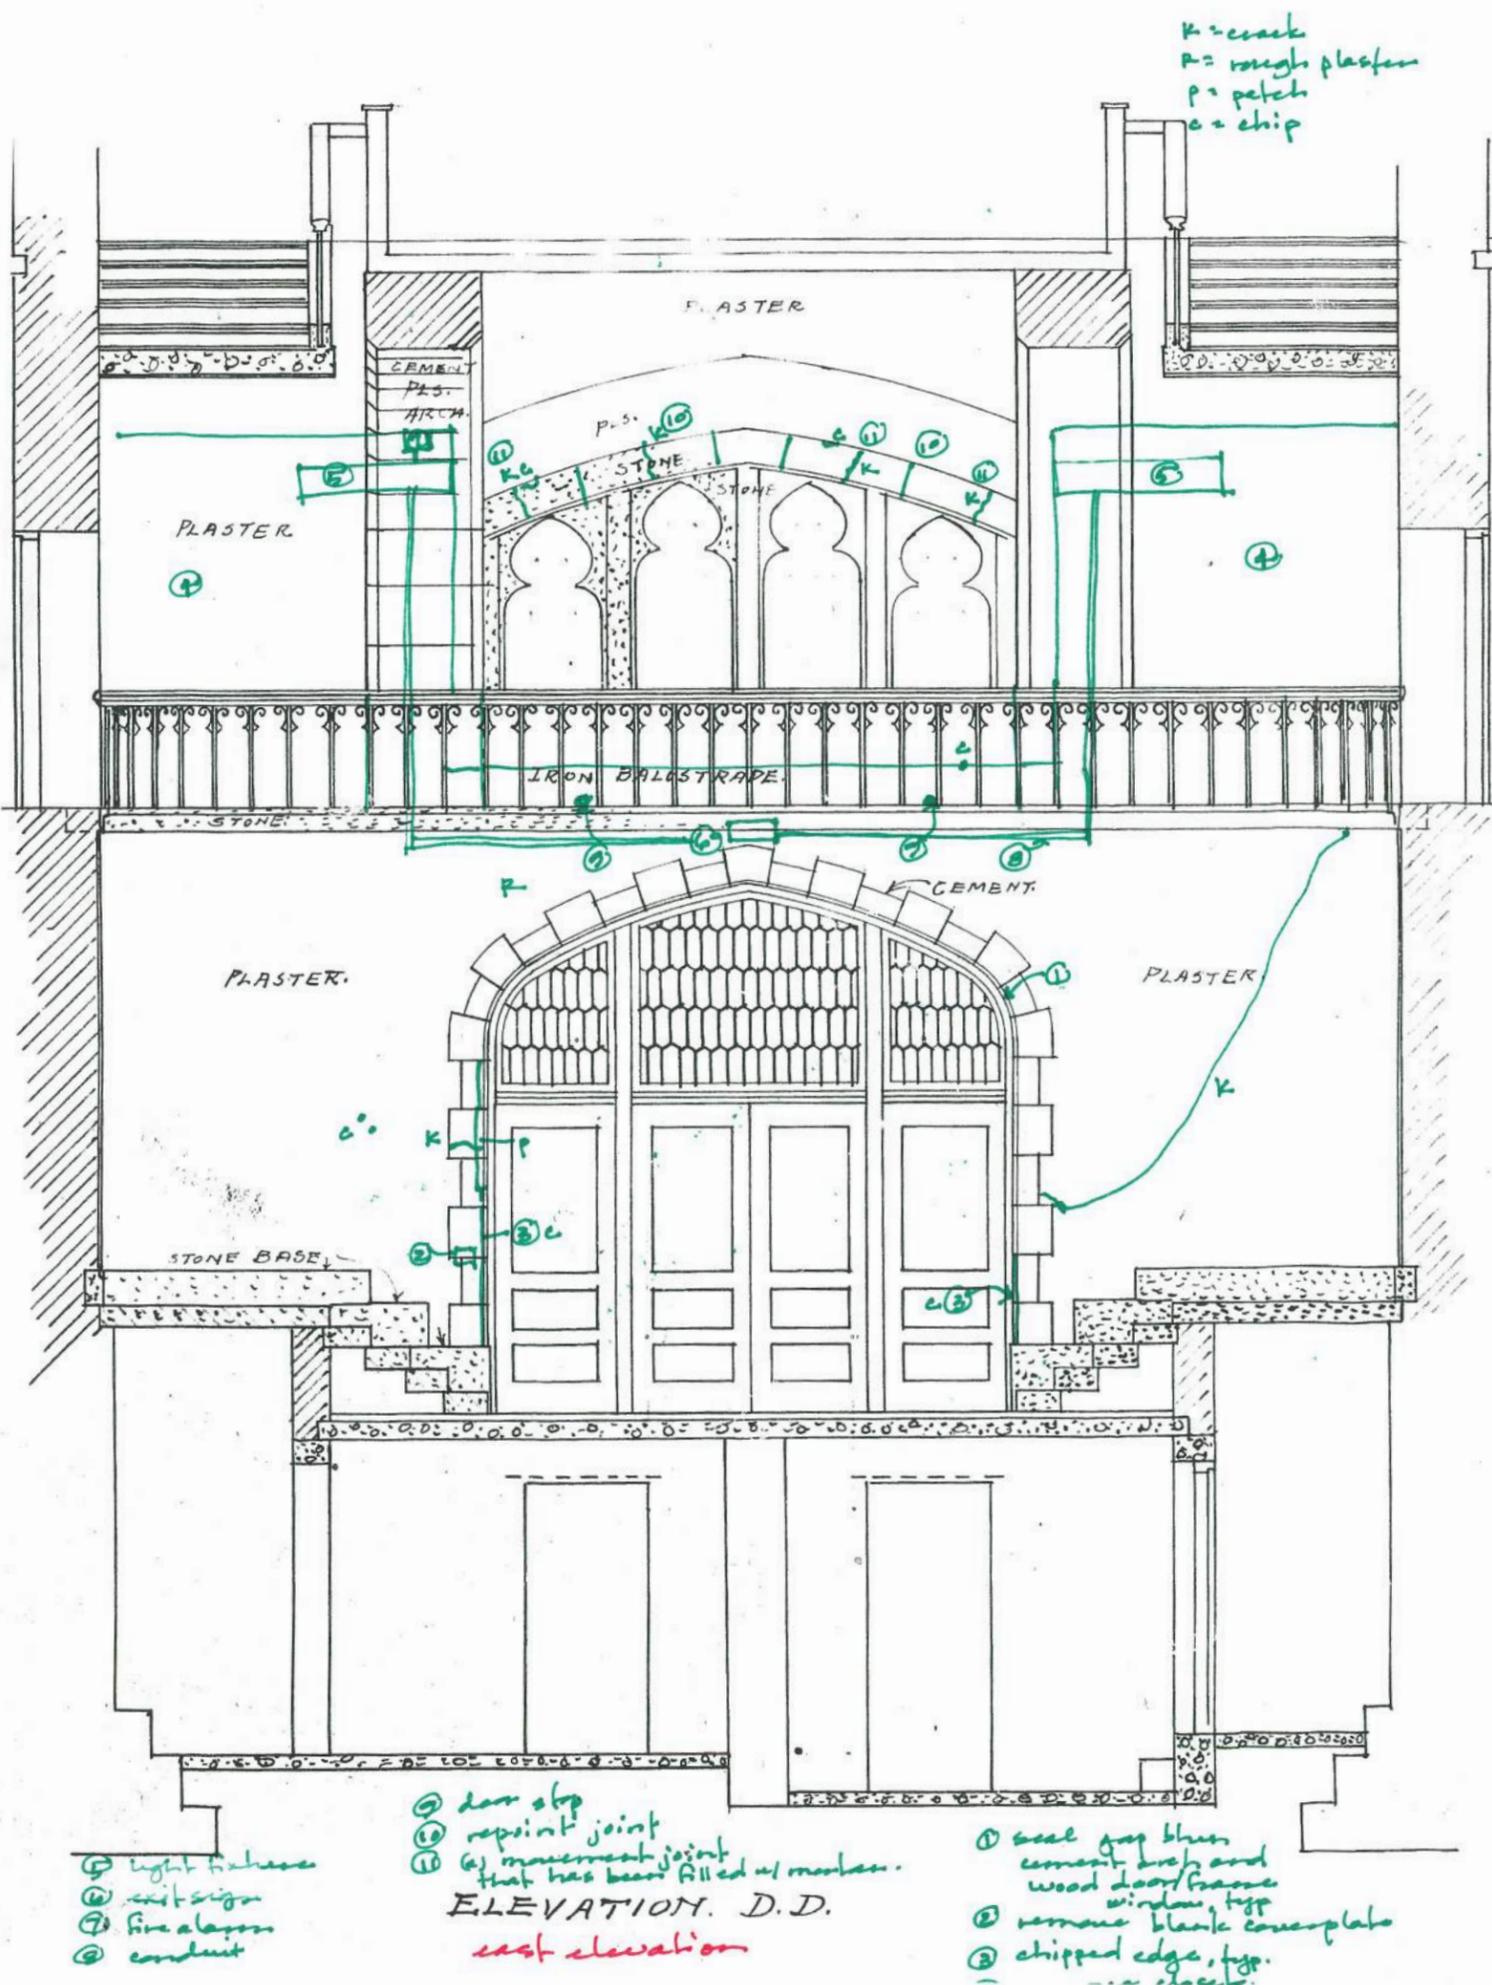
1. Cracks in plaster walls
2. Gouges and chips in plaster walls
3. Broken and delaminating paint and plaster on walls
4. Areas of rough plaster
5. Non-historic light fixtures.
6. Exposed sprinkler piping.
7. Non-historic 2x4 lay-in ceiling.
8. Exposed conduit.
9. Open joints in stone.

1. Cracks, gouges, and chips in plaster walls
 - a. Structural Cracks: Remove base coat on either side of crack. Rout out crack 1/4" wide x 3/8" deep. Do not straighten or deviate from crack more than 1/8". Clean and prime as required. Inject epoxy grout appropriate for plaster wall repair to stabilize crack. Install surface applied fiberglass sheet per manufacturer's recommendations. Re-coat with 3-coat plaster system to feather in to match existing adjacent surfaces.

- b. Surface cracking, gouges and chips: Where entire wall surface is cracked or damaged, a wall restoration system (Nu-Wal Restoration System or equivalent) may be utilized. Prepare surfaces in accordance with manufacturer's recommendations. Sand ridges of cracks gouges and chips to even plane. Fill cracks, gouges and chips greater than 1/16". Repair large holes with patching plaster or drywall compound. Prime all bare plaster and patched areas. Seal chalky surfaces with penetrating surface conditioner in accordance with manufacturer's instructions. Apply plaster restoration system in accordance with manufacturer's instructions. Ensure completed application forms a seamless, monolithic surface, leaves no differing textures, and covers cracks and holes.

2. Broken and delaminating paint and plaster on walls
 - a. Loose or peeling paint: Remove unsound material as required. Fill/replaster as required to blend and match existing adjacent surfaces.

3. Areas of rough plaster:
 - a. Sand down area of rough plaster and skim coat, as required to provide a finish to match adjacent finishes.
4. Replace non-historic light fixtures with historically accurate fixtures (refer to electrical narrative).

5. Remove fire sprinkler piping and conceal in walls and ceilings (refer to mechanical narrative).
7. Remove exposed conduit and conceal in walls and ceilings (refer to electrical narrative).

8. Open joints in stone at window heads:
 - a. Remove any accumulated dirt, grease, wax, etc. from joint. Remove any loose grout back to stable grout. Rout out remaining joint with a bladed tool to a minimum depth of 1/4". Repoint with a polyurethane joint filler tinted to match existing grout.
