University of Idaho Administration Building

Entry Foyer & Main Stair Renovation
North Entry Mosaic Tile Restoration

Condition Survey

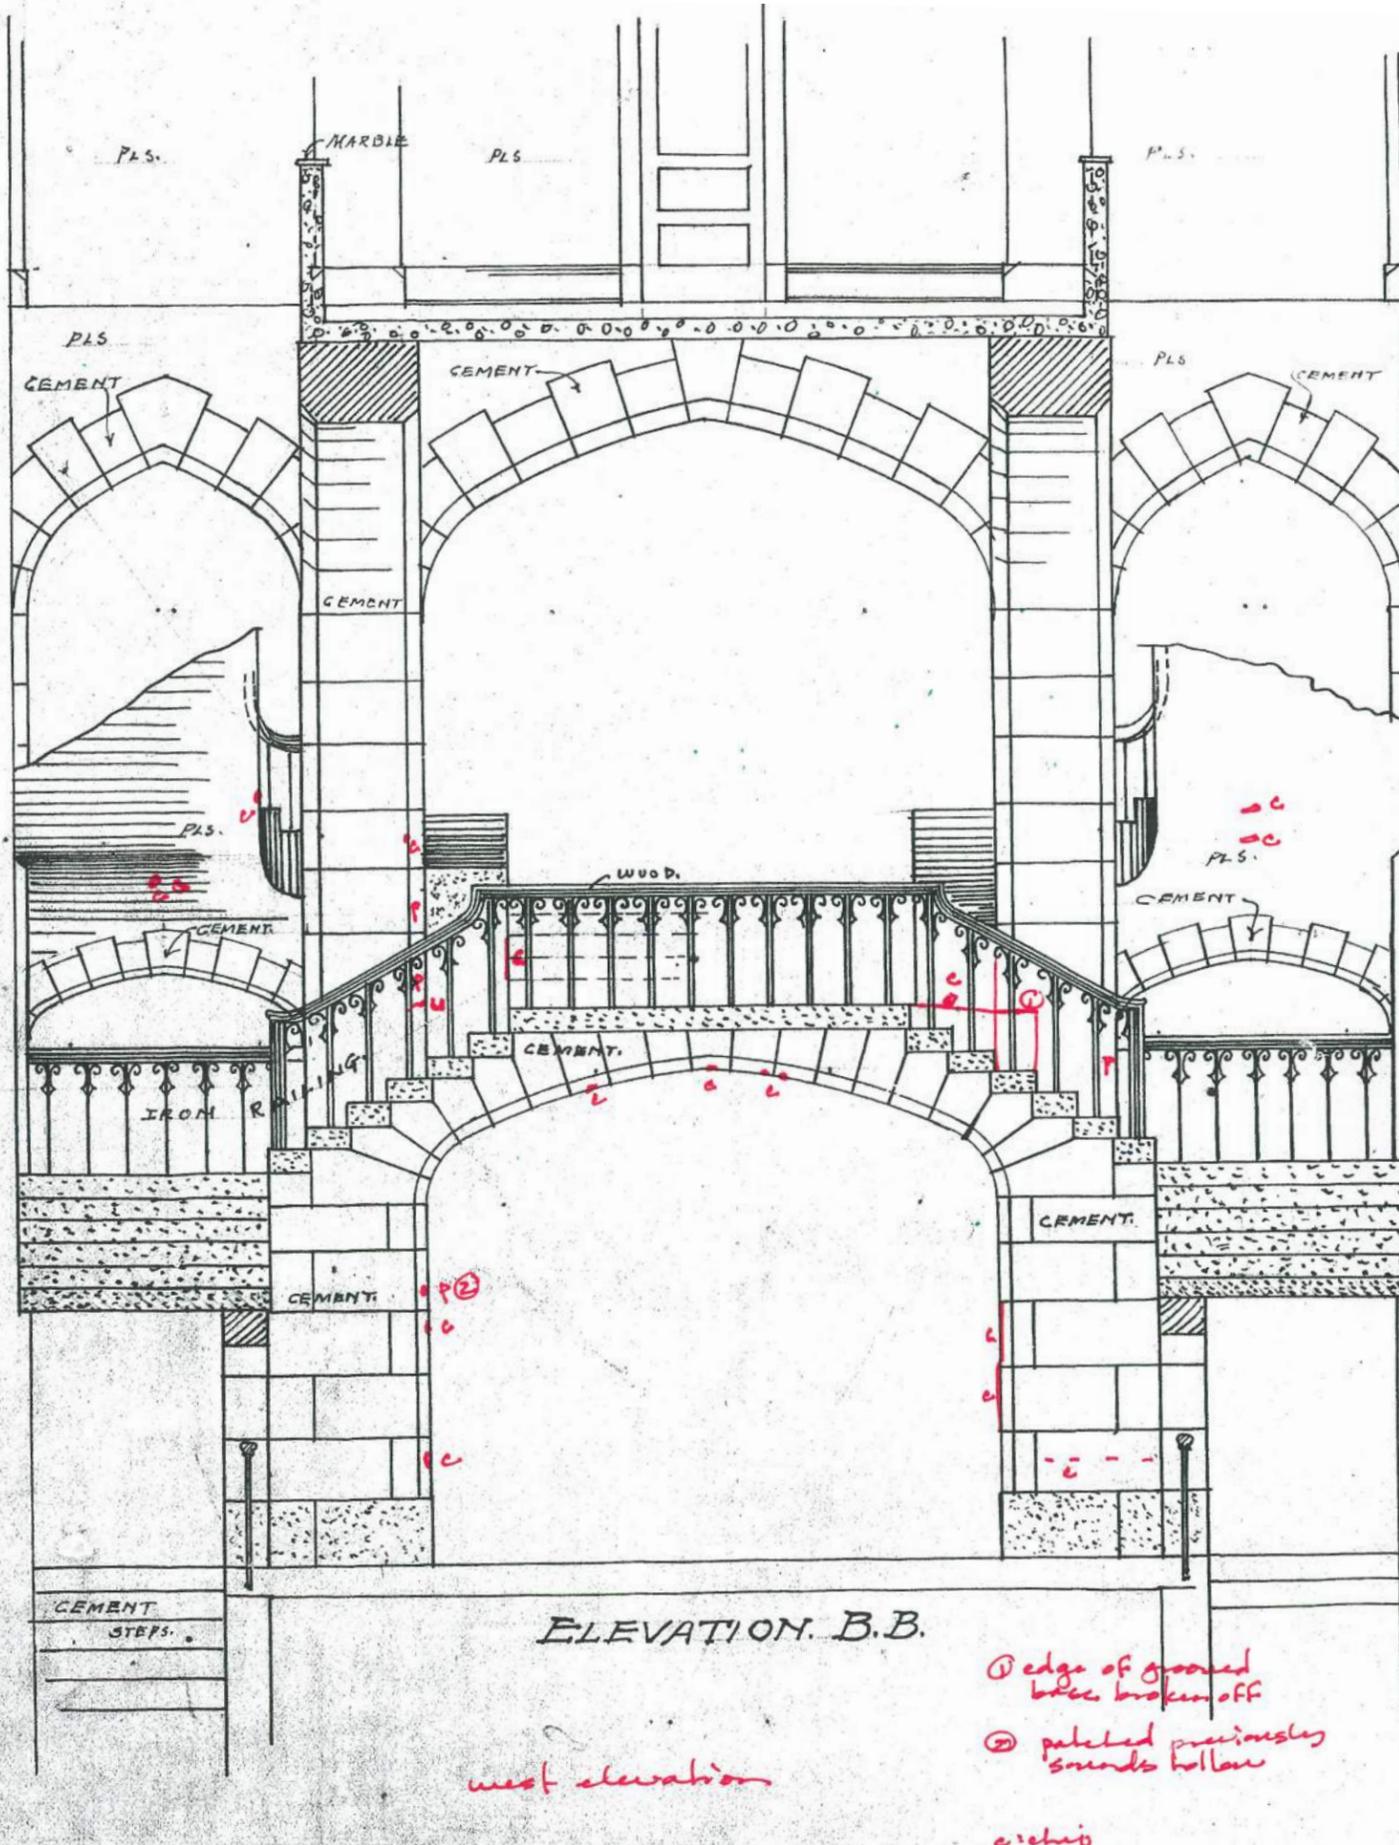
1. Chipped plaster or cement walls and arches
2. Delaminating plaster
3. Non-original patch in plaster or cement wall

1. Cracks, gouges, and chips in plaster or cement walls and arches
 - a. Structural Cracks: Remove base coat on either side of crack. Rout out crack 1/4" wide x 3/8" deep. Do not straighten or deviate from crack more than 1/8". Clean and prime as required. Inject epoxy grout appropriate for plaster wall repair to stabilize crack. Install surface applied fiberglass sheet per manufacturer's recommendations. Re-coat with 3-coat plaster system to feather in to match existing adjacent surfaces.

- b. Surface cracking, gouges and chips: Where entire wall surface is cracked or damaged, a wall restoration system (Nu-Wal Restoration System or equivalent) may be utilized. Prepare surfaces in accordance with manufacturer's recommendations. Sand ridges of cracks gouges and chips to even plane. Fill cracks, gouges and chips greater than 1/16". Repair large holes with patching plaster or drywall compound. Prime all bare plaster and patched areas. Seal chalky surfaces with penetrating surface conditioner in accordance with manufacturer's instructions. Apply plaster restoration system in accordance with manufacturer's instructions. Ensure completed application forms a seamless, monolithic surface, leaves no differing textures, and covers cracks and holes.

2. Broken and delaminating paint and plaster on walls
 - a. Remove unsound material as required. Fill/replaster as required to blend and match existing adjacent surfaces.

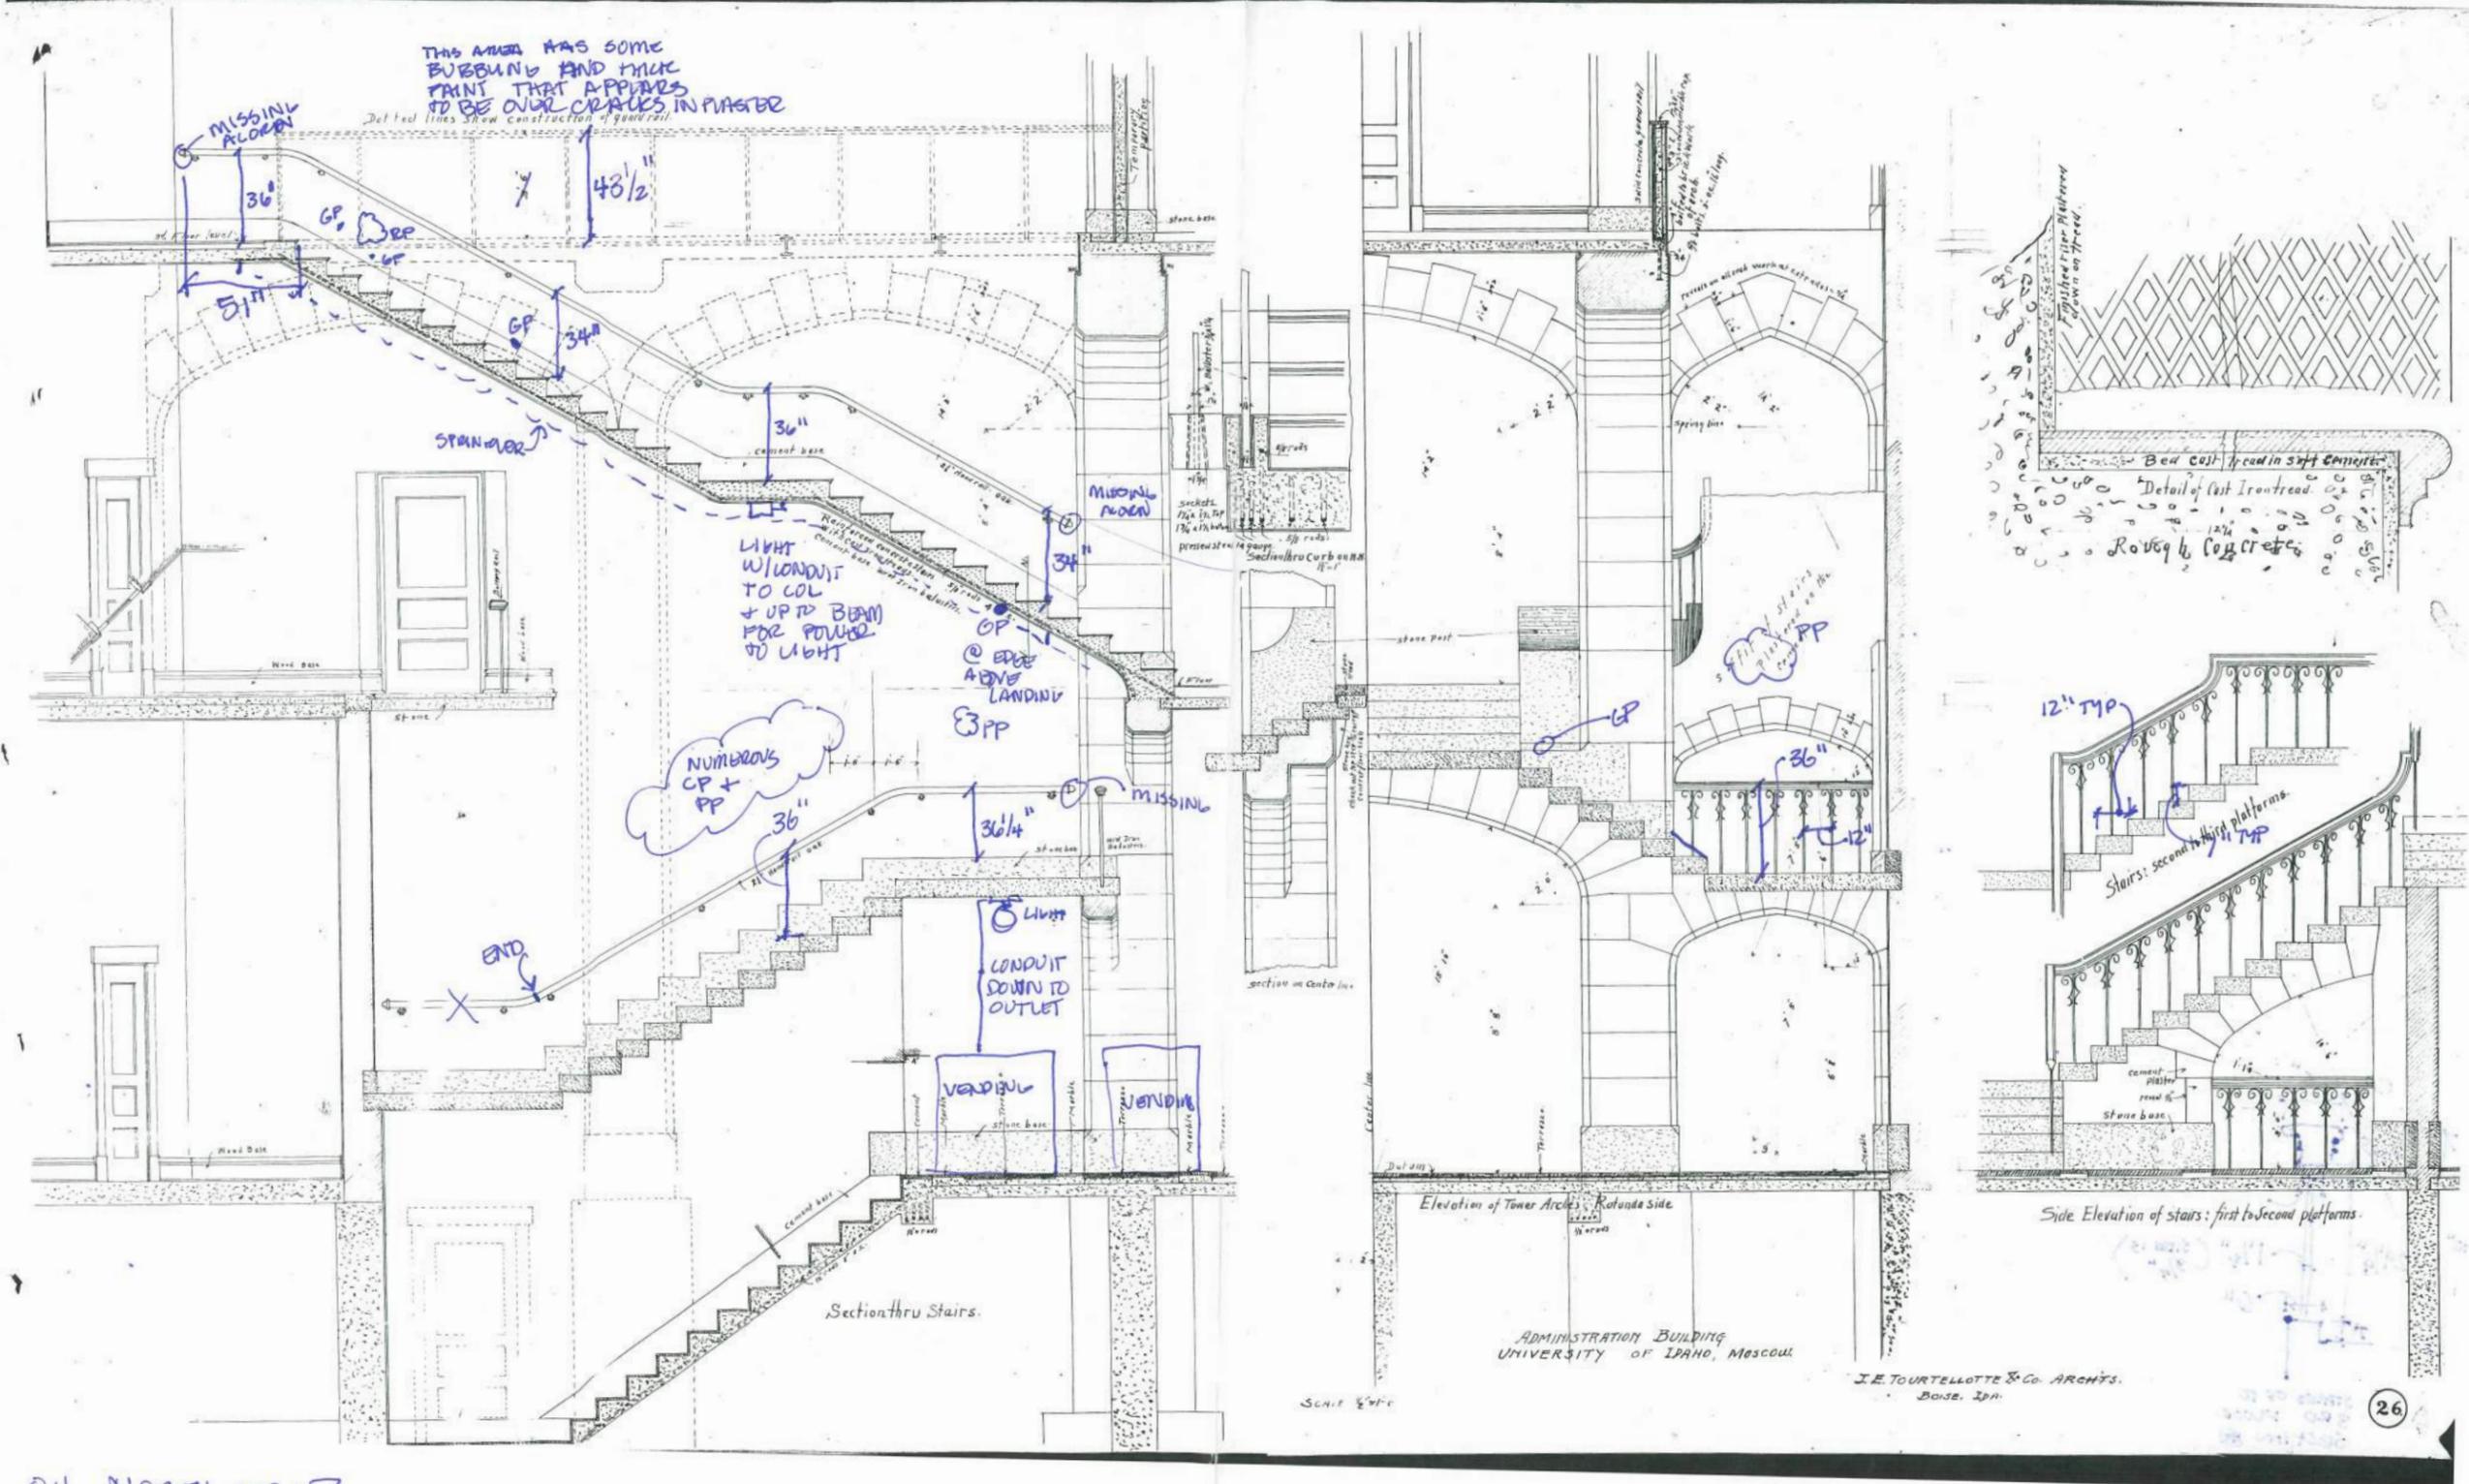
OH NORTH STAIRS

1. Cracks, gouges and chips in plaster walls.
2. Non-historic light fixtures.
3. Exposed sprinkler piping.
4. Exposed conduit.

1. Cracks, gouges and chips in plaster walls.
 - a. Structural Cracks: Remove base coat on either side of crack. Rout out crack ¼" wide x 3/8" deep. Do not straighten or deviate from crack more than 1/8". Clean and prime as required. Inject epoxy grout appropriate for plaster wall repair to stabilize crack. Install surface applied fiberglass sheet per manufacturer's recommendations. Re-coat with 3-coat plaster system to feather in to match existing adjacent surfaces.

- b. Surface cracking, gouges and chips: Where entire wall surface is cracked or damaged, a wall restoration system (Nu-Wal Restoration System or equivalent) may be utilized. Prepare surfaces in accordance with manufacturer's recommendations. Sand ridges of cracks gouges and chips to even plane. Fill cracks, gouges and chips greater than 1/16". Repair large holes with patching plaster or drywall compound. Prime all bare plaster and patched areas. Seal chalky surfaces with penetrating surface conditioner in accordance with manufacturer's instructions. Apply plaster restoration system in accordance with manufacturer's instructions. Ensure completed application forms a seamless, monolithic surface, leaves no differing textures, and covers cracks and holes.

2. Replace non-historic light fixtures with historically accurate fixtures (refer to electrical narrative).
3. Remove fire sprinkler piping and conceal in walls and ceilings (refer to mechanical narrative).

4. Remove non-historic lay-in acoustic tile, and install a new plaster ceiling.
5. Remove exposed conduit and conceal in walls and ceilings (refer to electrical narrative).

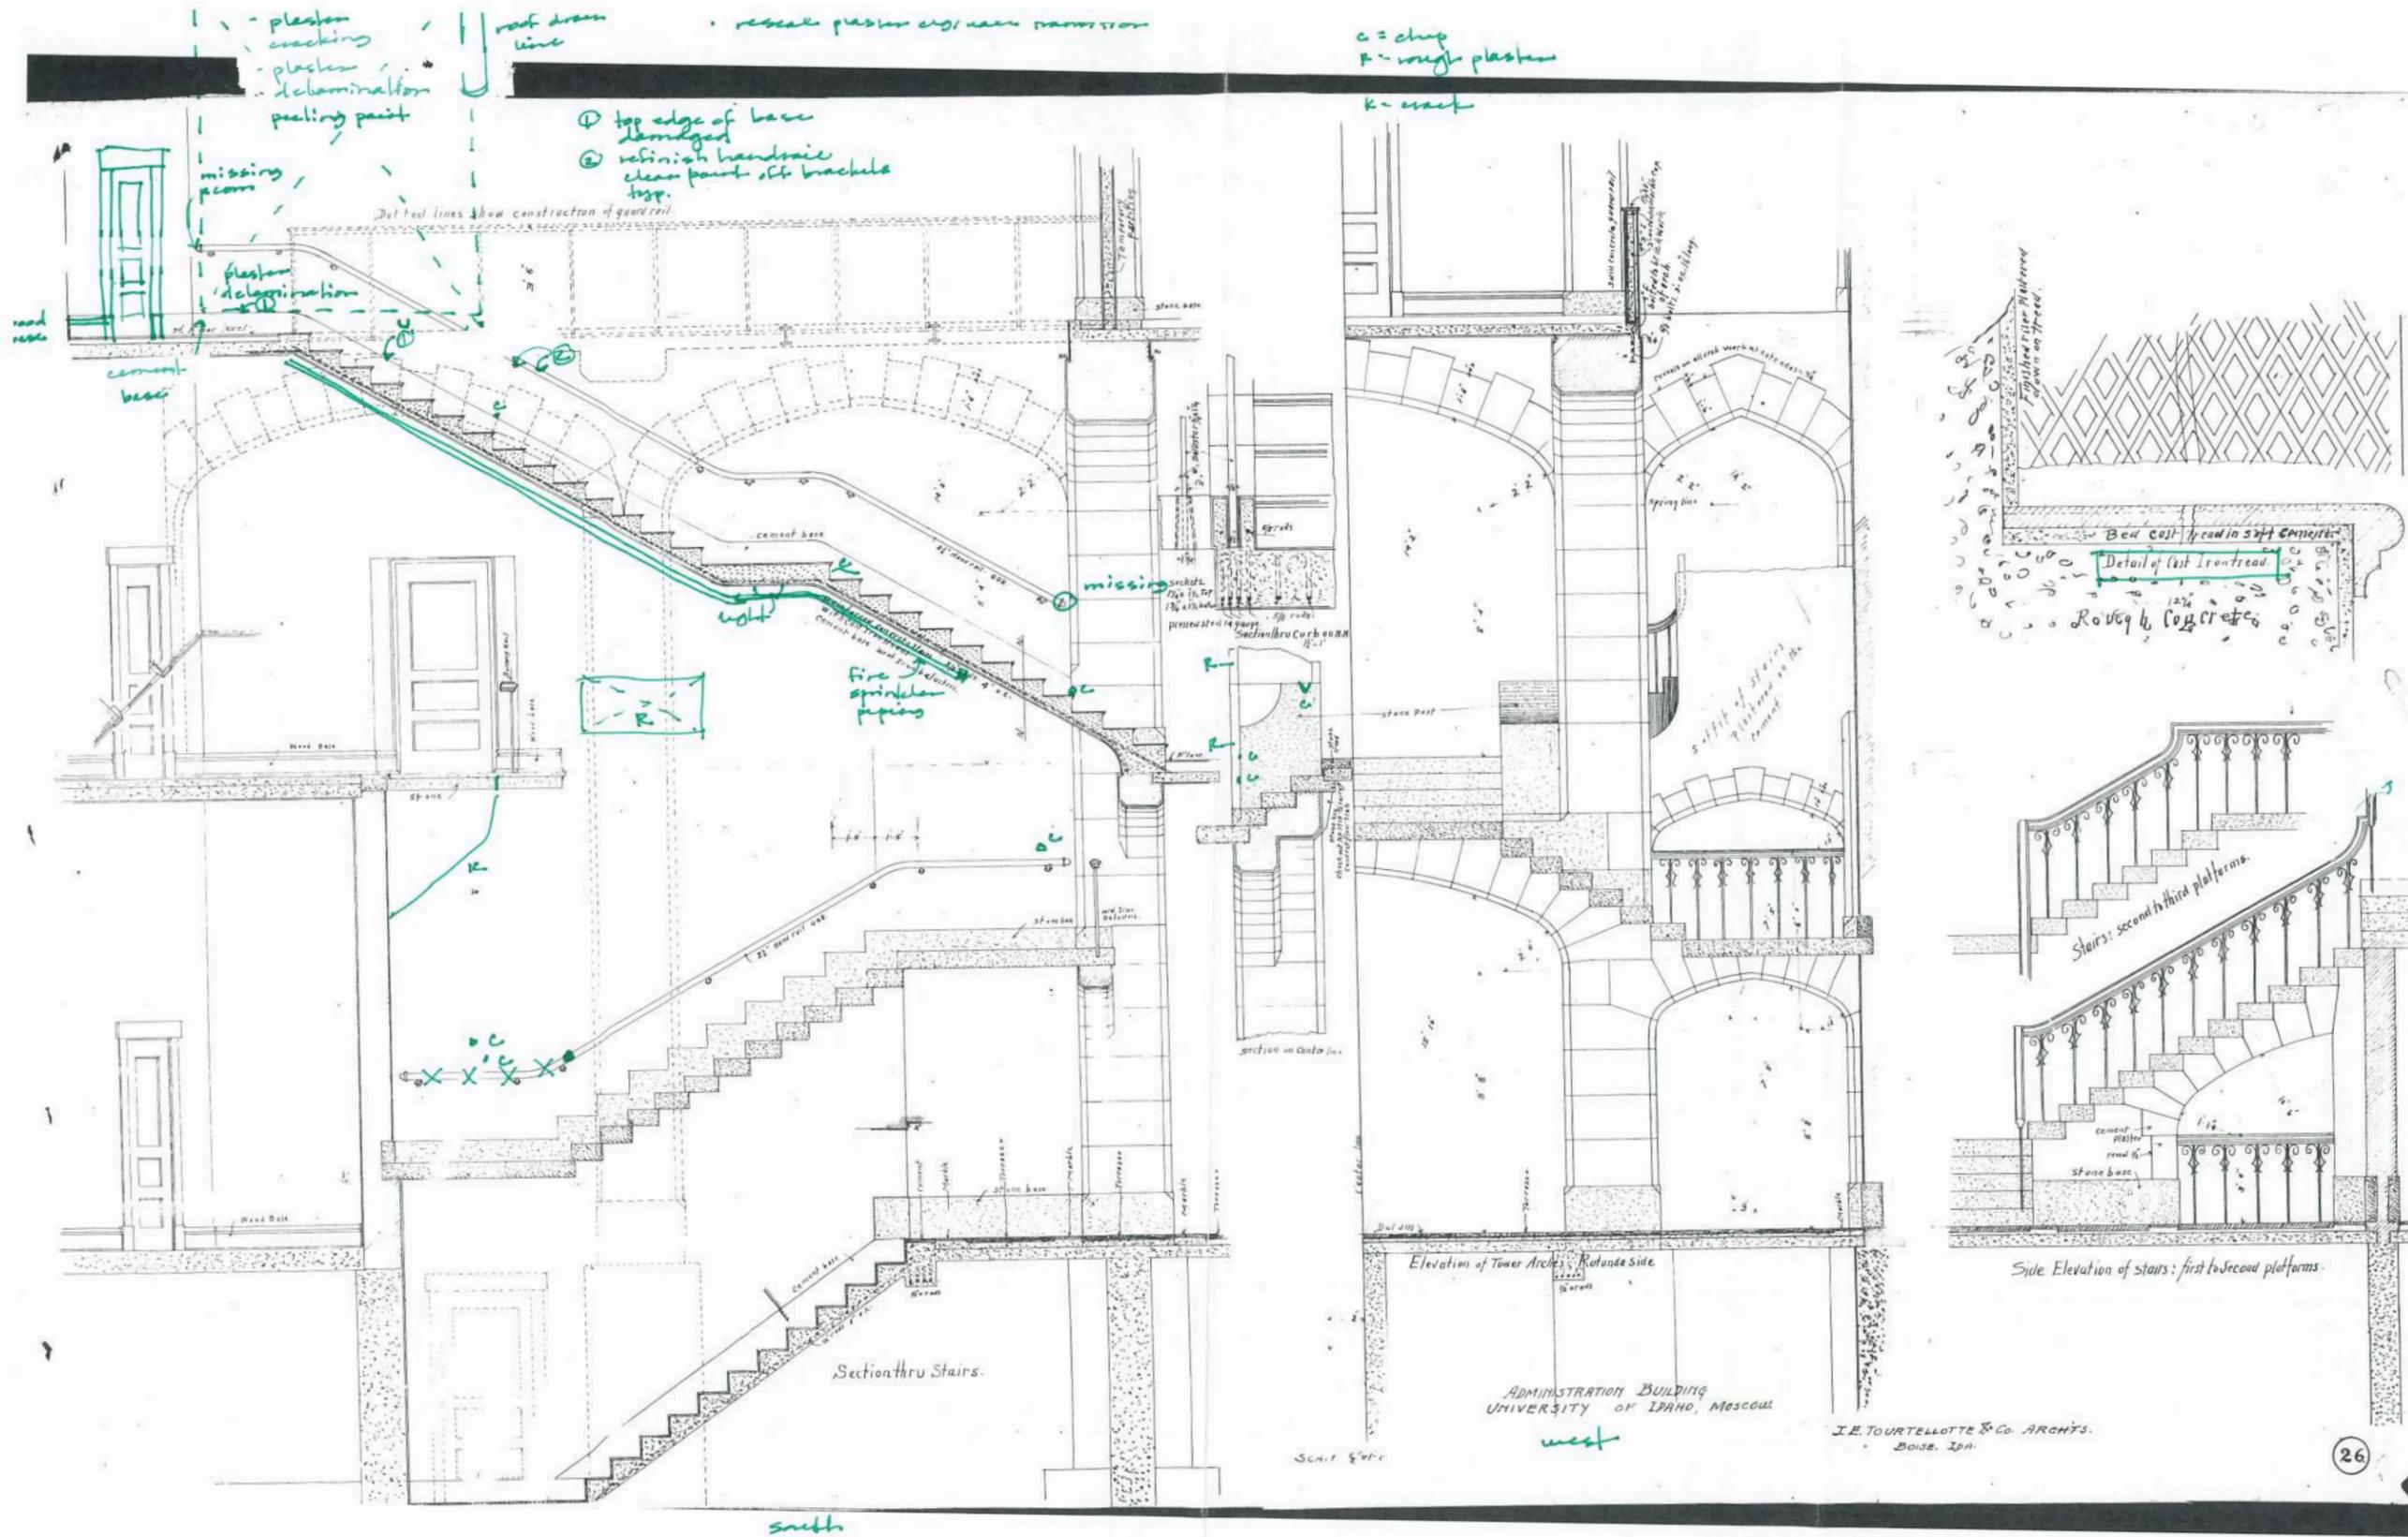
1. Cracks, gouges and chips in plaster walls.
2. Non-historic light fixtures.
3. Exposed sprinkler piping.
4. Exposed conduit.
5. Rough plaster
6. Delaminating plaster

1. Cracks, gouges and chips in plaster walls.
 - a. Structural Cracks: Remove base coat on either side of crack. Rout out crack ¼” wide x 3/8” deep. Do not straighten or deviate from crack more than 1/8”. Clean and prime as required. Inject epoxy grout appropriate for plaster wall repair to stabilize crack. Install surface applied fiberglass sheet per manufacturer’s recommendations. Re-coat with 3-coat plaster system to feather in to match existing adjacent surfaces.

- b. Surface cracking, gouges and chips: Where entire wall surface is cracked or damaged, a wall restoration system (Nu-Wal Restoration System or equivalent) may be utilized. Prepare surfaces in accordance with manufacturer’s recommendations. Sand ridges of cracks gouges and chips to even plane. Fill cracks, gouges and chips greater than 1/16”. Repair large holes with patching plaster or drywall compound. Prime all bare plaster and patched areas. Seal chalky surfaces with penetrating surface conditioner in accordance with manufacturer’s instructions. Apply plaster restoration system in accordance with manufacturer’s instructions. Ensure completed application forms a seamless, monolithic surface, leaves no differing textures, and covers cracks and holes.

2. Replace non-historic light fixtures with historically accurate fixtures (refer to electrical narrative).
3. Remove fire sprinkler piping and conceal in walls and ceilings (refer to mechanical narrative).

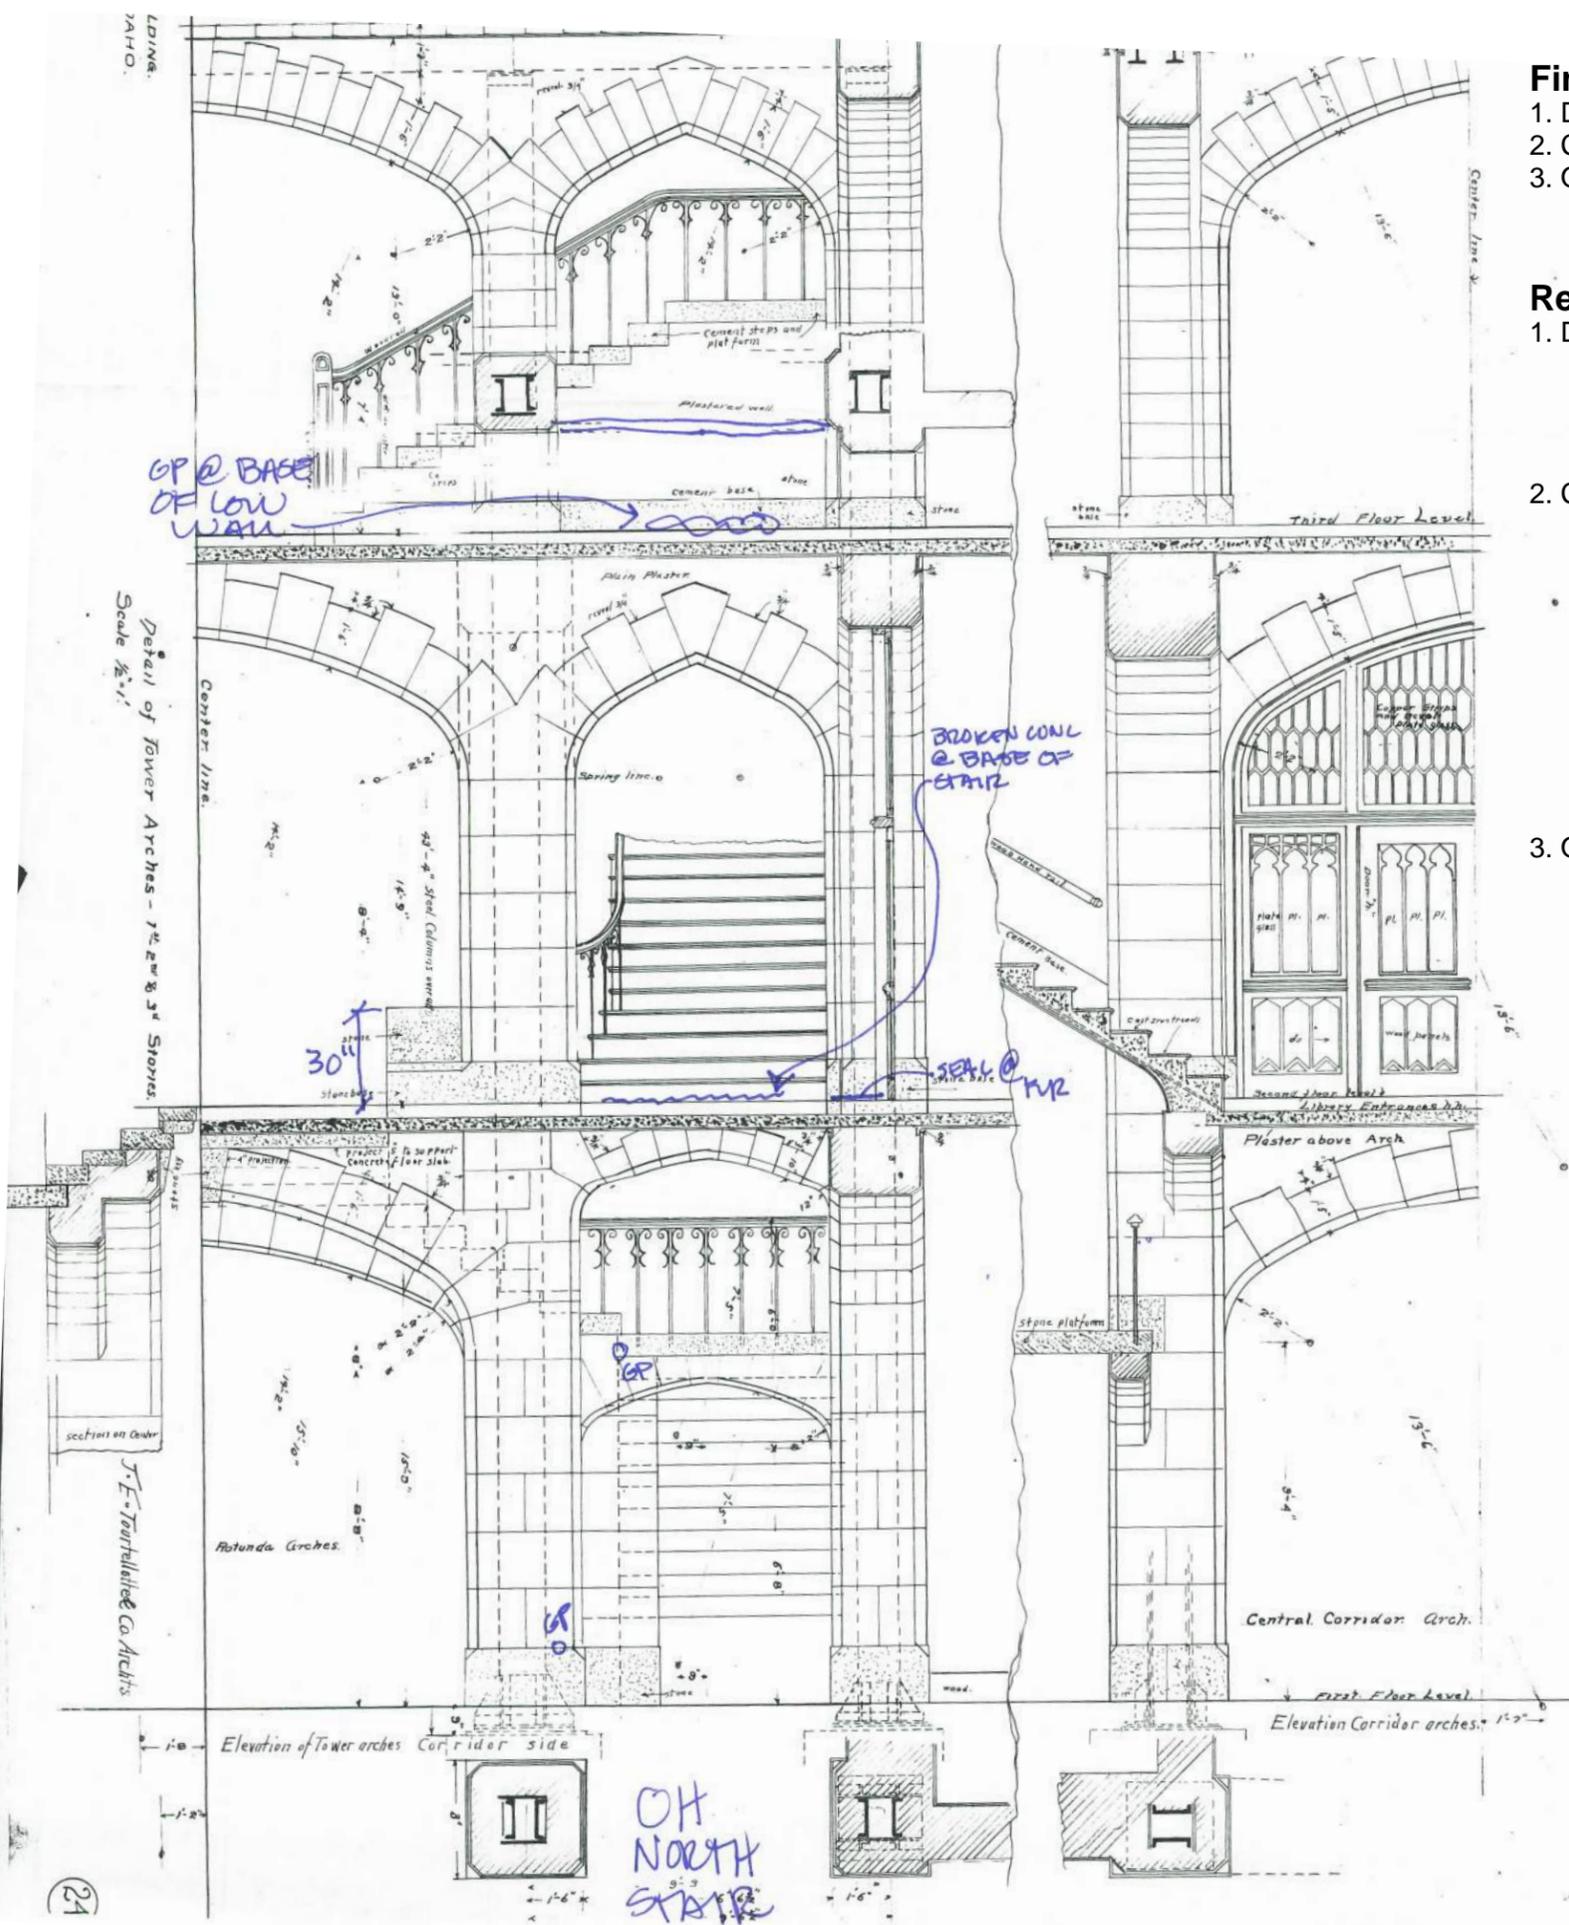
1. Delaminating concrete at stairs
2. Chip or gouge in plaster or cement.
3. Open joint

3. Open joint at base of wall:
 - a. Remove loose and deteriorating material along entire length of joint and repoint.

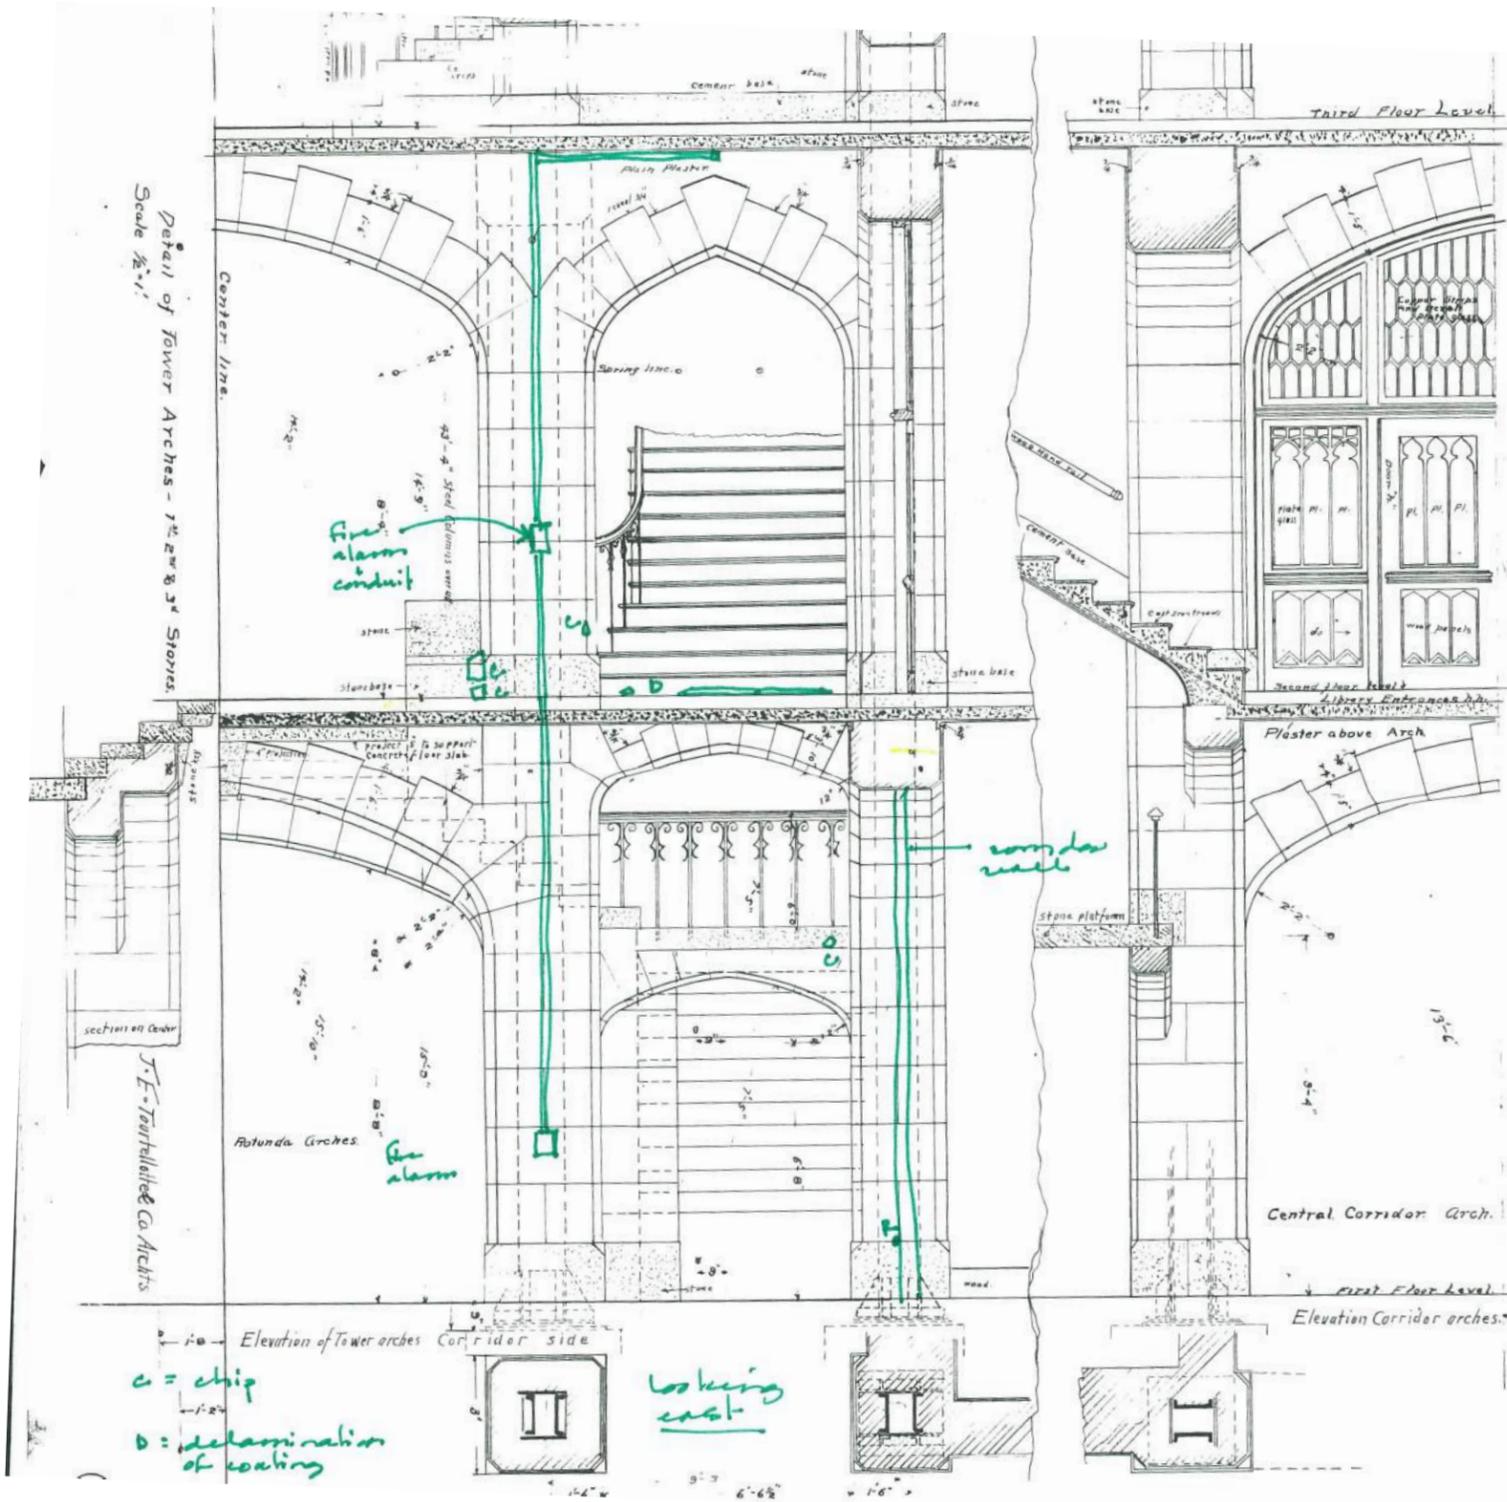
1. Non-historic light fixtures
2. Exposed fire sprinkler piping.
3. Exposed conduit

1. Replace non-historic light fixtures with historically accurate fixtures (refer to electrical narrative).
2. Remove fire sprinkler piping and conceal in walls and ceilings (refer to mechanical narrative).
3. Remove exposed conduit and conceal in walls and ceilings (refer to electrical narrative).

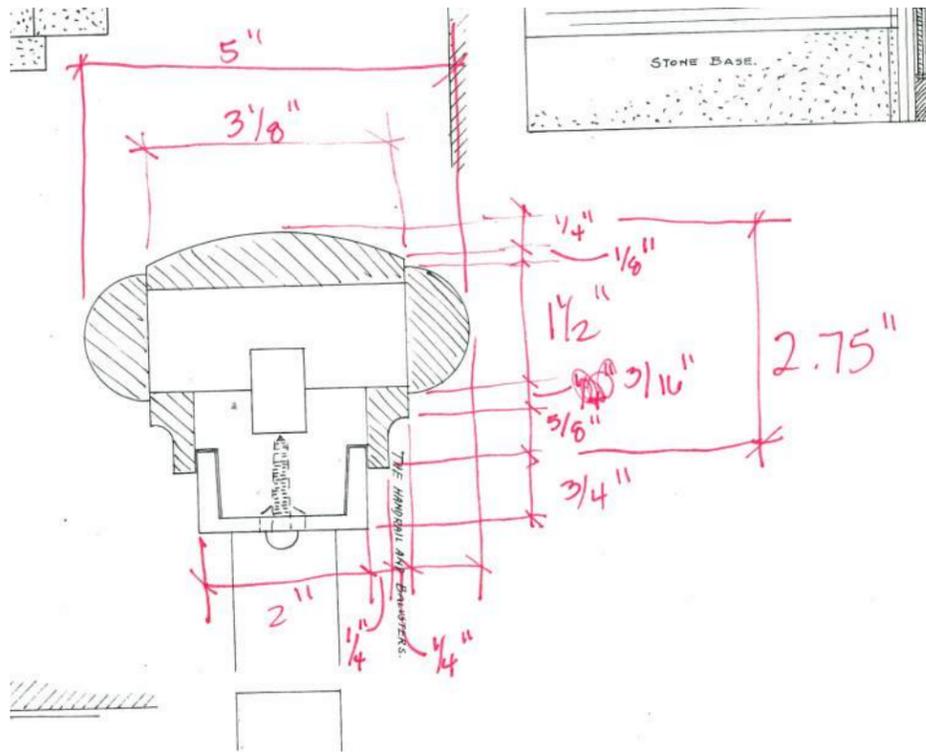
1. Guardrails are too low per code
2. Handrail gripping profile does not meet code
3. Handrails are missing decorative acorns at terminations.
4. Handrails do not extend beyond bottom and top riser per code
5. Height of handrails at some locations do not meet code.
6. Spacing at guardrail iron pickets on stairs do not meet code.
7. Historic handrails will be exposed on second floor balcony when non-original closets are removed.

1. Apply a supplementary guardrail that meets code on landing side of historic guardrail that is low-profile and does not distract from the prominence of the historic guardrail.
2. Replace existing handrails with code compliant wood handrails.
3. Replace acorns.
4. Code compliant replacement wood handrails shall have extensions per code.
5. Replacement handrails shall meet code height.
6. Apply a supplementary guardrail that in conjunction with the existing historic guardrails meets code. Supplemental guardrail will be low-profile and shall not distract from the prominence of the historic guardrail.
7. Repair and refinish exposed historic guard rails.

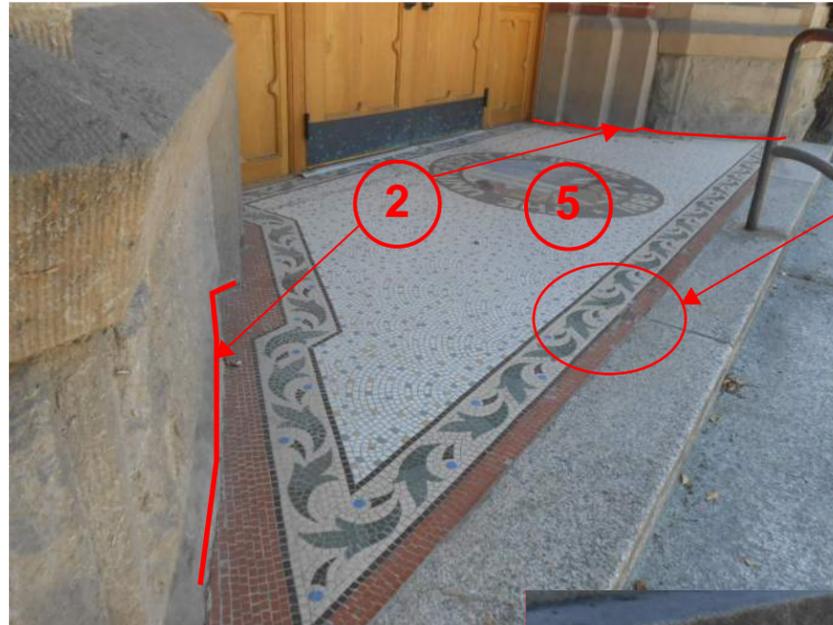
1. Cracks in mosaic
2. Missing sealant around perimeter of mosaic.
3. Open mortar joints
4. Missing or damaged mosaic tiles
5. Mosaic tile glaze failure
6. Missing sealant at stair joints
7. Rotated bottom stair step

1. Remove dirt and loose joint material entire length of crack. Regrout any loose tiles and infill the crack with new grout to match existing.
2. Remove any loose or deteriorated sealant and reseal.
3. Regrout loose tiles, remove damaged/loose mortar, and repoint using a grout that matches the existing.
4. Remove existing grout around missing or broken tiles with a grout saw. Remove broken tiles. Provide a new setting bed. Regrout around new tiles with grout to match existing.
5. Once repairs are made, and tiles are cleaned treat area with a mineral densifying agent, followed by a siloxane sub-surface repellent.
6. Remove loose or damaged sealant and reseal.
7. Remove stair in its entirety. Recompact soil below, and reform stair with concrete. Note that the adjacent sidewalk may need to be partially replaced to maintain slopes per code.

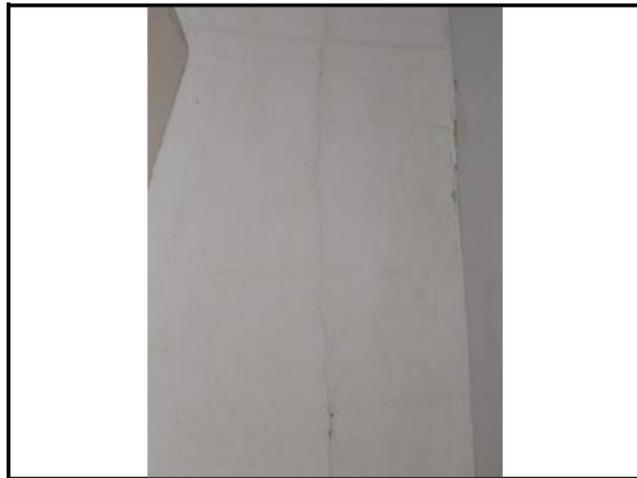
cracked plaster

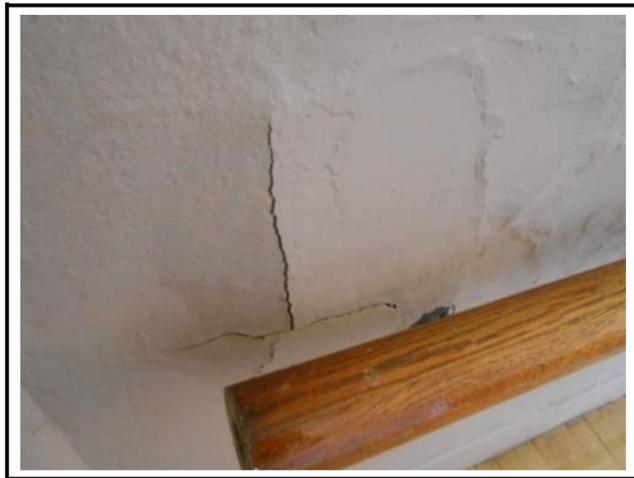
cracked plaster

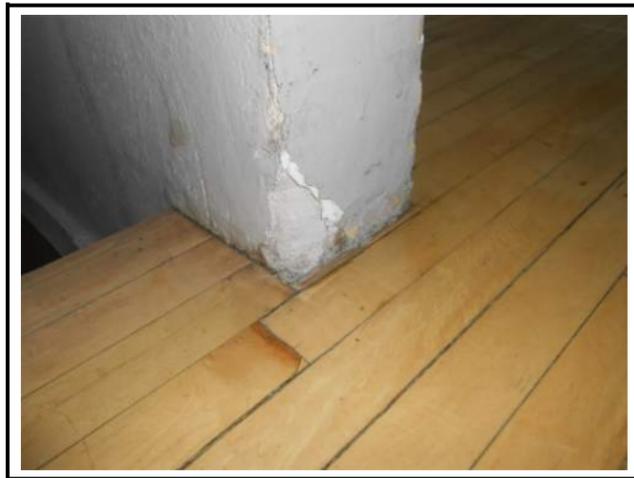
plaster gouges

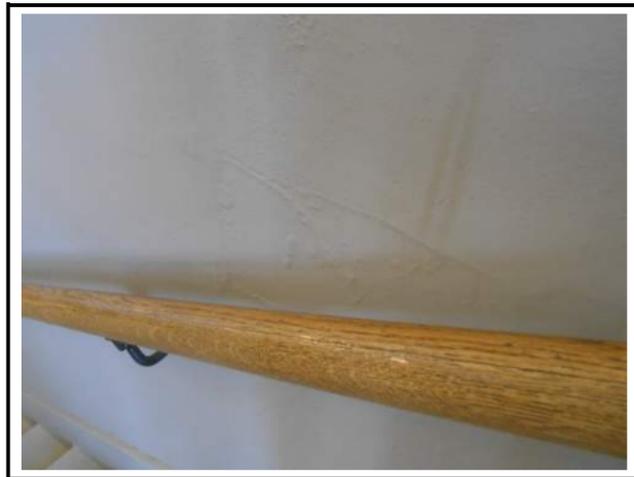
plaster cracks at wood railing

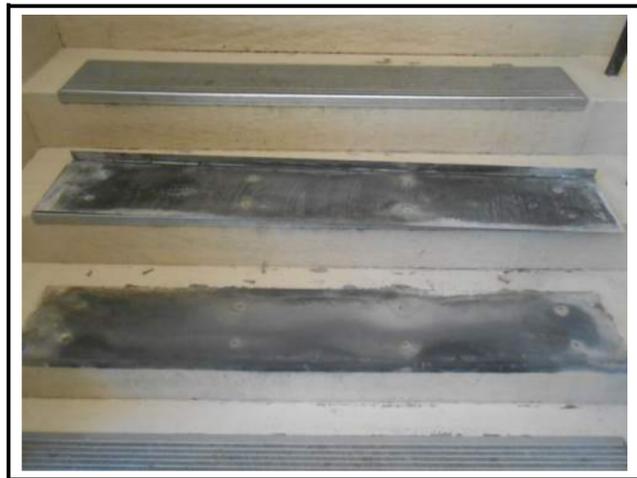
non-original stair nosings

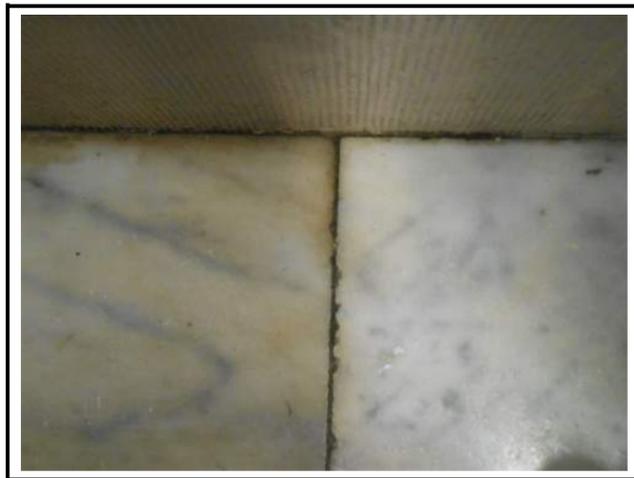
missing or loose marble floor grout

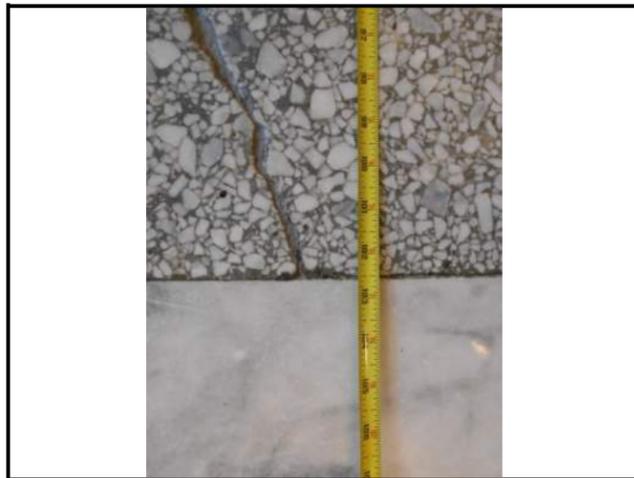
missing or loose terrazzo floor grout

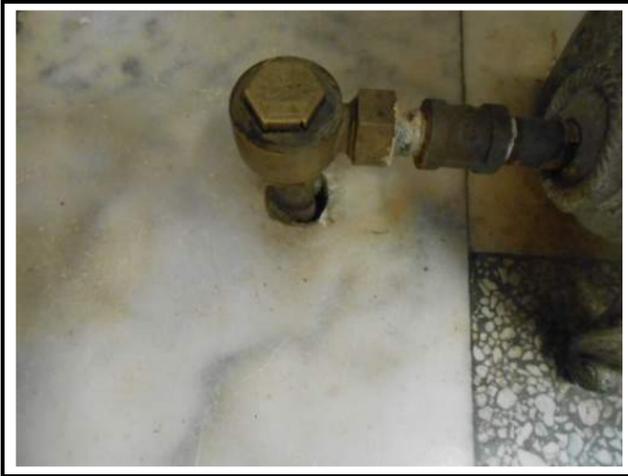
chip in marble flooring

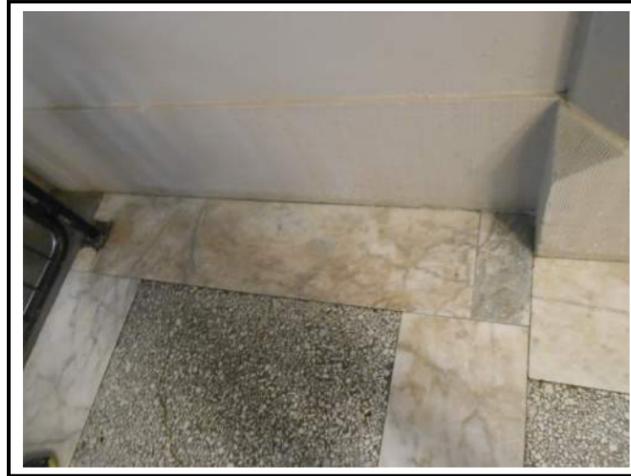
stained marble flooring

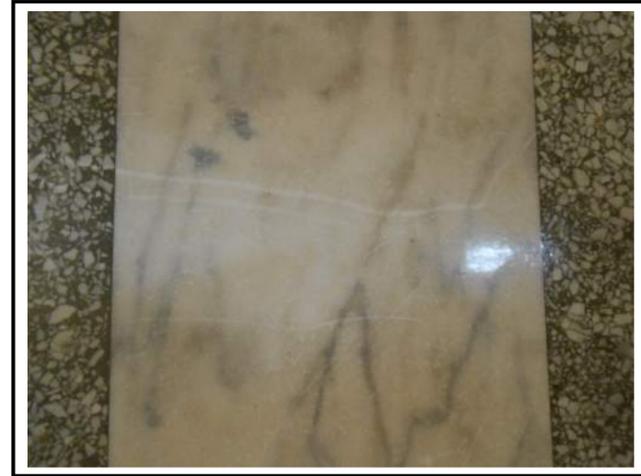
scratches in marble flooring

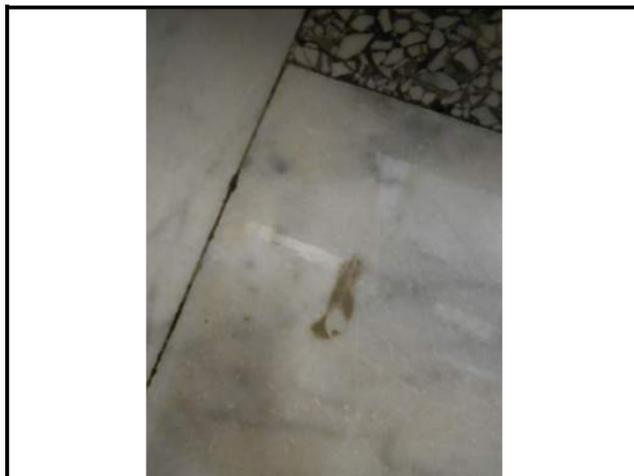
residue on marble flooring

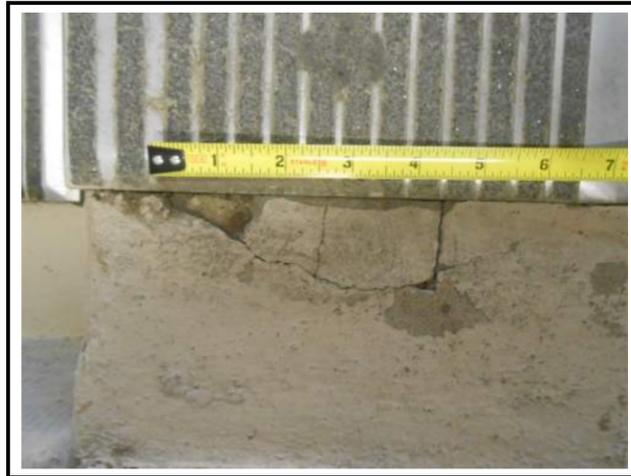
cracked concrete

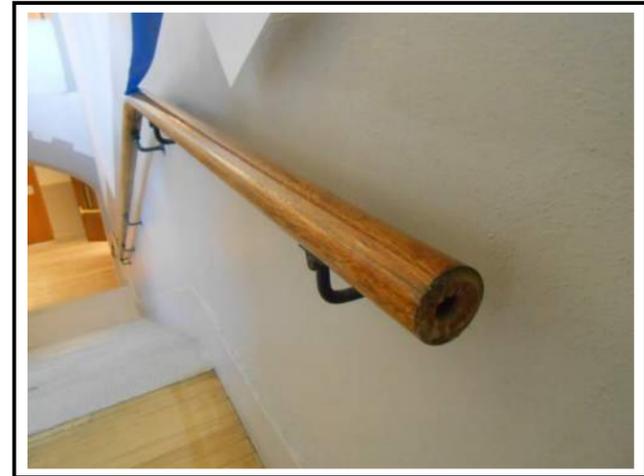
missing acorn on wood handrail

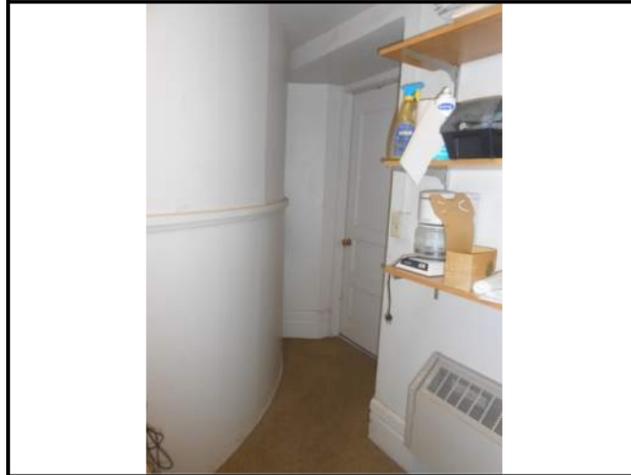
non-original carpet floor finish
