University of Idaho Administration Building

Entry Foyer & Main Stair Renovation
North Entry Mosaic Tile Restoration

Condition Survey

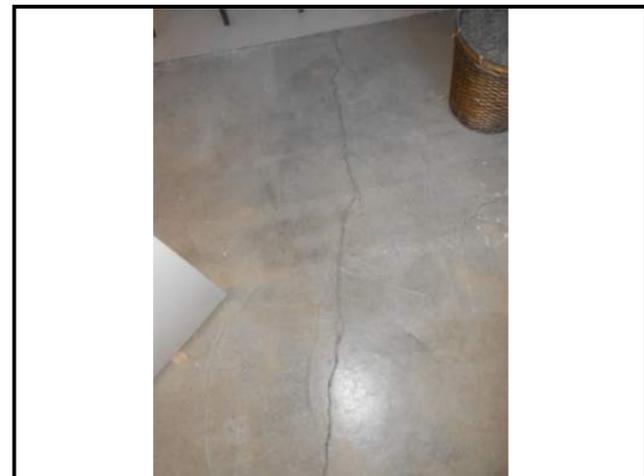
concrete cracks

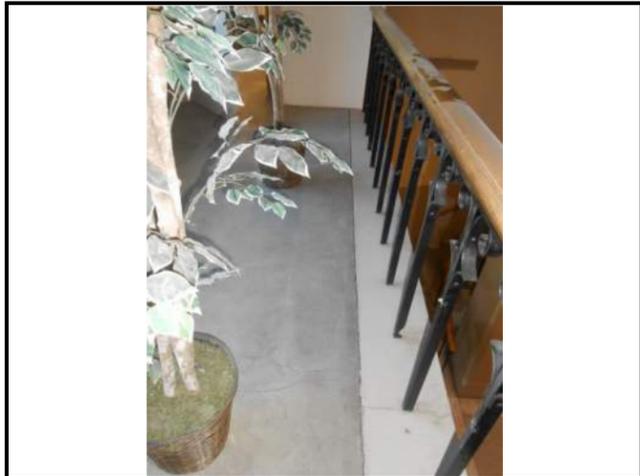
open concrete joints

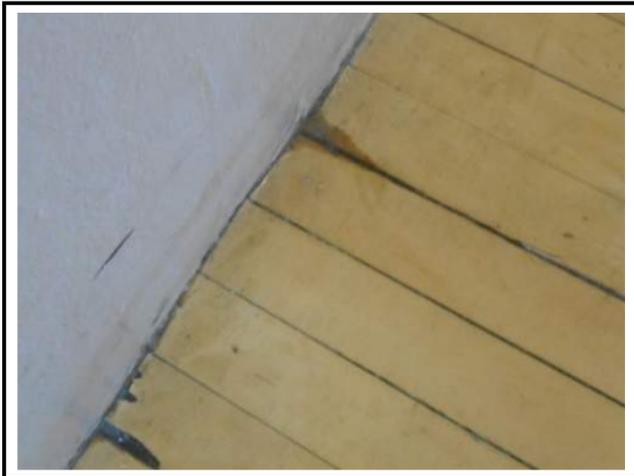
damaged wood floor at perimeter

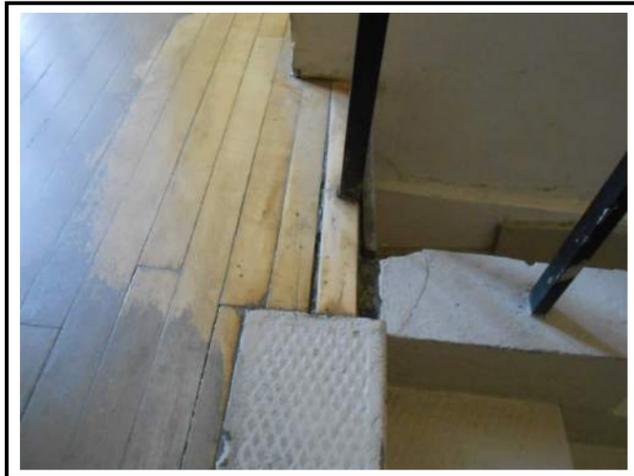
faded and worn wood floor

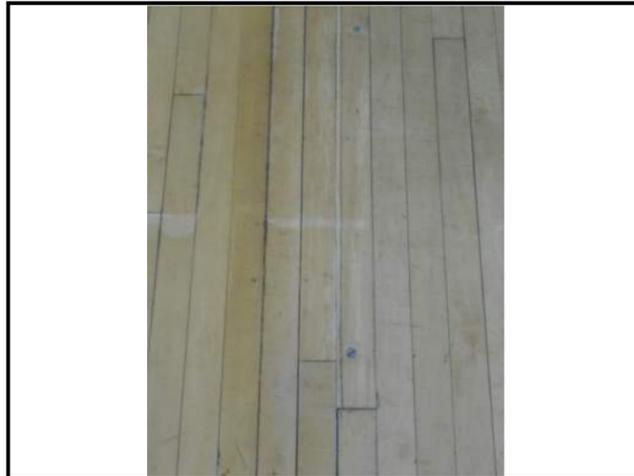
patched and screwed down wood floor

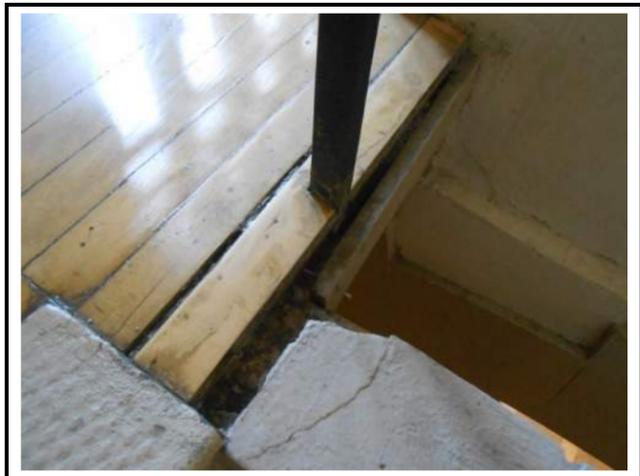
loose marble fascia at third floor landing

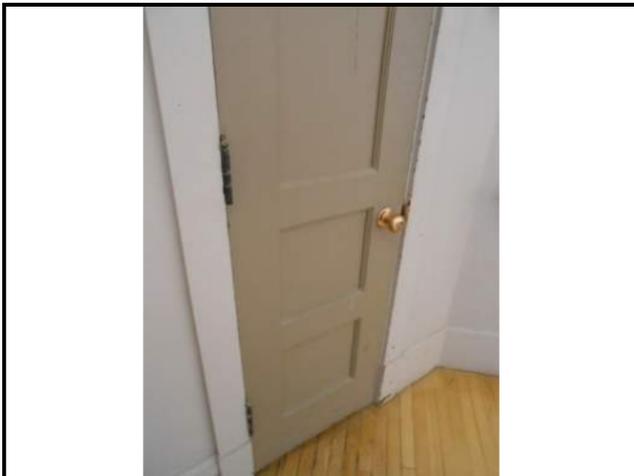
crack in original wood door

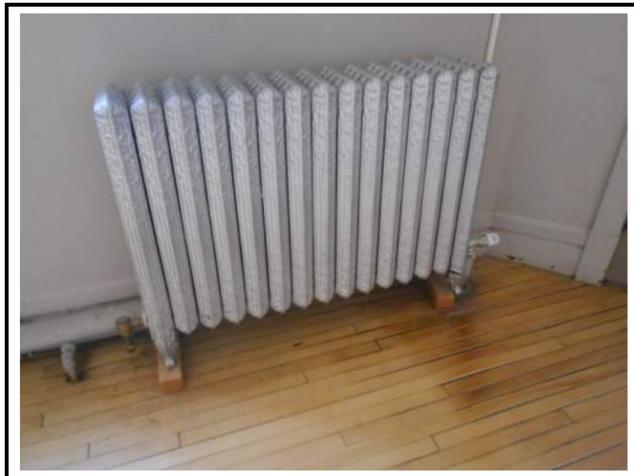
misaligned radiator

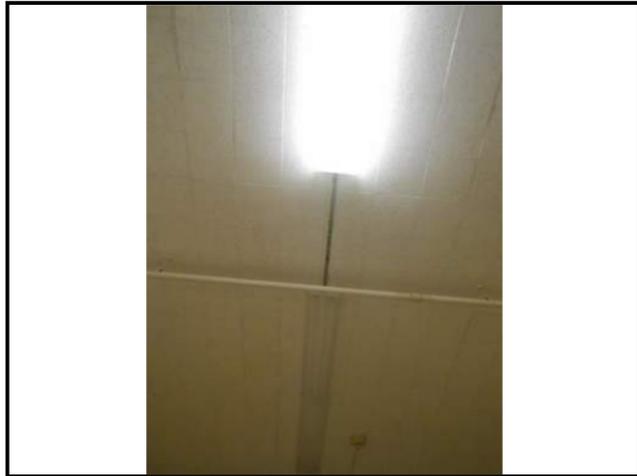
non-historic glue-on ceiling tile

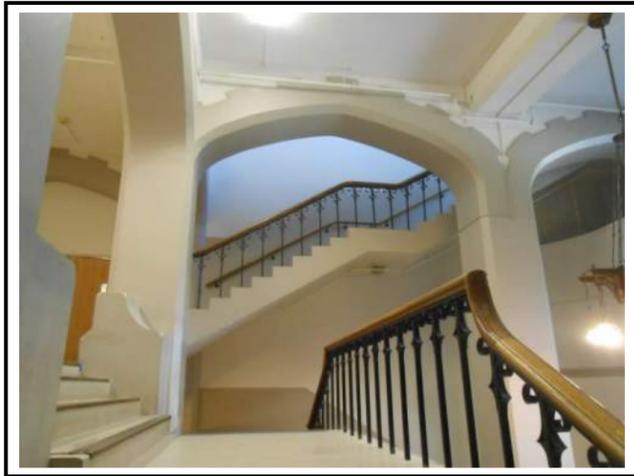
crack in plaster arch

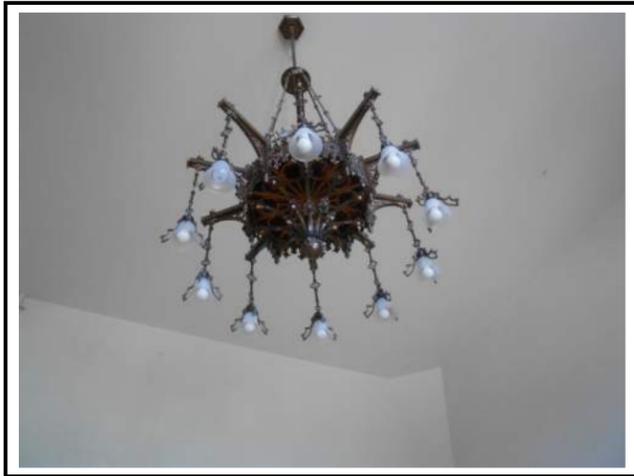
pendant mounted historic chandelier

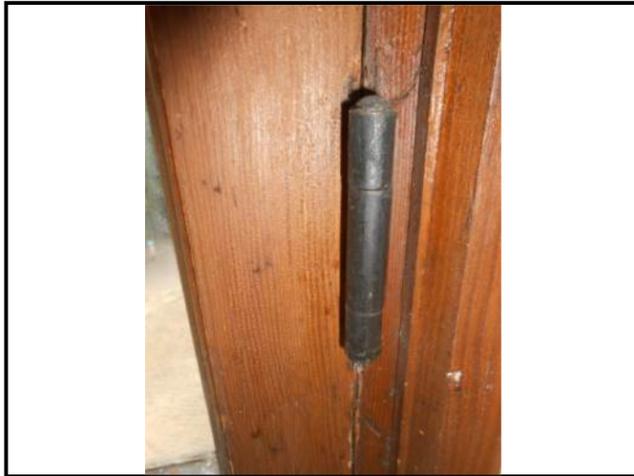
broken trim at wood windows

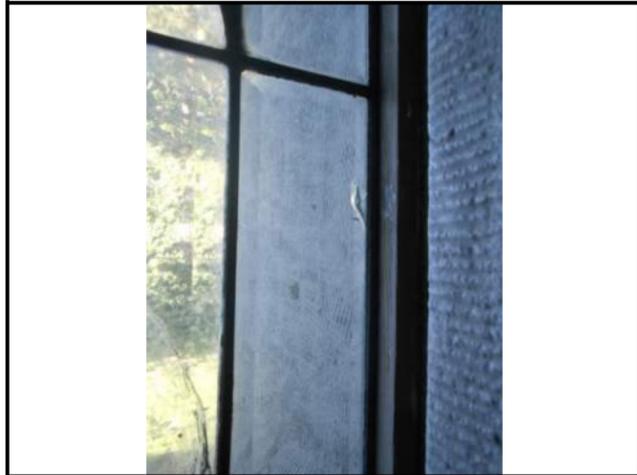
broken glass at wood windows

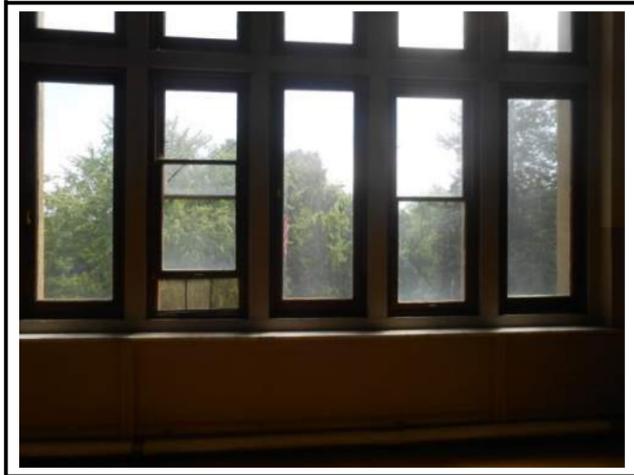
missing screens at wood windows

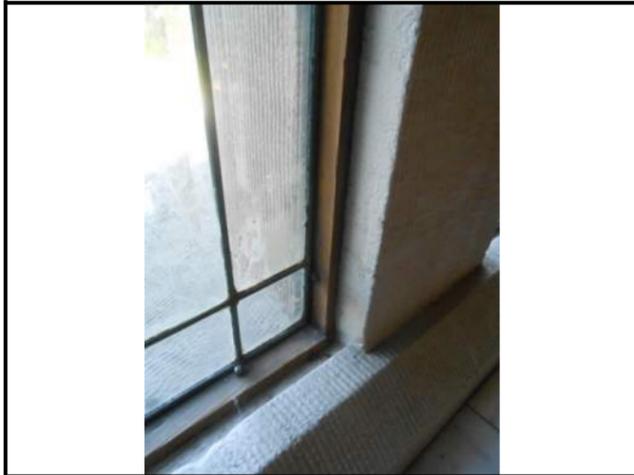
missing screws on wood window frame

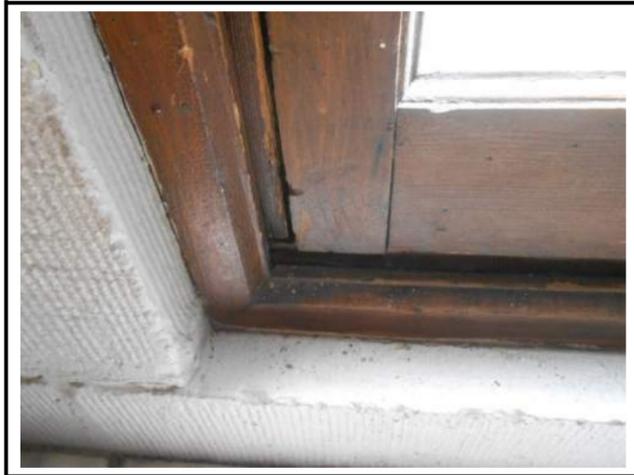
missing sealant around wood window frame

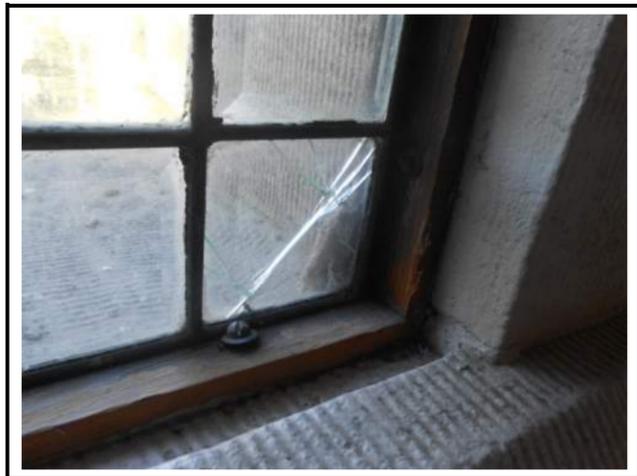
loose screws/broken glass at wood windows

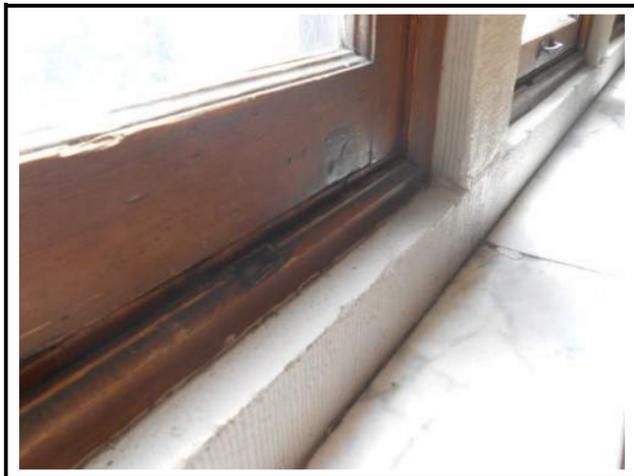
uneven finish on wood windows

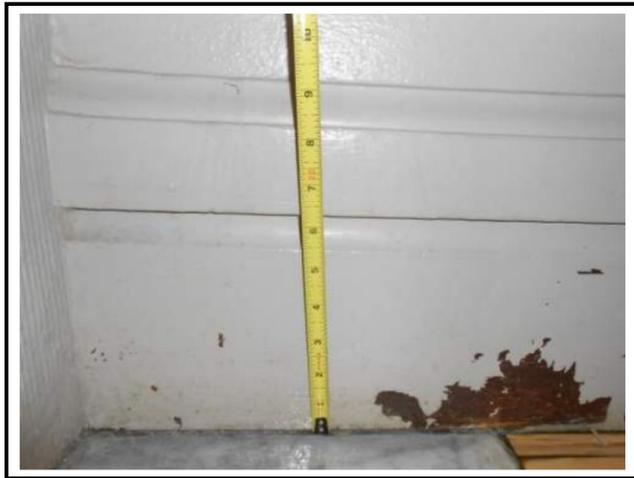
non-original paint on wood base

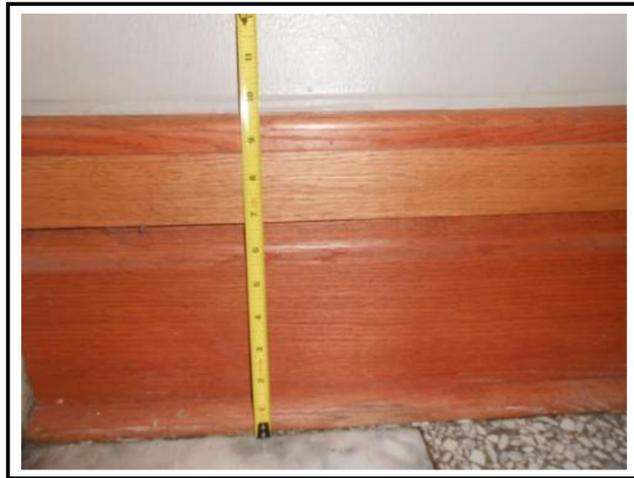
non-original stain on wood base

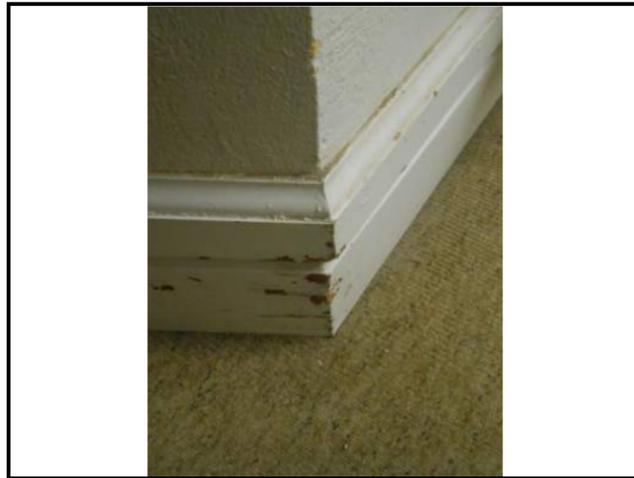
non-original paint on wood base

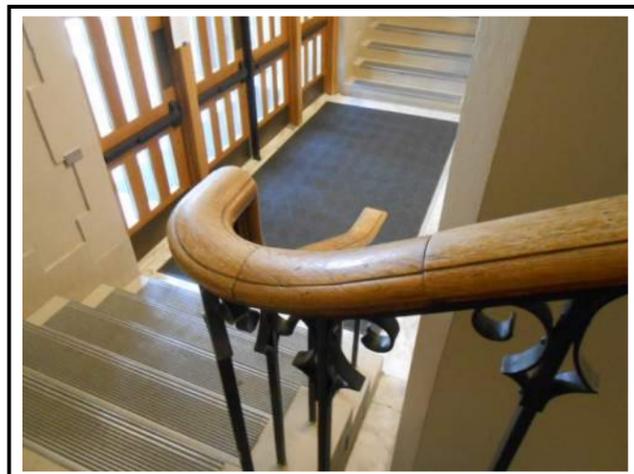
handrail gripping profile does not meet code
