**DPW PROJECT 13926  
603 WEST FRANKLIN STREET  
DEPARTMENT OF ADMINISTRATION  
BOISE, IDAHO**

**ASBESTOS-CONTAINING BUILDING MATERIAL AND LEAD PAINT  
SURVEY AND ASSESSMENT REPORT**

May 22, 2013

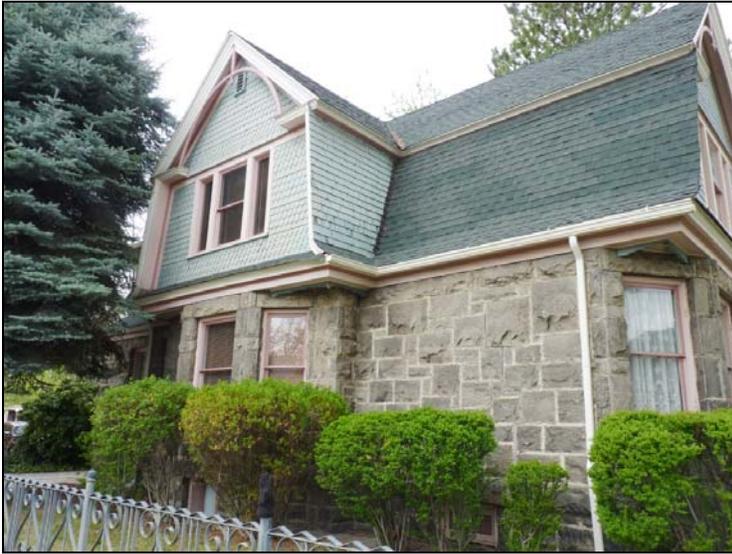
**1. View of non-asbestos asphalt shingled roofing found on the house. Also shows non-asbestos mortar found between the rock exterior finish.**

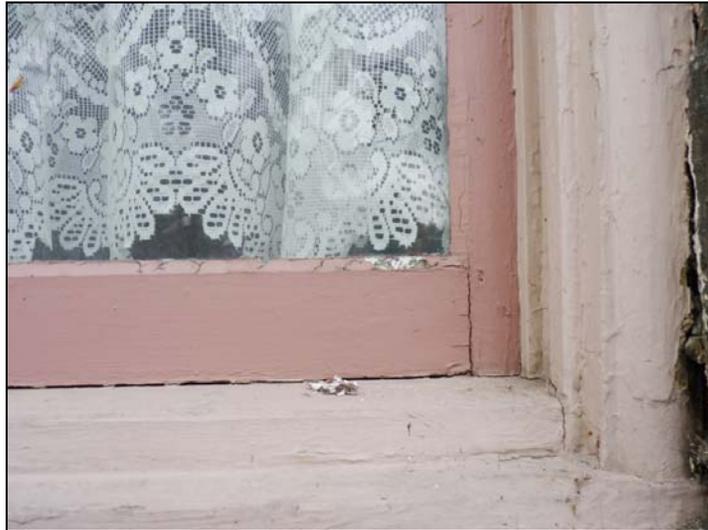
**2. View of the non-regulated asbestos-containing window glazing found on the exterior wood frame windows located around the house and garage.**

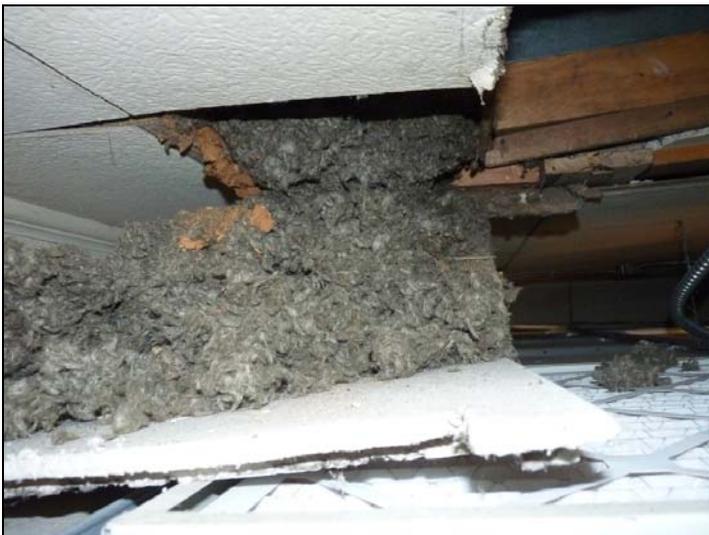
**3. View of non-asbestos (white) 12-inch ceiling tiles found above the suspended ceiling in the upper level. Also shows the blown-in insulation found within the attic space of the house.**

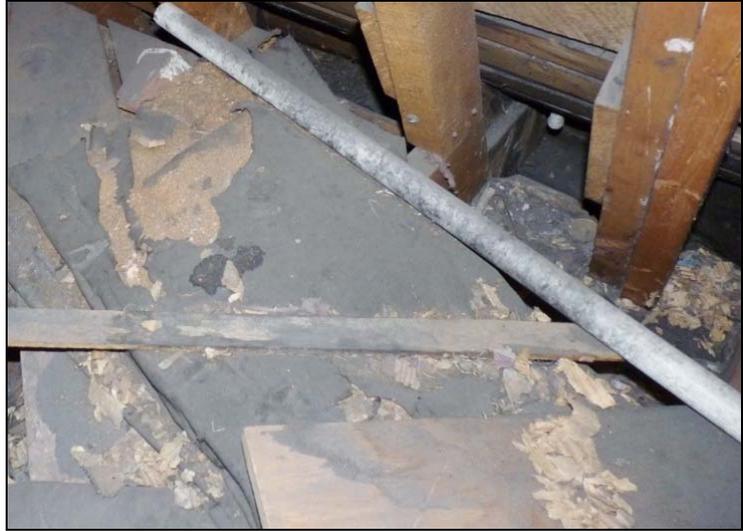
- 4. View of the non-asbestos batt insulation found in the attic spaces of the house.**

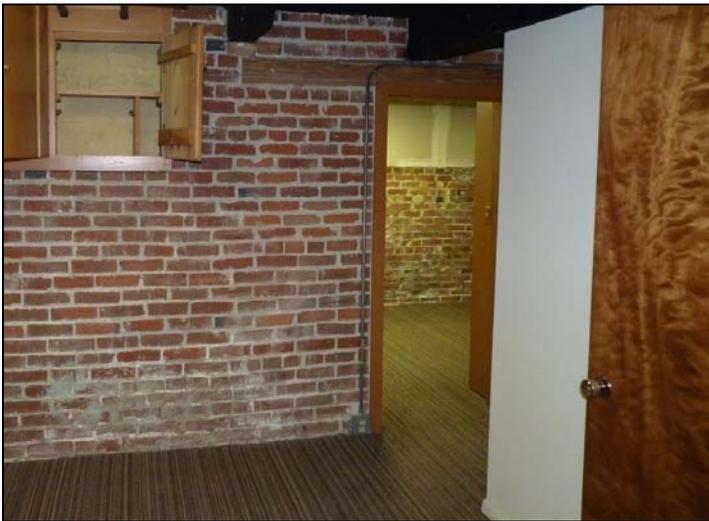
- 5. View of the non-asbestos brick/mortar and drywall finishes found within the basement of the house.**

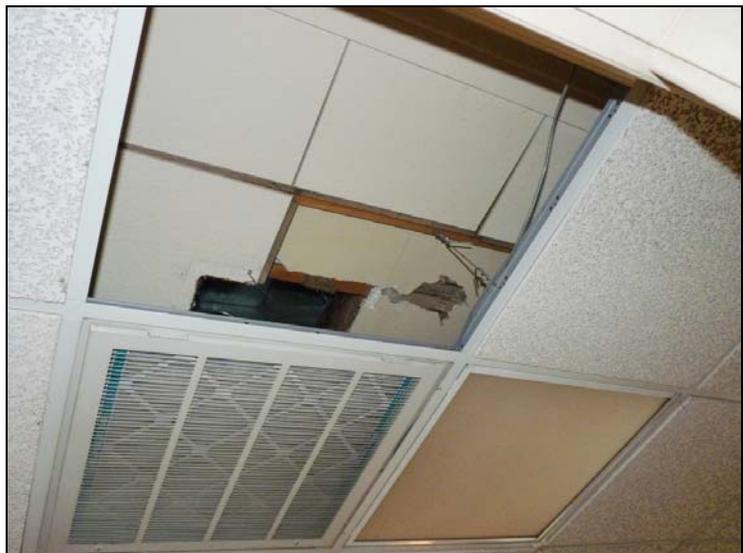
- 6. Views of the non-asbestos 2x2-foot and 12-inch by 16-inch ceiling tile and plaster ceiling finish found throughout the house.**

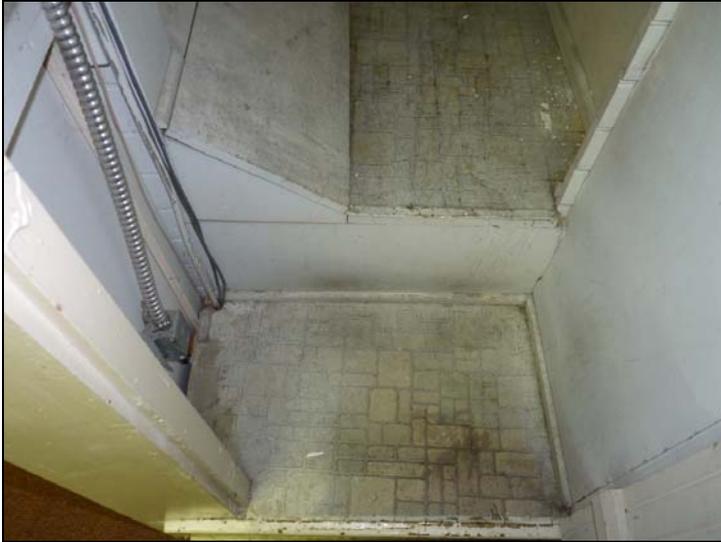
**7. View of the non-asbestos sheet vinyl flooring found inside the rear porch closet.**

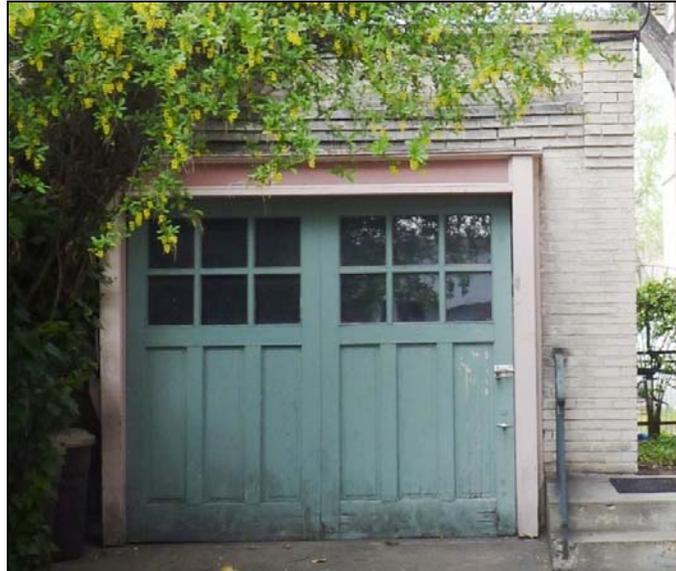
**8. View of the detached garage showing the non-asbestos brick and mortar construction.**

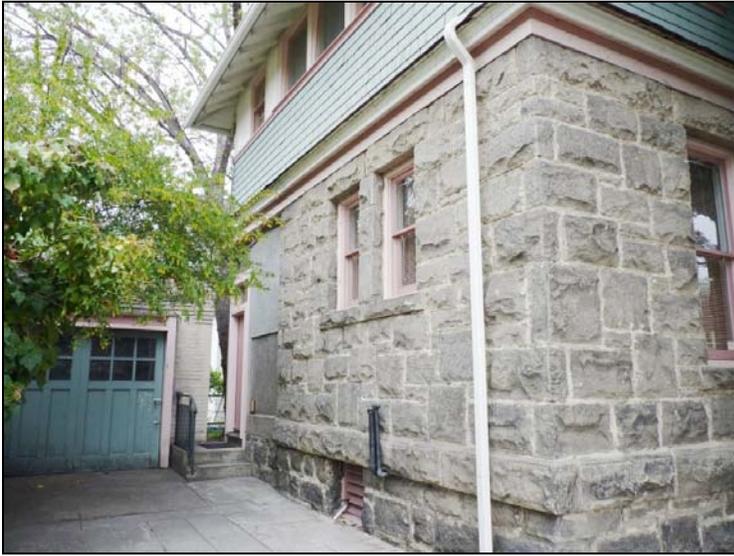
1. **View of lead-containing coatings (paints) found on the exterior of the house and garage. The exterior coatings were found to be in stable condition and are intact. The exterior coating can be managed in place.**

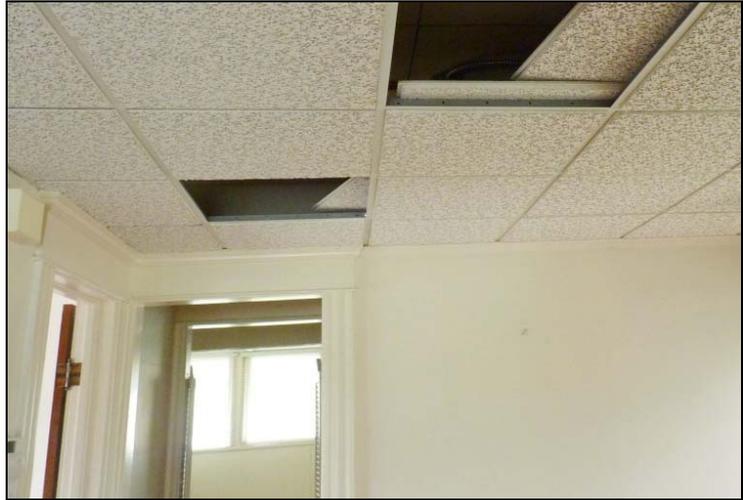
2. **View of the lead-containing coatings (white paint) found on the interior of the house. The white interior paint is in stable and intact condition.**

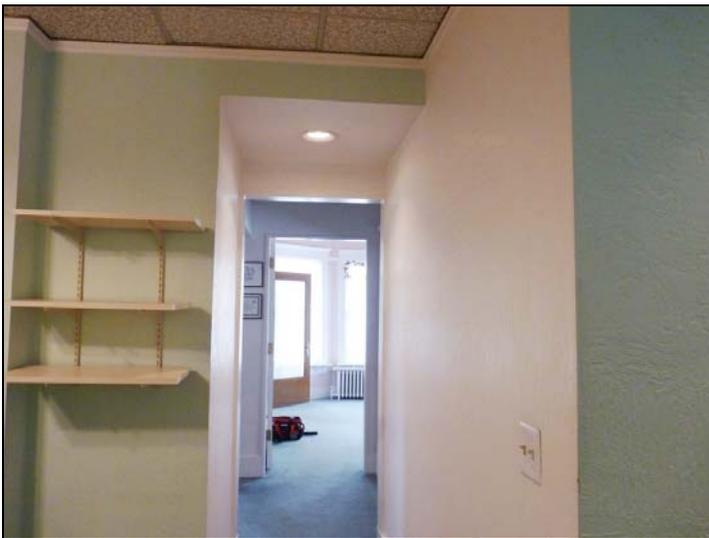
3. **View of the non-regulated (<0.5%) lead-containing coatings (pink, teal and grey-green paint) found on the interior of the house. The interior paint is in stable and intact condition, and can be managed in place.**

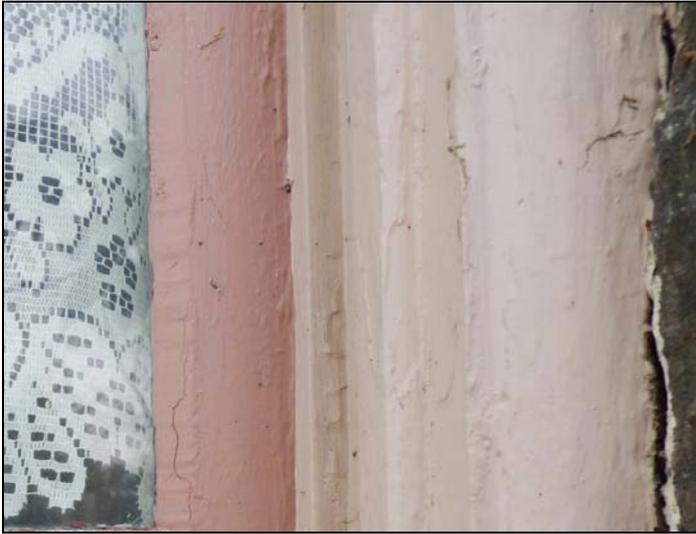
The non-friable window caulking was found to be in good-to-fair condition; however, this material, if not managed properly, may become damaged which poses a potential health threat to the building occupants and contractor employees. The ACM can be managed in-place until it has been removed.

1. View of the asbestos-containing caulking used around the wood framed windows. The caulking is located between the frame and the grey mortar and rock exterior found on the lower sections of the house.

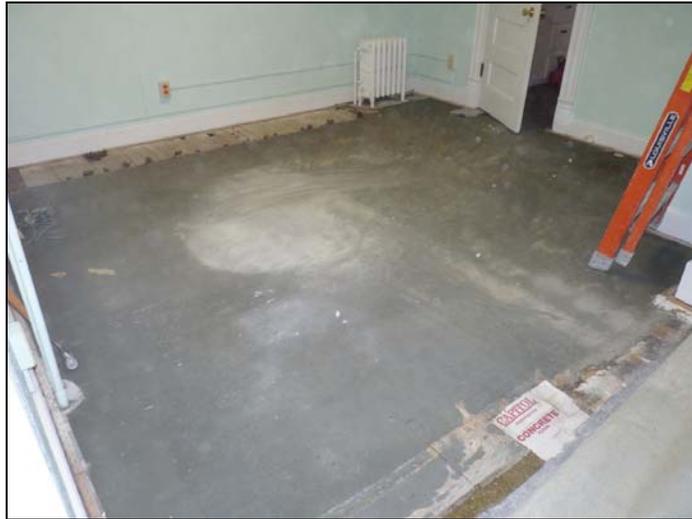
2. Pre-abatement view of the asbestos-containing vinyl floor tile (VAT) found beneath the carpet within the old kitchen space located at the rear of the house.

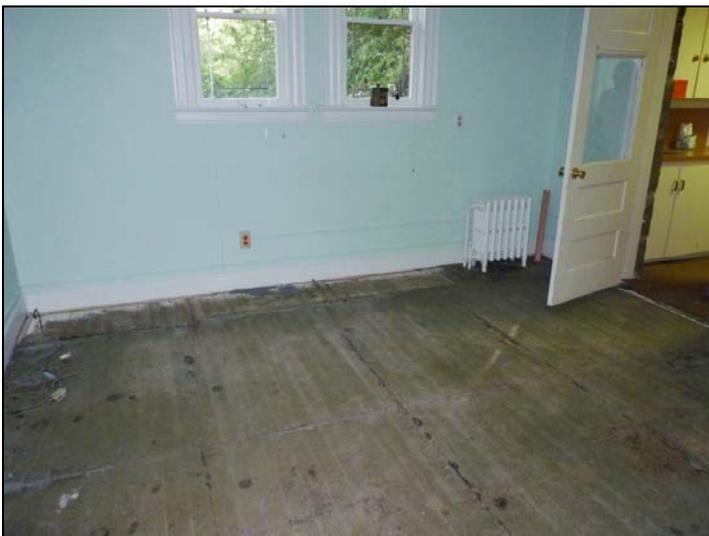
3. Post-abatement view of kitchen space once the VAT had been removed. Also shows the air monitoring pump in the windowsill.

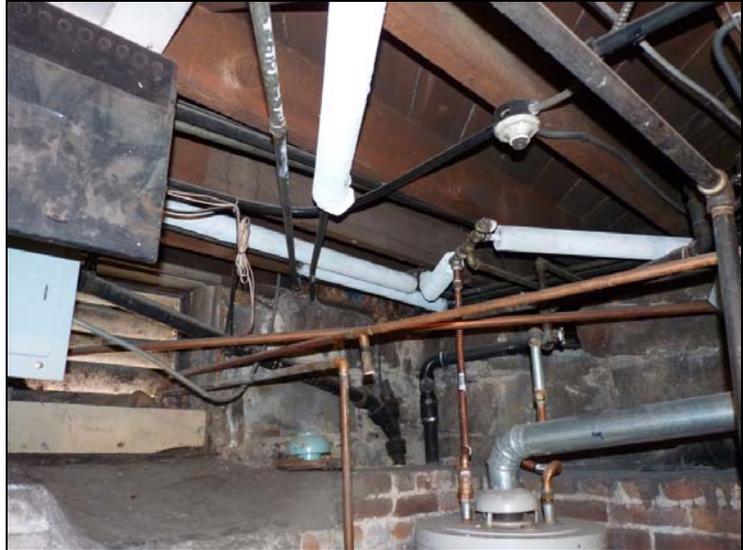
4. Pre-abatement view of the asbestos-containing TSI pipe run and fitting insulation found within the basement mechanical room and various locations throughout the basement and crawlspaces.

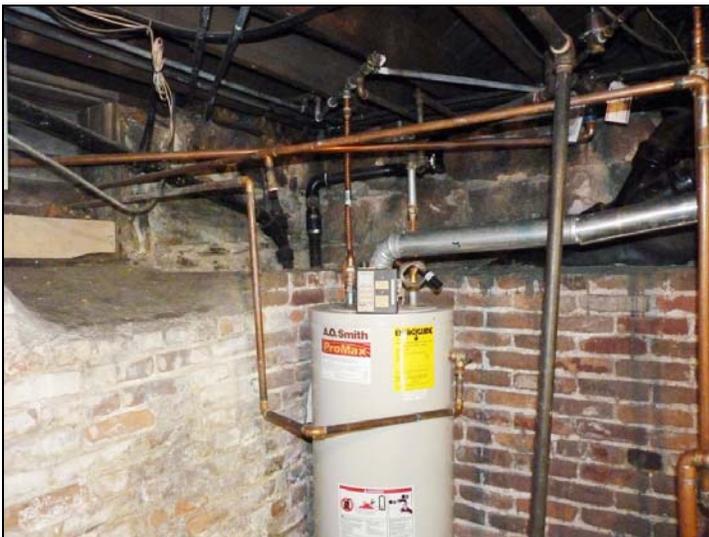
5. Post-abatement view of the basement mechanical room. Also shows the air monitoring sampling pump used to collect post-abatement airborne fiber levels within the space.

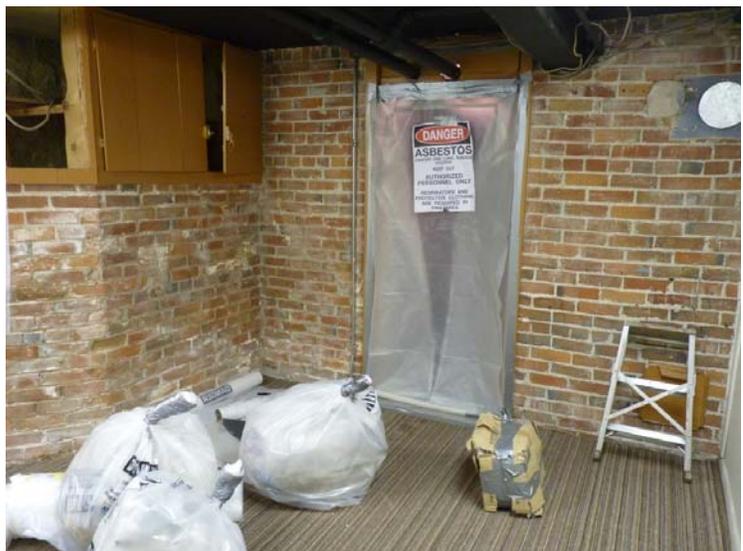
6. Views of the poly containment barrier and warning signs used by the contractor to control access to the space. Also shows the double-bagged TSI waste.

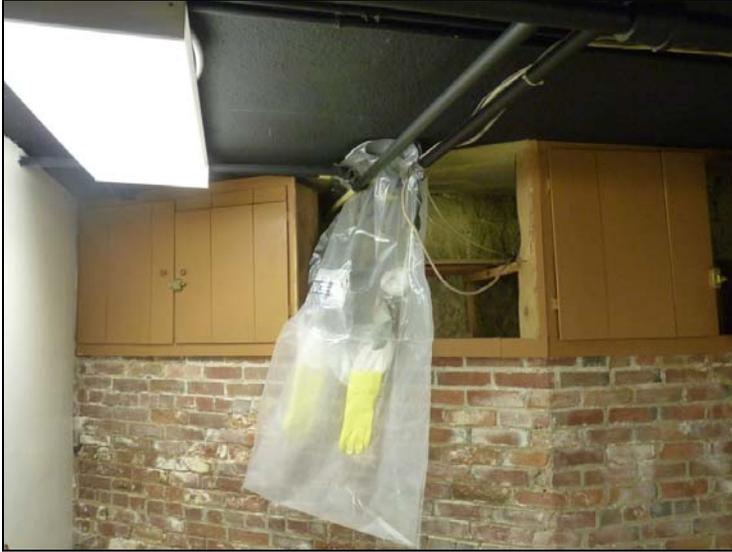
**7. View of the glove-bag used to remove sections of the TSI pipe and fitting insulation found within the basement and crawlspaces of the house.**

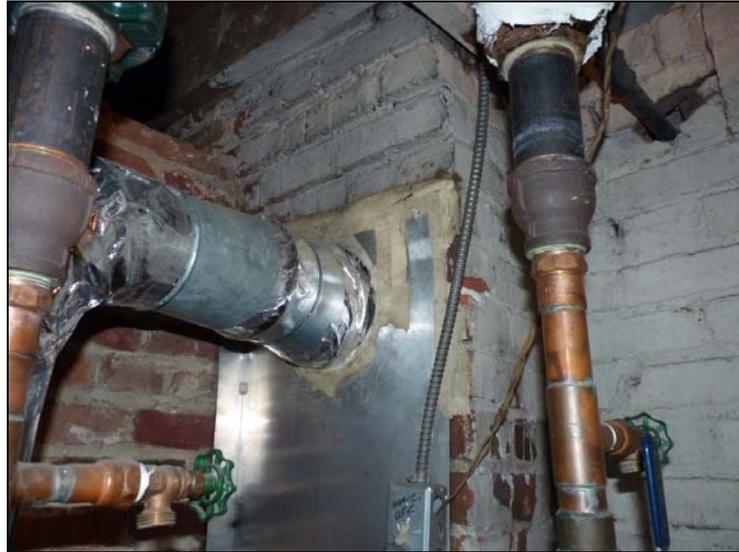
**8. Pre-abatement view of the asbestos paper duct tape located in the basement mechanical room.**

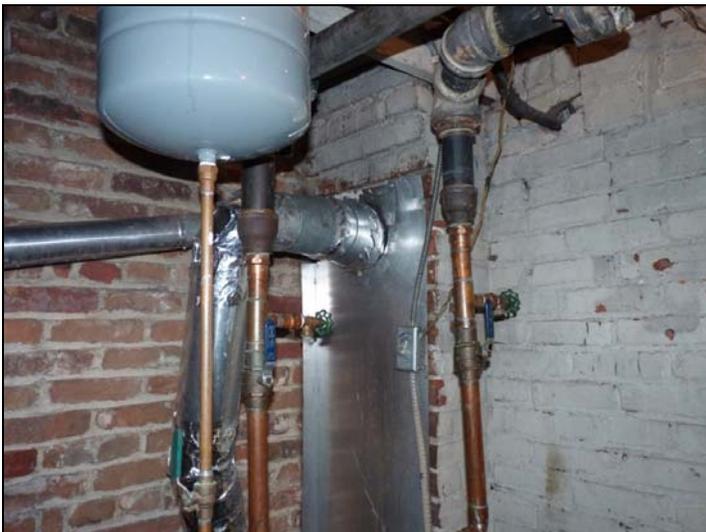
**9. Post-abatement view of the basement mechanical room showing that the asbestos paper duct tape has been removed.**
