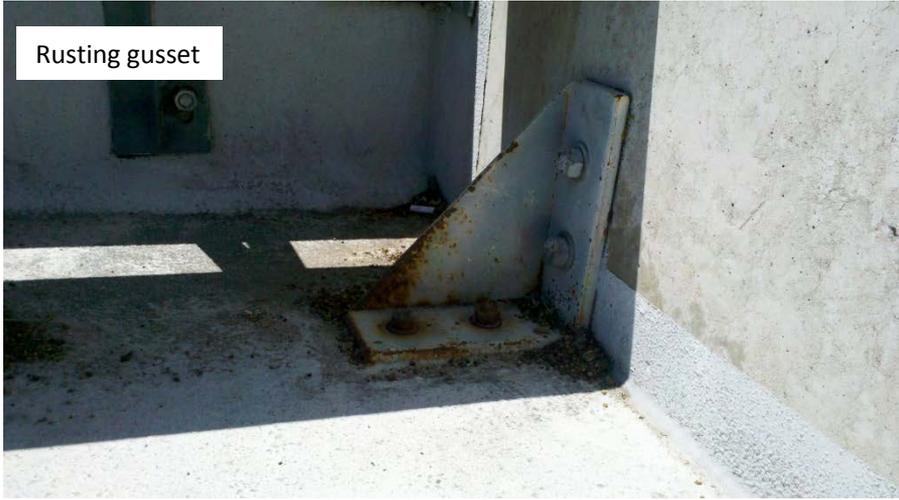
Rusting gusset

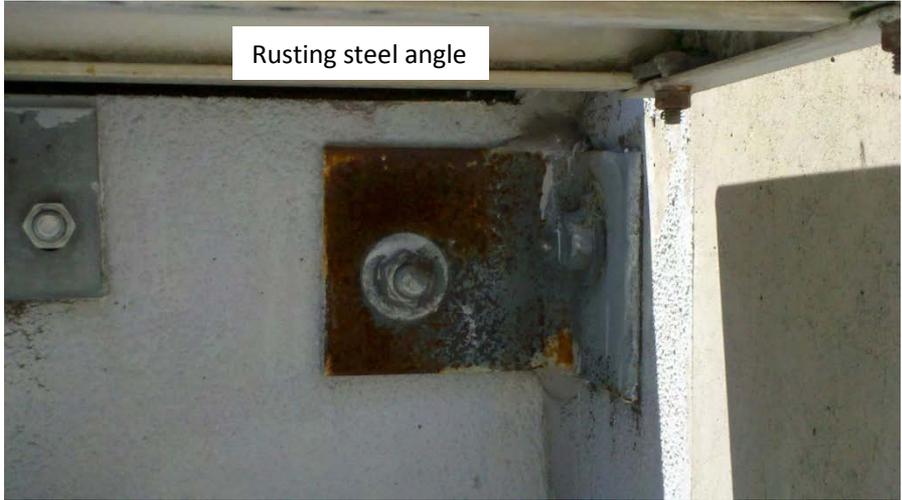
Rusting steel angle

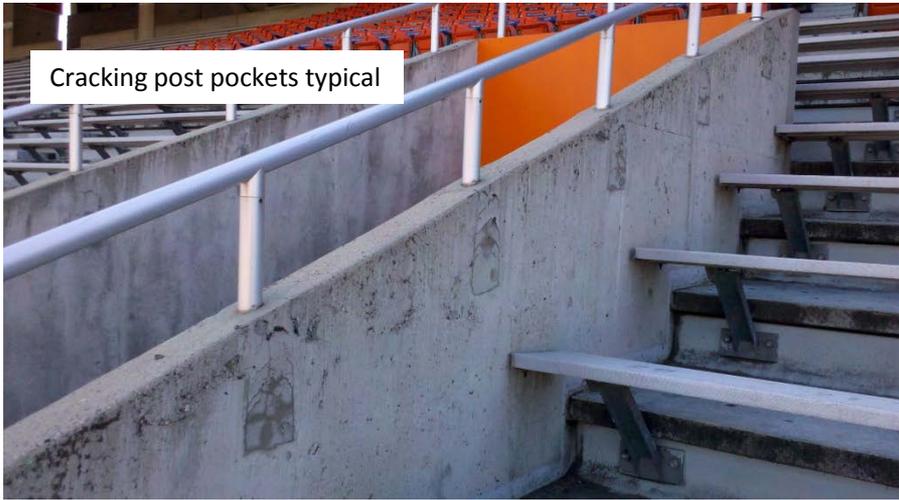
Cracking post pockets typical

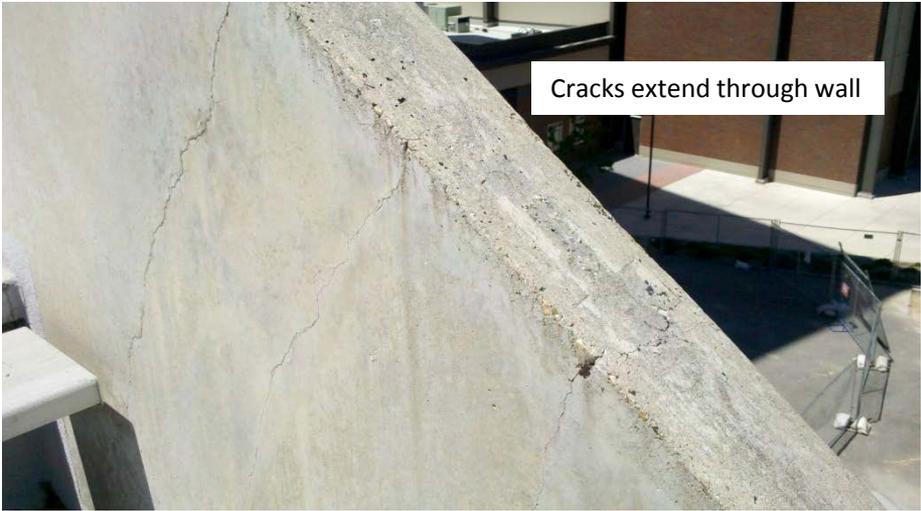
Cracks extend through wall

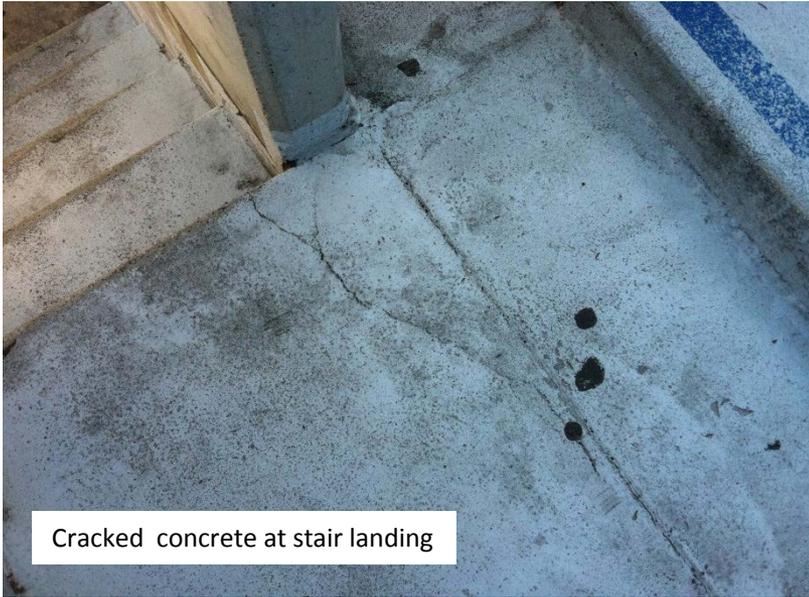
Cracked concrete at stair landing

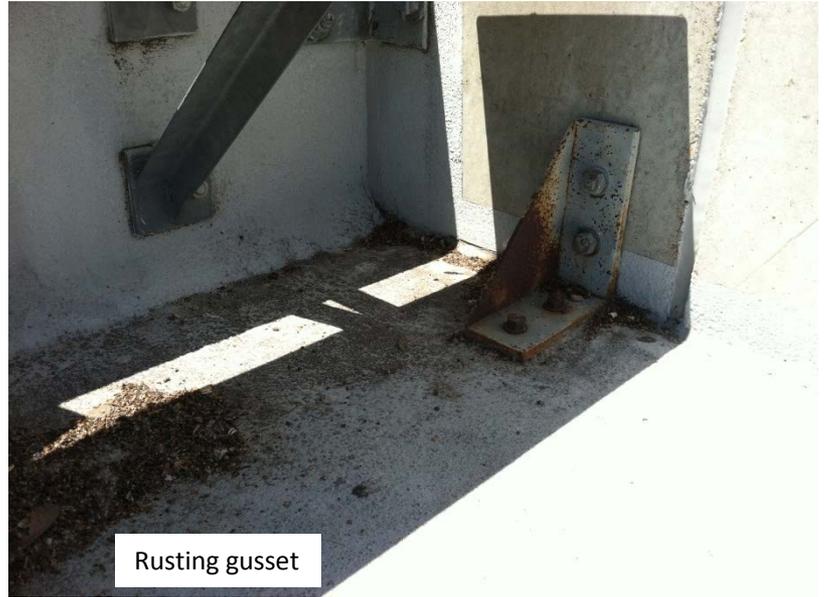
Rusting gusset

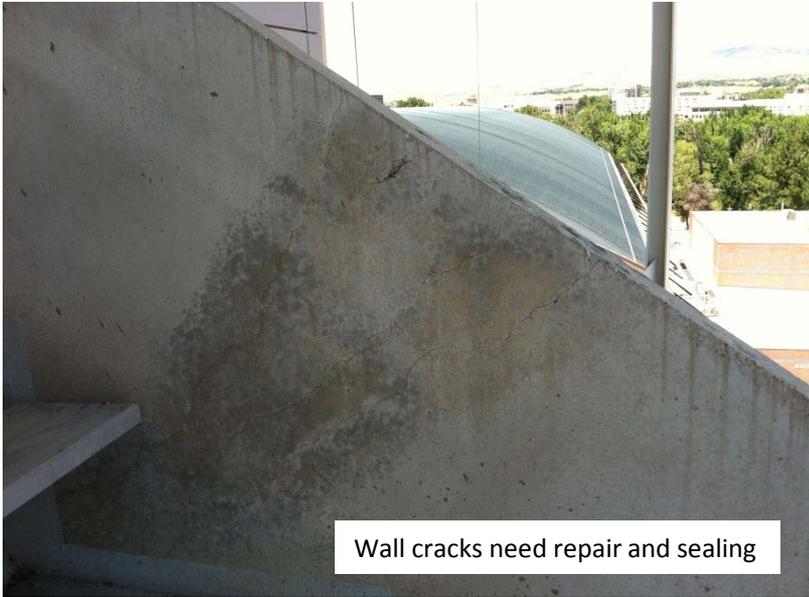
Wall cracks need repair and sealing

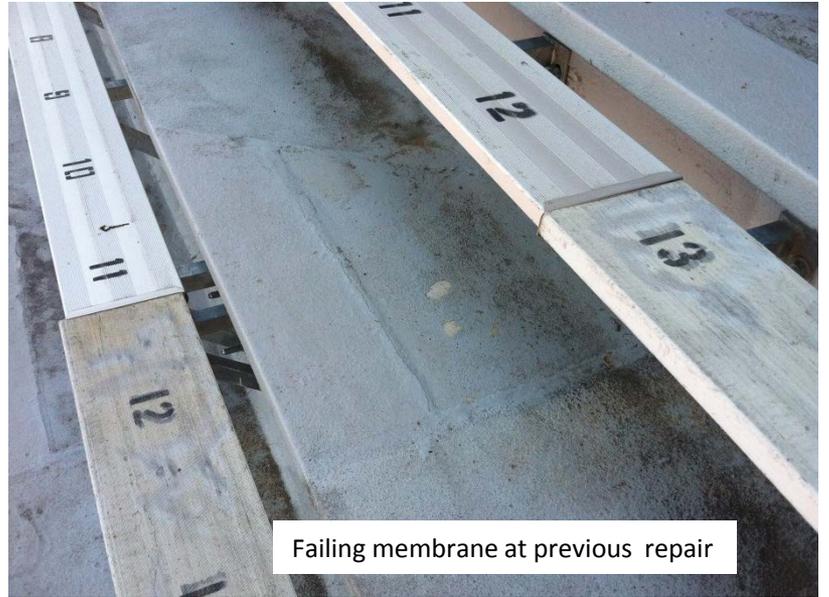
Failing membrane at previous repair

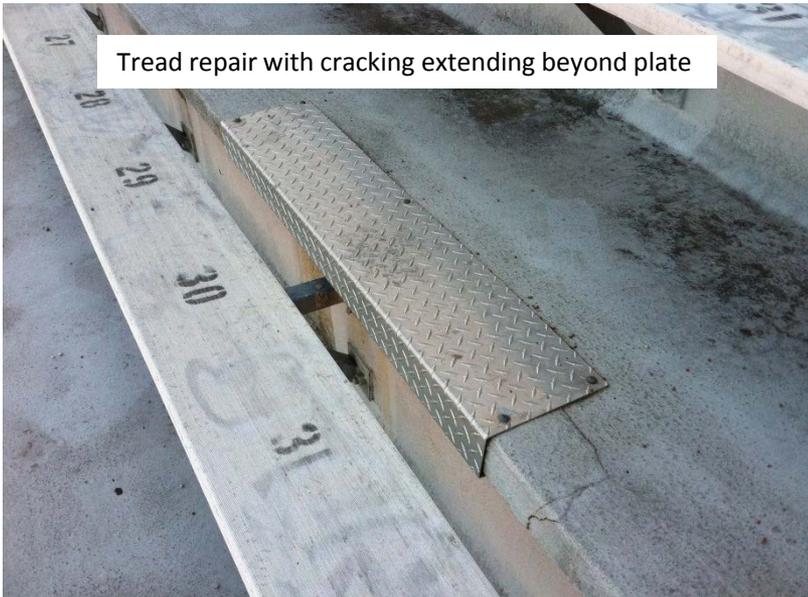
Tread repair with cracking extending beyond plate

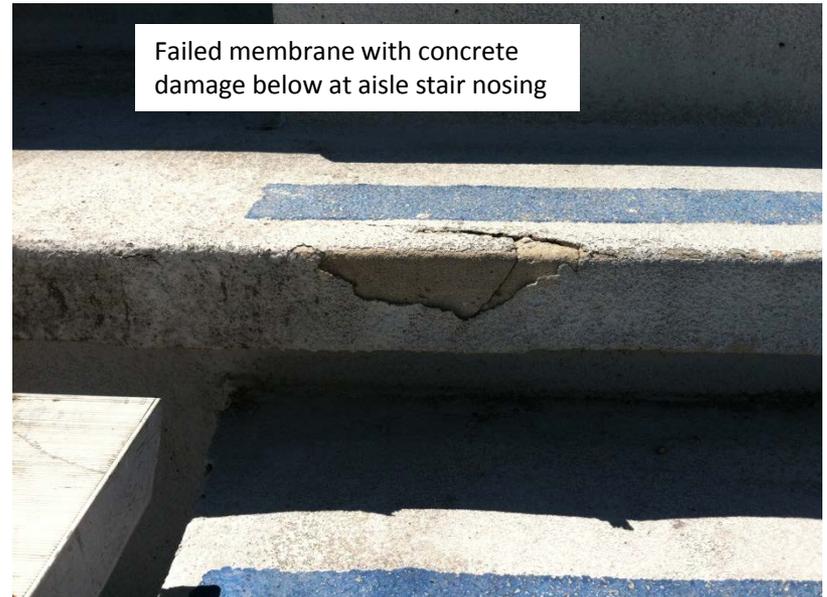
Failed membrane with concrete damage below at aisle stair nosing

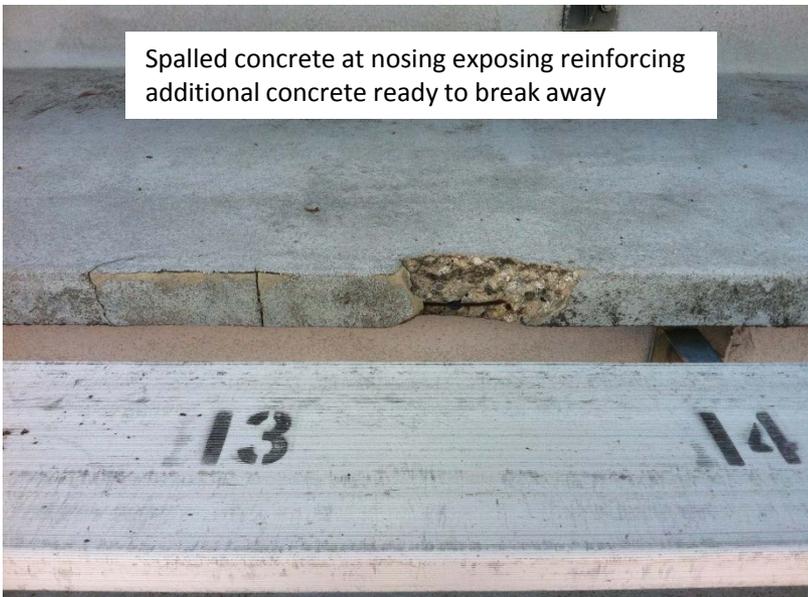
Spalled concrete at nosing exposing reinforcing additional concrete ready to break away

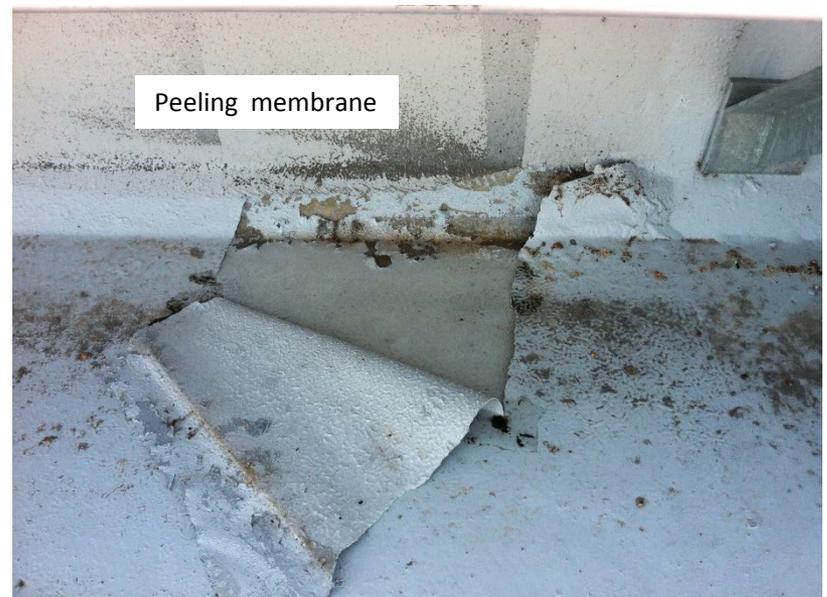
Peeling membrane

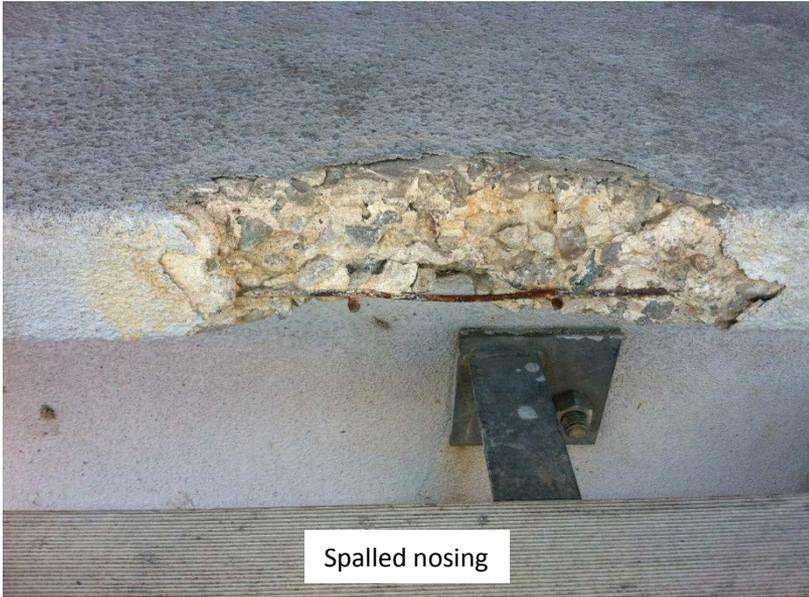
Spalled nosing

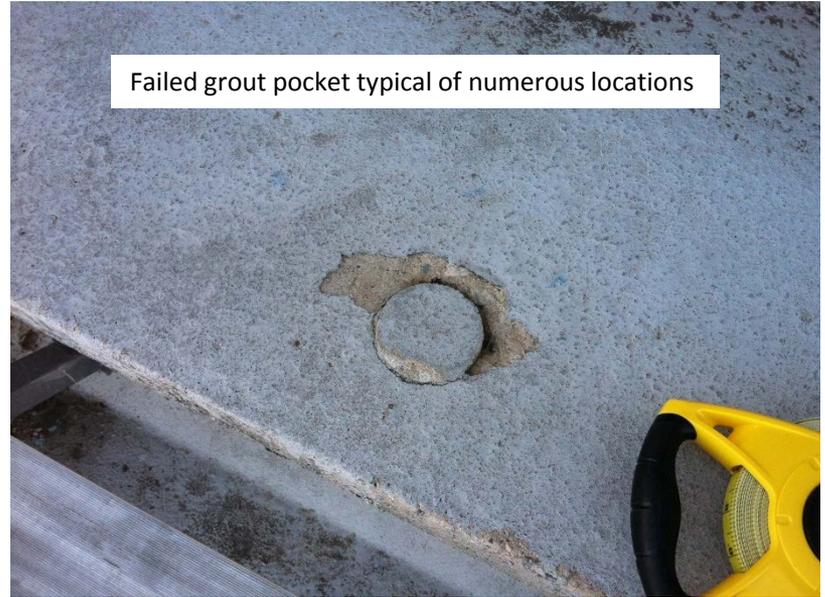
Failed grout pocket typical of numerous locations

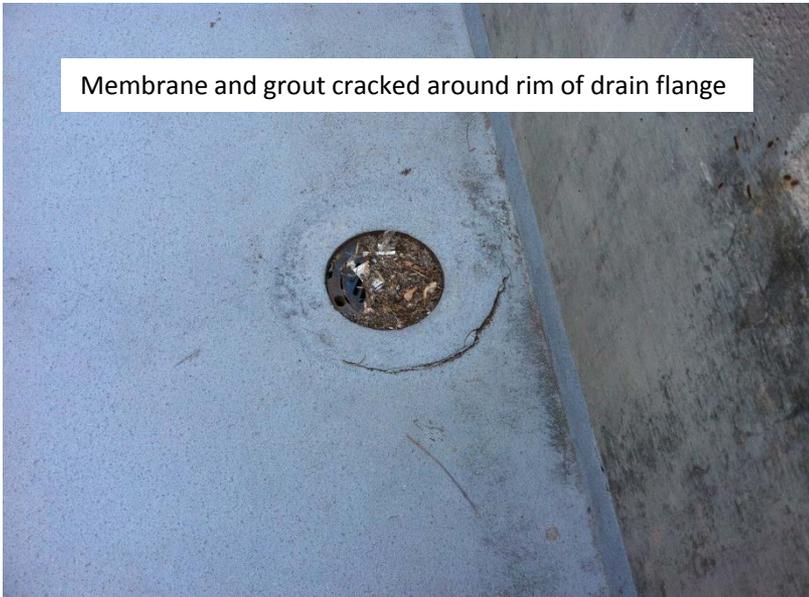
Membrane and grout cracked around rim of drain flange

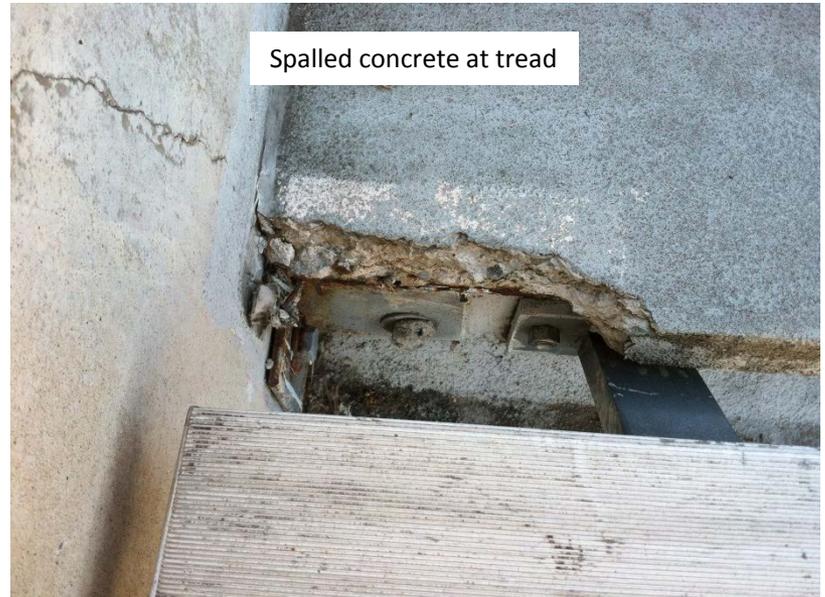
Spalled concrete at tread

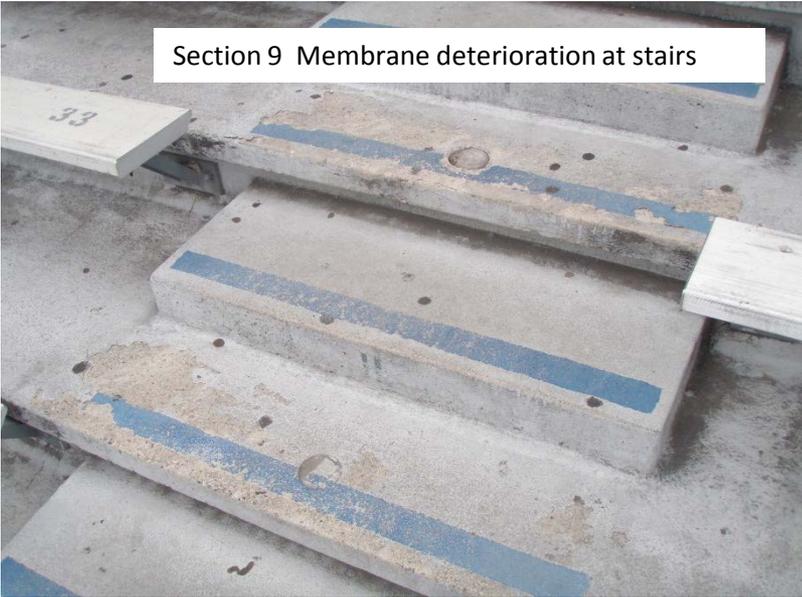
Section 9 Membrane deterioration at stairs

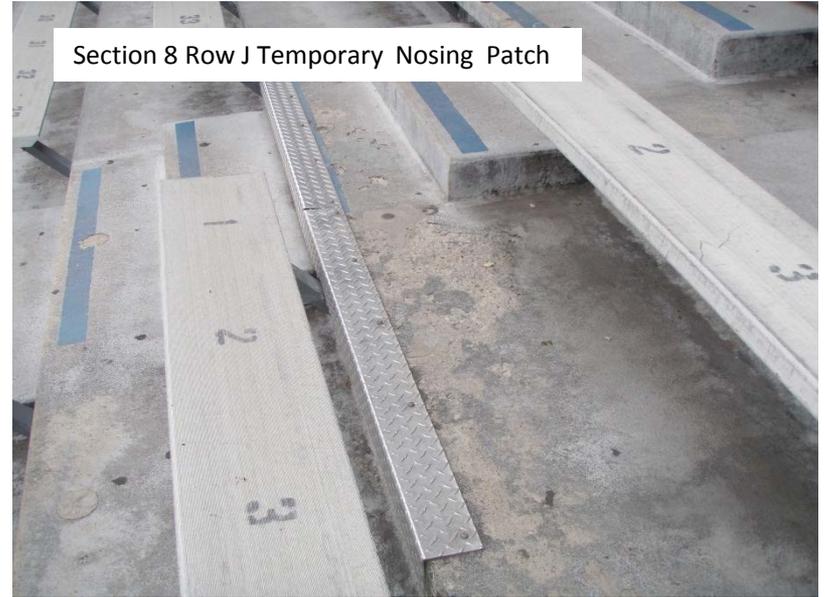
Section 8 Row J Temporary Nosing Patch

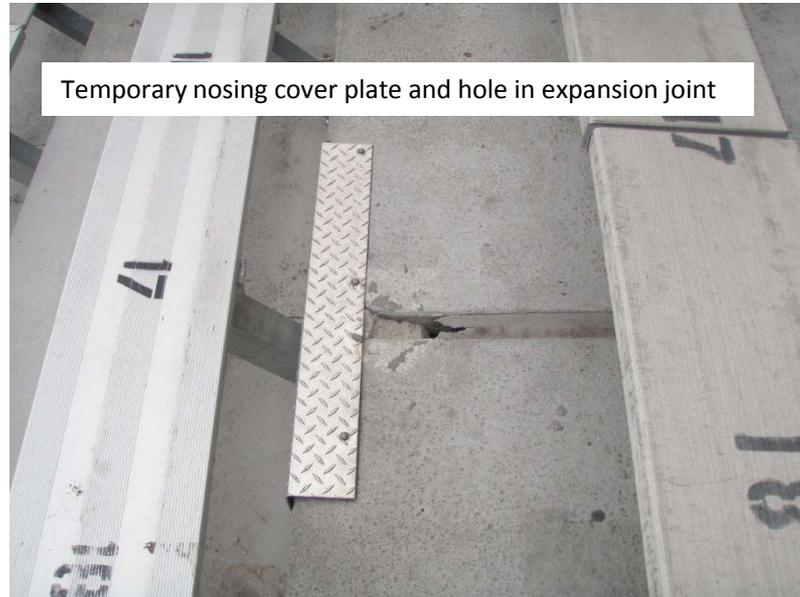
Temporary nosing cover plate and hole in expansion joint
