**DPW PROJECT 20-910
HEADQUARTERS BUILDING
IDAHO DEPARTMENT OF TRANSPORTATION
BOISE, IDAHO**

**ASBESTOS-CONTAINING BUILDING MATERIAL
SURVEY AND ASSESSMENT REPORT**

FEBRUARY 2021

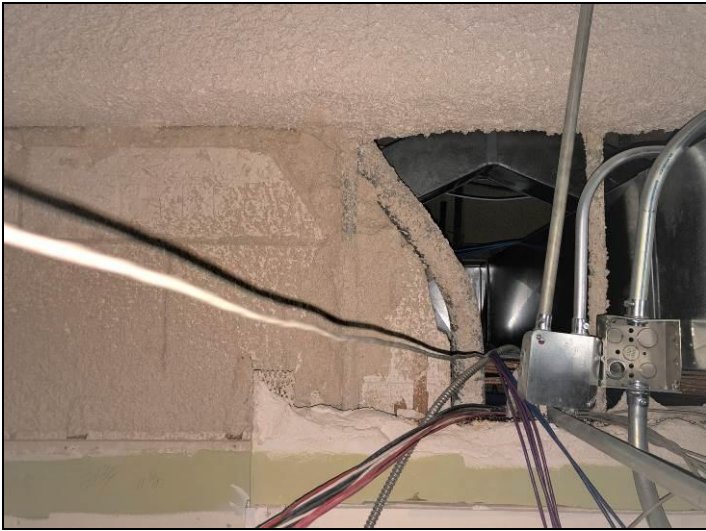
1. View of the friable asbestos-containing spray-on fire-proofing and over-spray located above the suspended and hard ceilings found in various locations throughout the building.

The following actions are highly recommended: Isolate and restrict access to space located above the suspended and hard ceilings located within the original segments of the building's first, second and third floors. Any loose fireproofing, overspray, TSI fitting and pipe run insulation, and debris should be properly cleaned up by a competent asbestos abatement contractor prior to conducting any work within these spaces.

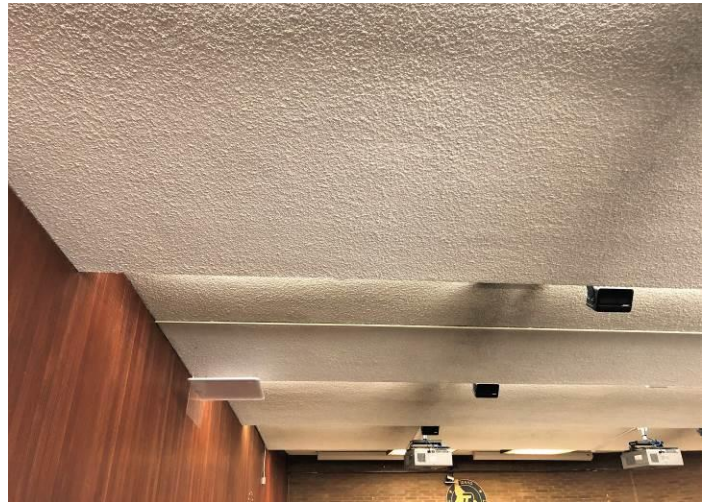
2. View of the friable asbestos containing spray-on ceiling texture found within the auditorium.

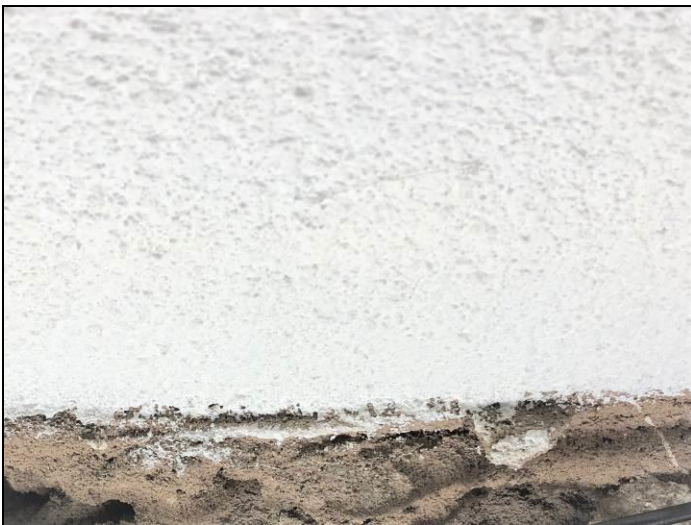
3. Close-up view of the friable asbestos-containing brown scratch coat found beneath the spray-on popcorn ceiling texture located in the auditorium.

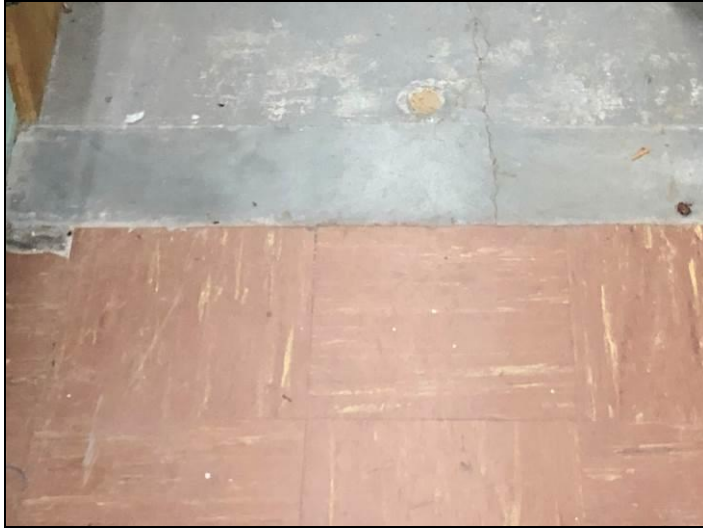
4. **View of the asbestos-containing brown 9-inch vinyl floor tile and black mastic located within room 119 telephone equipment room.**

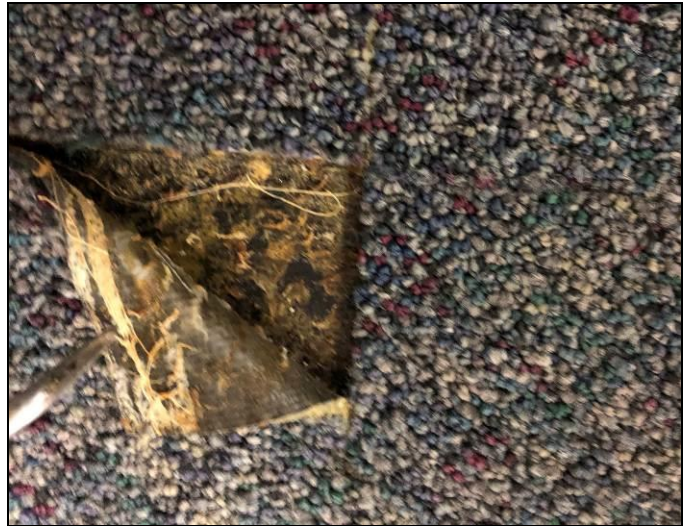
5. **View of the asbestos-containing residual black mastic found beneath carpeting in various areas throughout the building.**

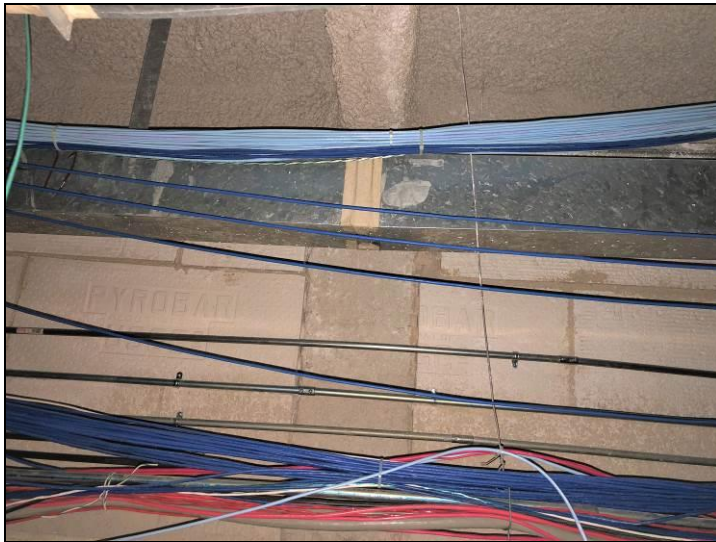
6. **View of the friable asbestos paper duct tape applied to the joints and seams of the metal HVAC ducts found in various locations above the ceilings and in the basement mechanical room.**

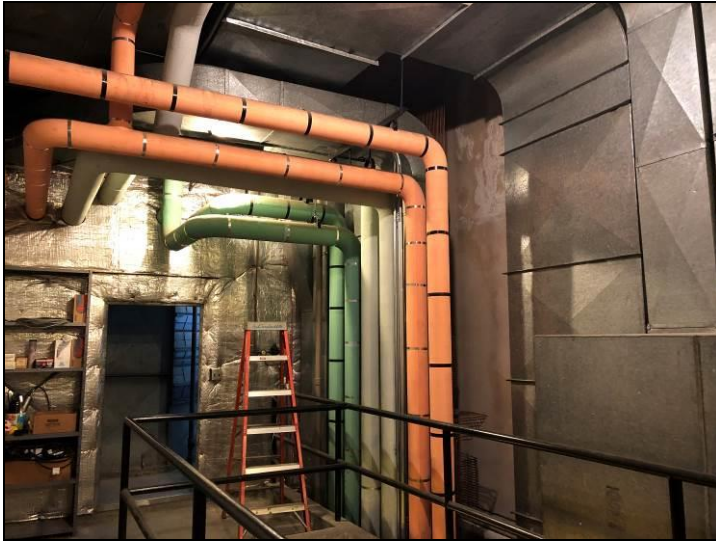
7. View of the asbestos-containing TSI fittings and pipe run insulation found in the penthouse mechanical room. These materials are similar to those found in various other locations within the building.

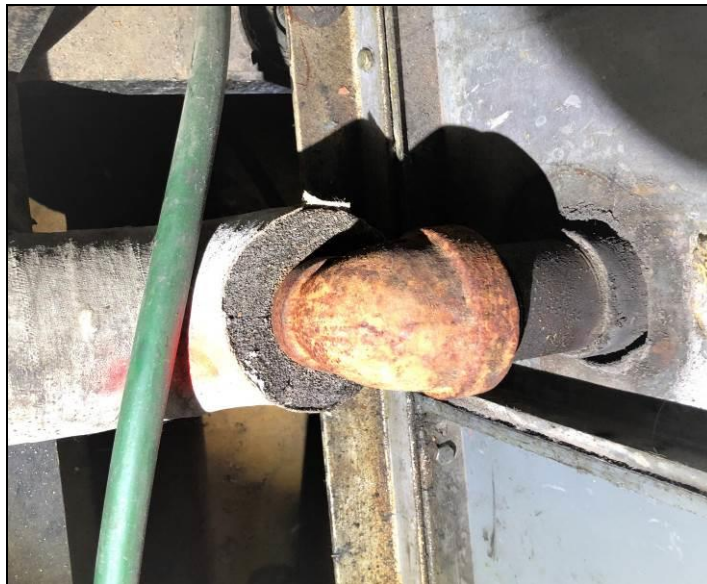
8. View of the canvas covering found over the asbestos felt paper on the black pumice-like pipe insulation. This material is found in various locations throughout the building.

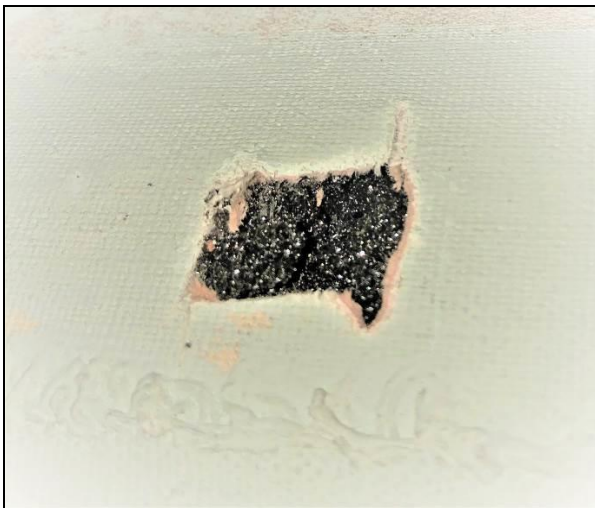
9. Closeup view of the asbestos-containing felt paper on the black pumice-like insulated pipes found within the building.

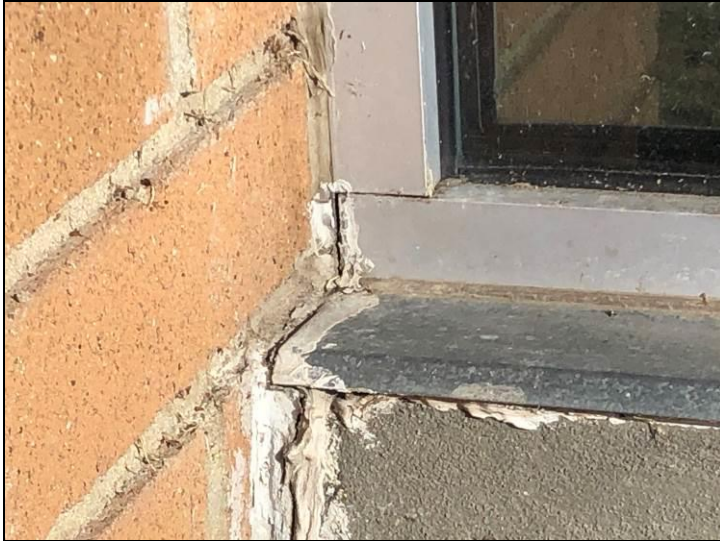
1. View of the non-asbestos brick and mortar, stucco finish, and the grey and light grey caulking found on the exterior of the building.

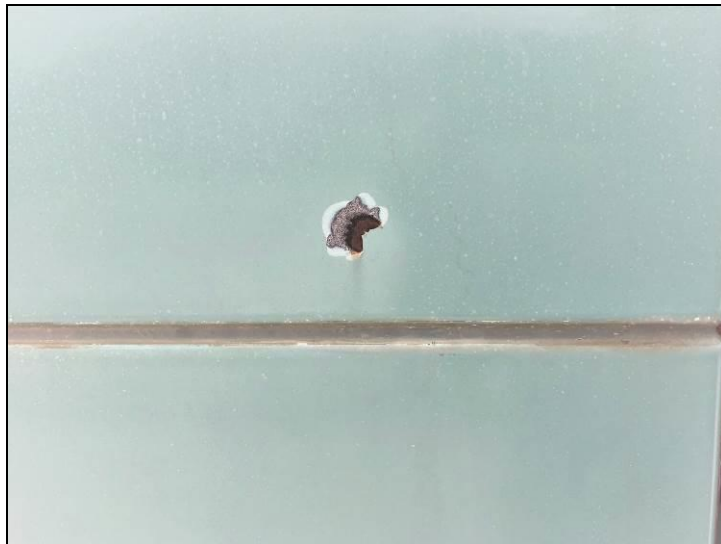
2. View of the non-asbestos silicone caulking found between the porcelain wall panels located on the exterior of the penthouse.

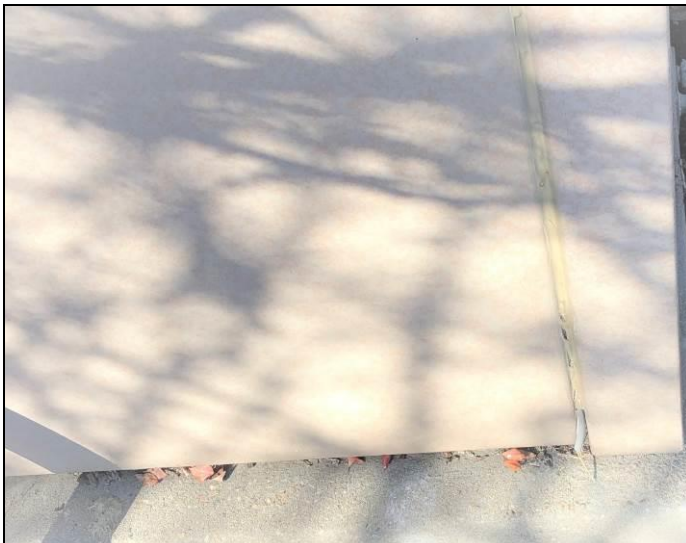
3. View of the non-asbestos expansion joint caulking found between the porcelain panels located on the exterior of the lower section of the main building.

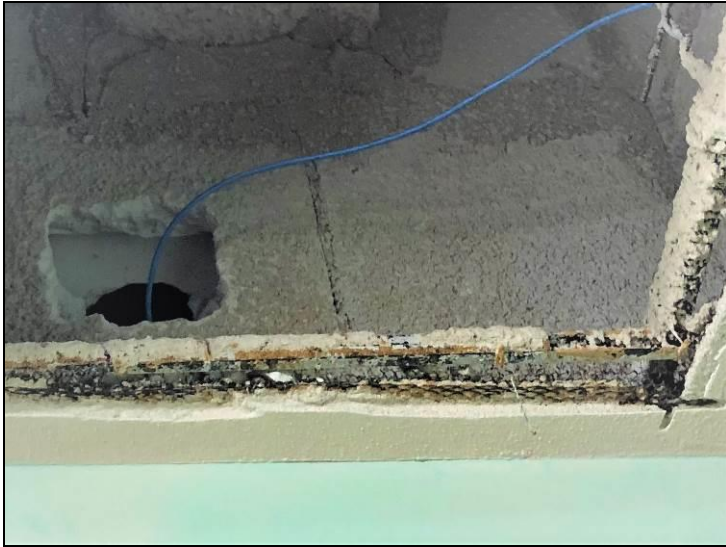
4. View of the non-asbestos CMU block/mortar and the stucco-like plaster finish found on the ceilings and walls found in various locations throughout the building.

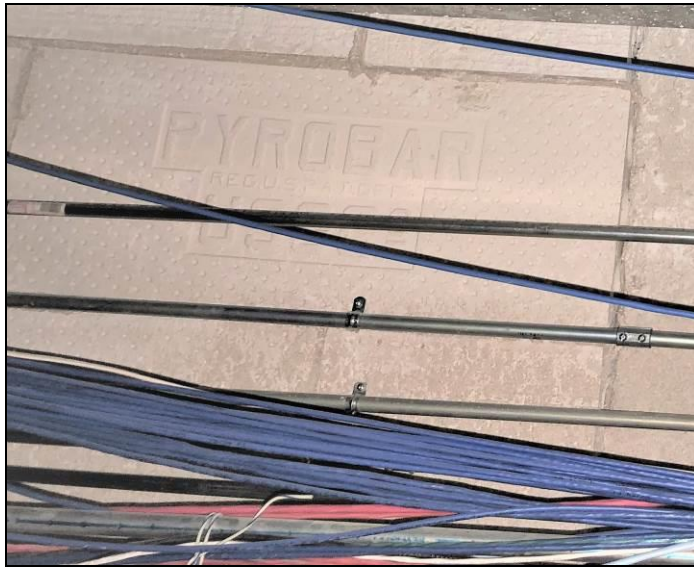
5. View of the non-asbestos pyrobar block and mortar used to construct the interior walls within the original segment of the building.

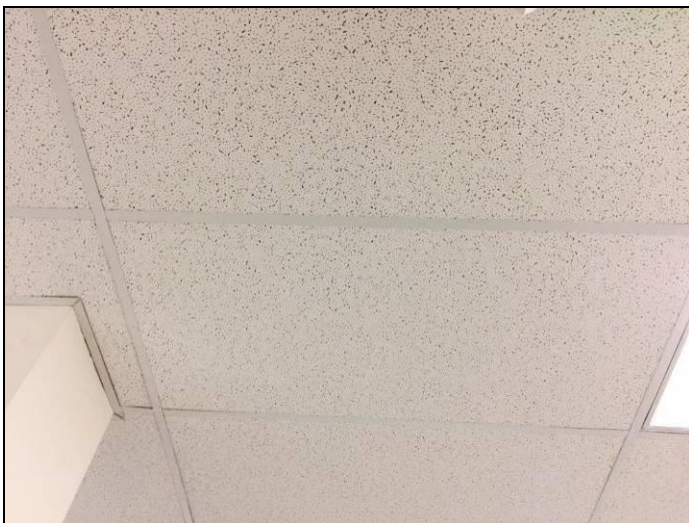
6. View of the non-asbestos 2'x4' suspended ceiling tiles found in various locations throughout the building.

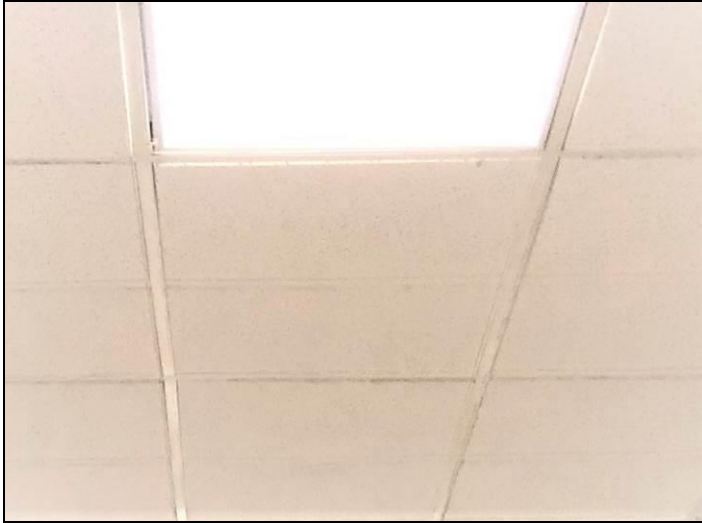
7. View of the non-asbestos 2'x4' (2'x2' pattern) ceiling tiles found in various locations within the building.

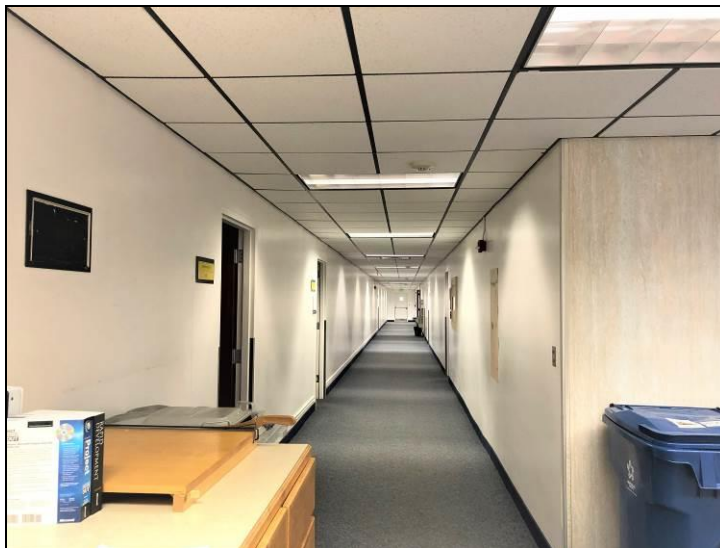
8. View of the non-asbestos 2'x2' ceiling tiles found in various locations throughout the building. Also shows the non-asbestos vinyl wall covering found on the hallway walls.

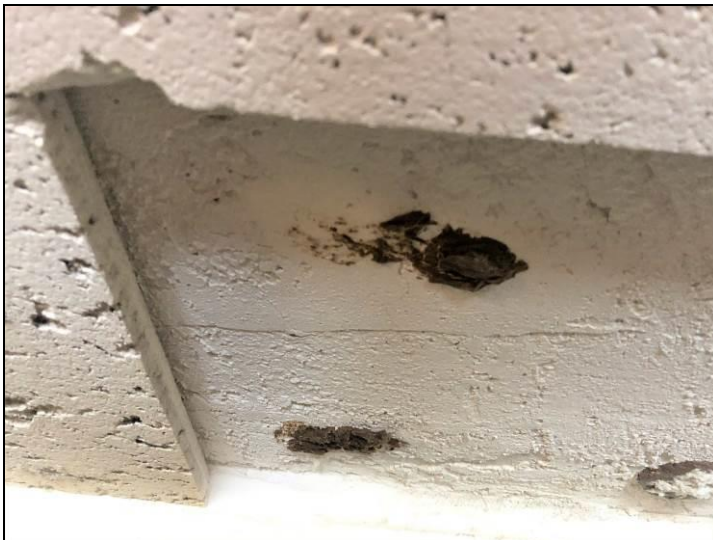
9. View of the non-asbestos 12"x12" concealed spline ceiling tiles and the non-asbestos fiberglass duct insulation found in various locations throughout the building.

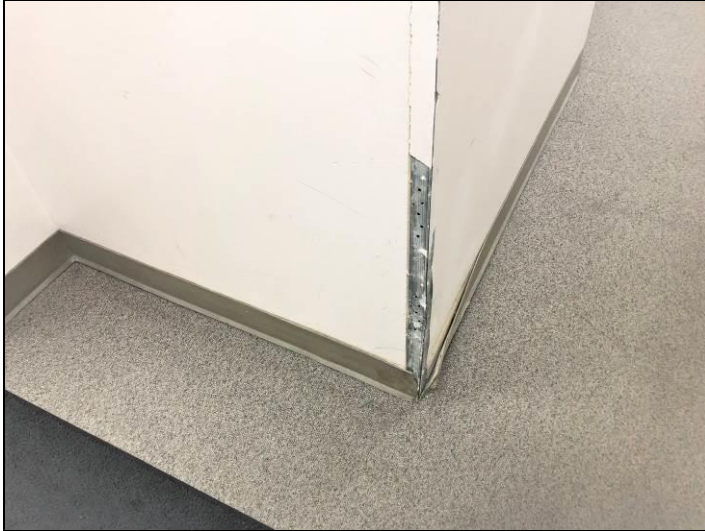
10. View of the drywall (sheetrock) and joint compound found on the interior walls located throughout the building. Also shows the non-asbestos vinyl cove base found in various areas within the building.

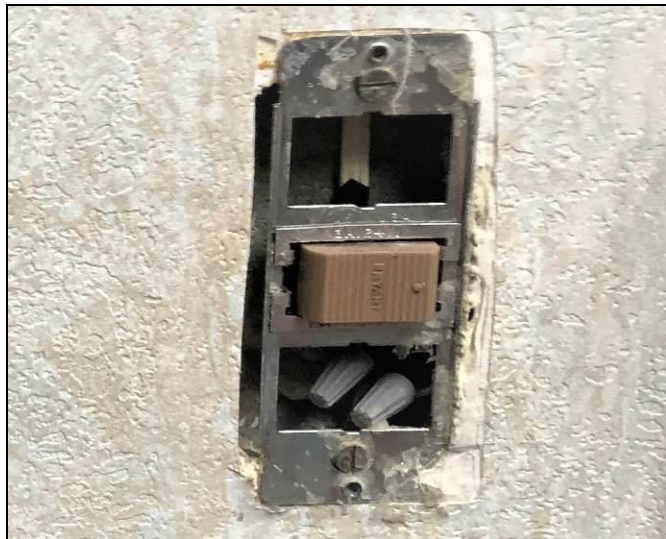
11. Closeup view of the non-asbestos vinyl wall covering found in various locations within the main building.

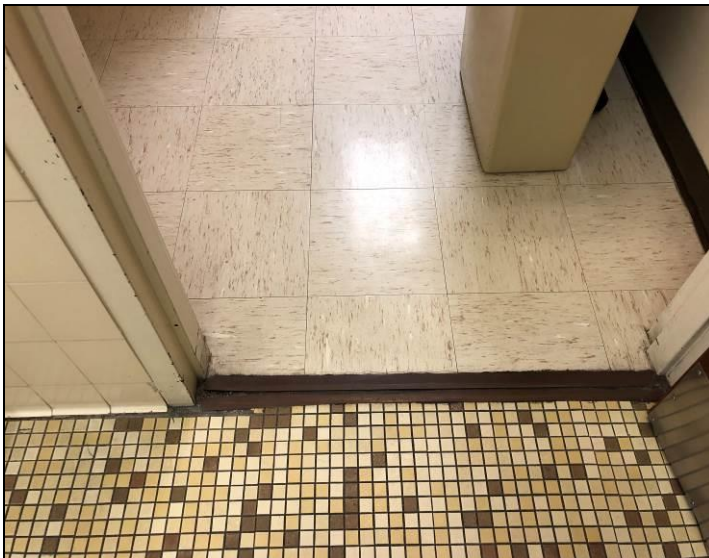
12. View of the non-asbestos ceramic grout found on the restroom walls and floors located throughout the building. Also shows the non-asbestos 12-inch floor tiles found in various locations.

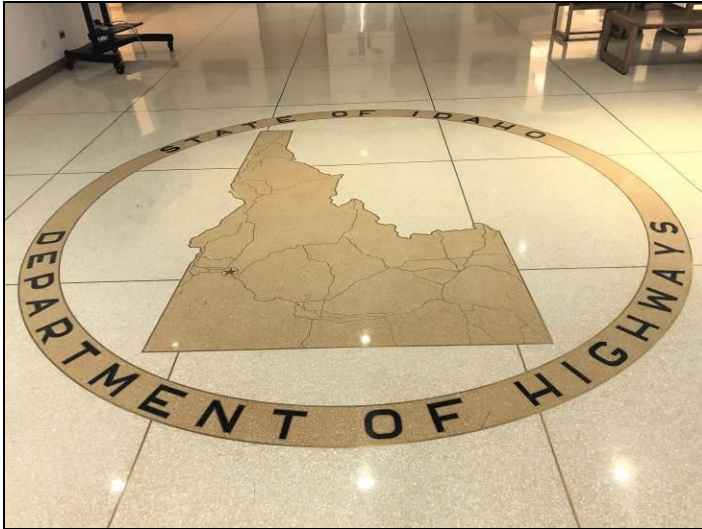
13. View of the non-asbestos terrazzo flooring located in the main entry lobby.

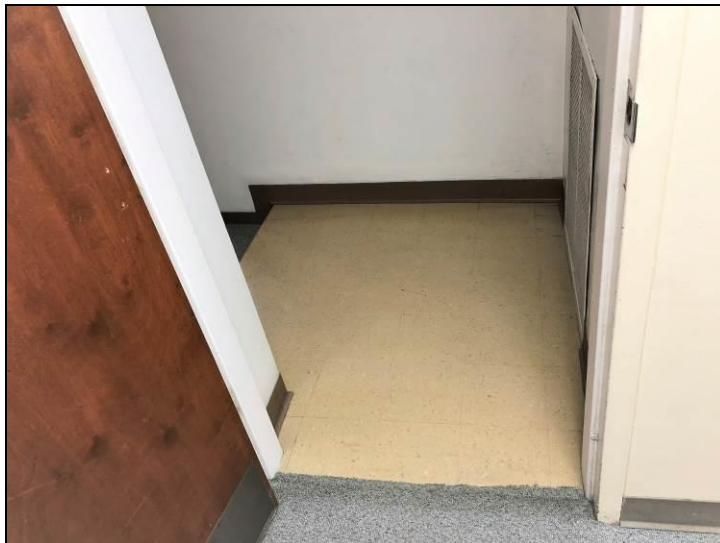
14. View of the non-asbestos 9-inch vinyl floor tile located on the 1st floor. Dark brown, tan, and yellow mastic were used to adhere the tile to the concrete flooring. Similar tile is concealed beneath the blue raised dot vinyl flooring located in the stairwells.

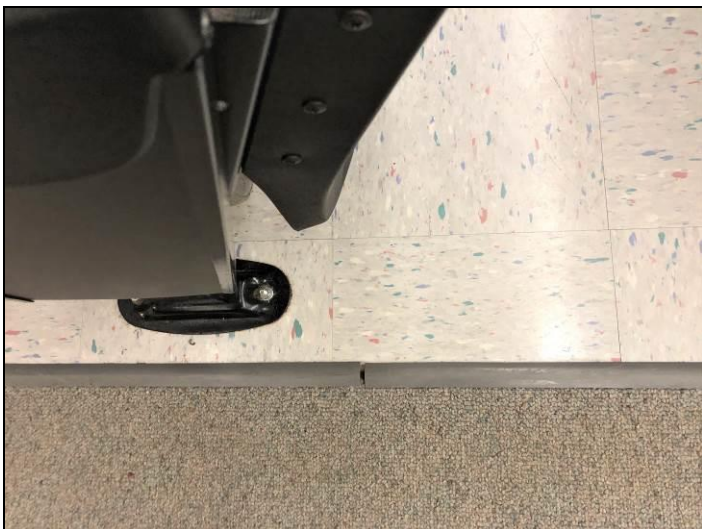
15. View of the new non-asbestos 12-inch vinyl floor tiles found within the auditorium located on the main level of the building.

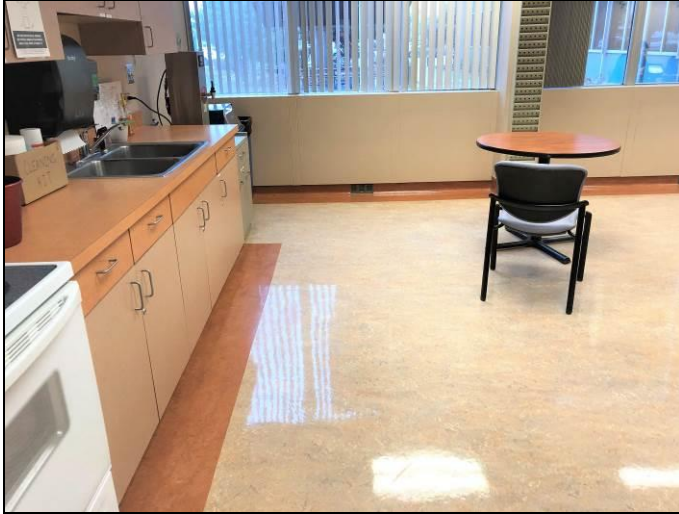
16. View of the new non-asbestos sheet vinyl flooring and cove base found in the large breakroom located on the first floor.

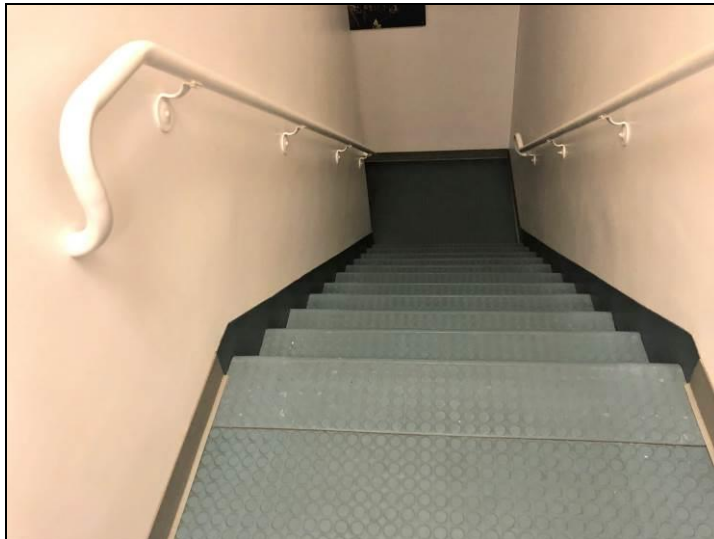
17. View of the non-asbestos blue raised dot vinyl flooring found within the stairwells. Non-asbestos 9-inch vinyl floor tiles were found beneath the vinyl flooring.

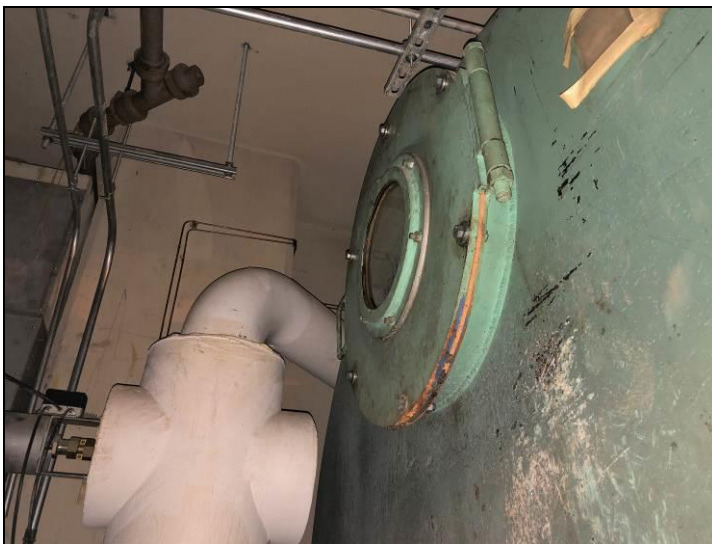
18. View of the non-asbestos gasket material located at the inspection plate found on the north end of the lager tank located in the basement mechanical room.

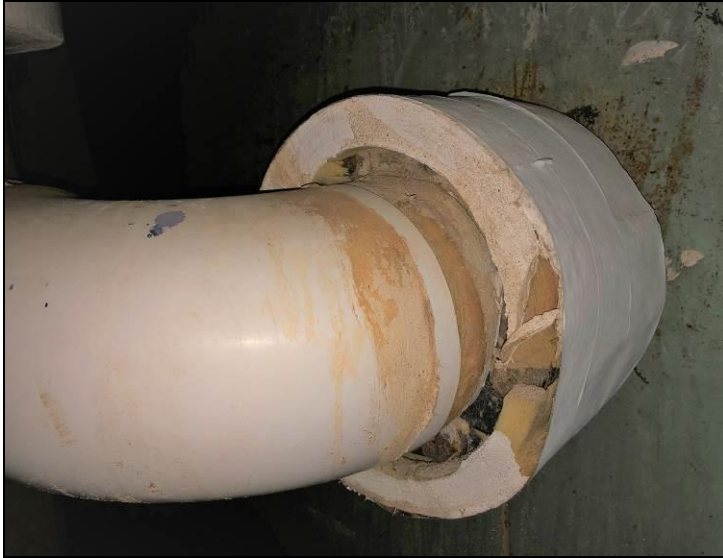
19. View of the non-asbestos TSI (new fiberglass) pipe-run insulation with white plastic fittings found in the basement mechanical room. Also shows the non-asbestos coating applied to the exposed end of the insulation.

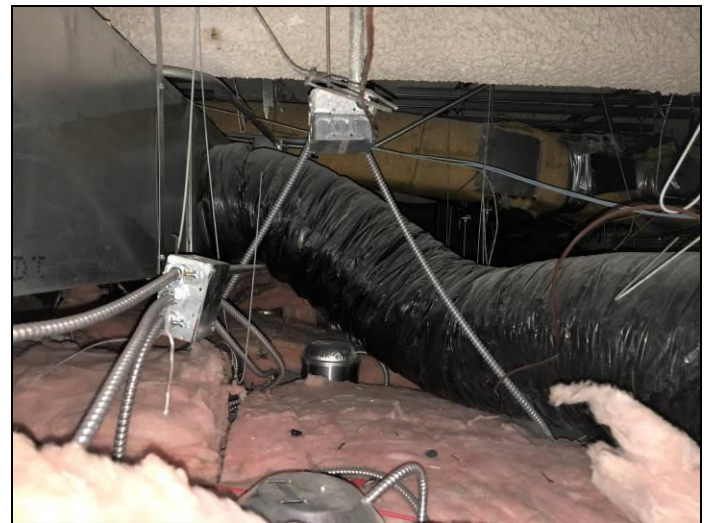
20. View of the non-asbestos poly covered and uncovered fiberglass duct insulation. Also shows the non-asbestos batt insulation found above the ceilings.

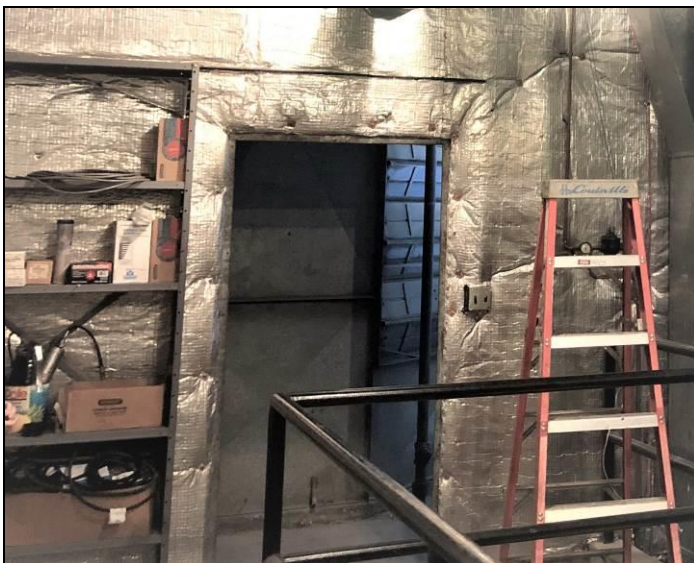
21. View of the non-asbestos foil covered fiberglass insulation found on the metal wall between the air handler and the penthouse mechanical room. Similar materials were found on the exterior of the HVAC ducts found in various locations throughout the building.
