THE L&R GROUP

680 South Progress Avenue, Suite 2A
Meridian, Idaho 83642
208-813-7700

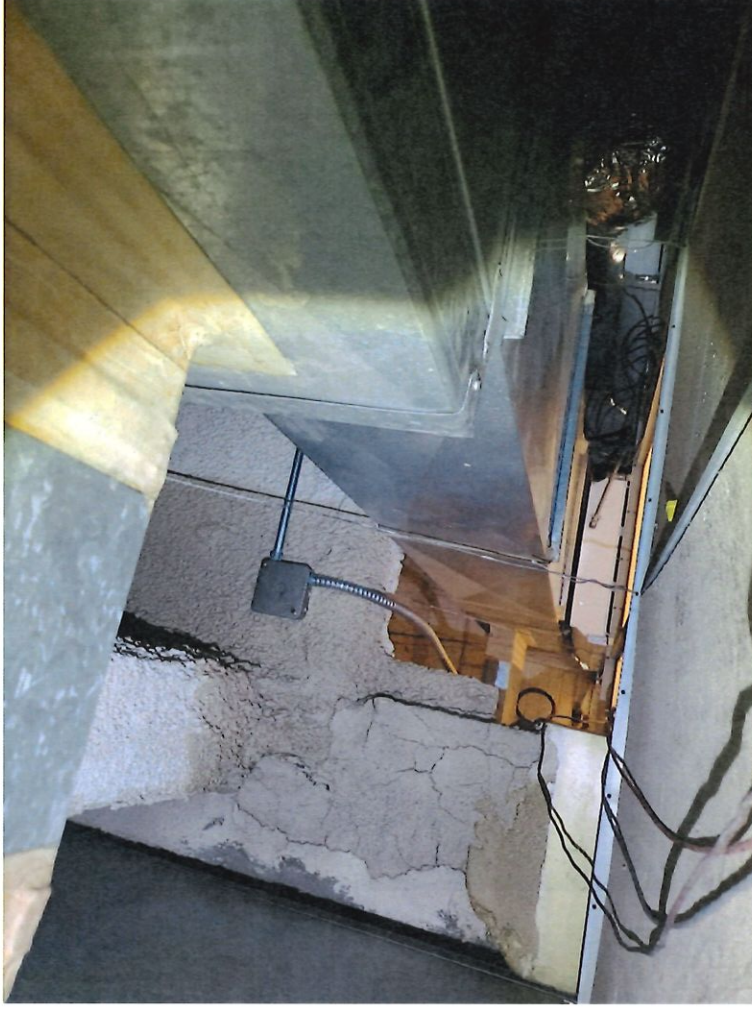
4) Saturated spray-on fireproofing material with visible cracks within the ceiling cavity in a Training & Development office.

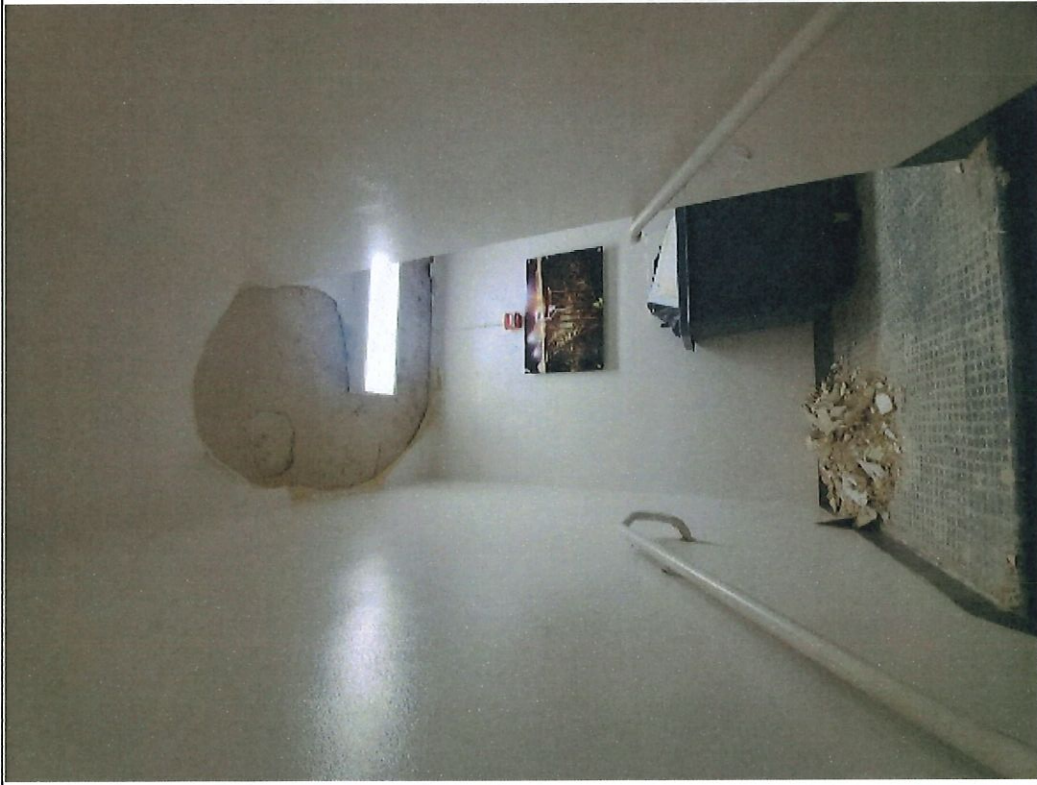
5) Water-damaged plaster material on the ceiling within the main stairwell.

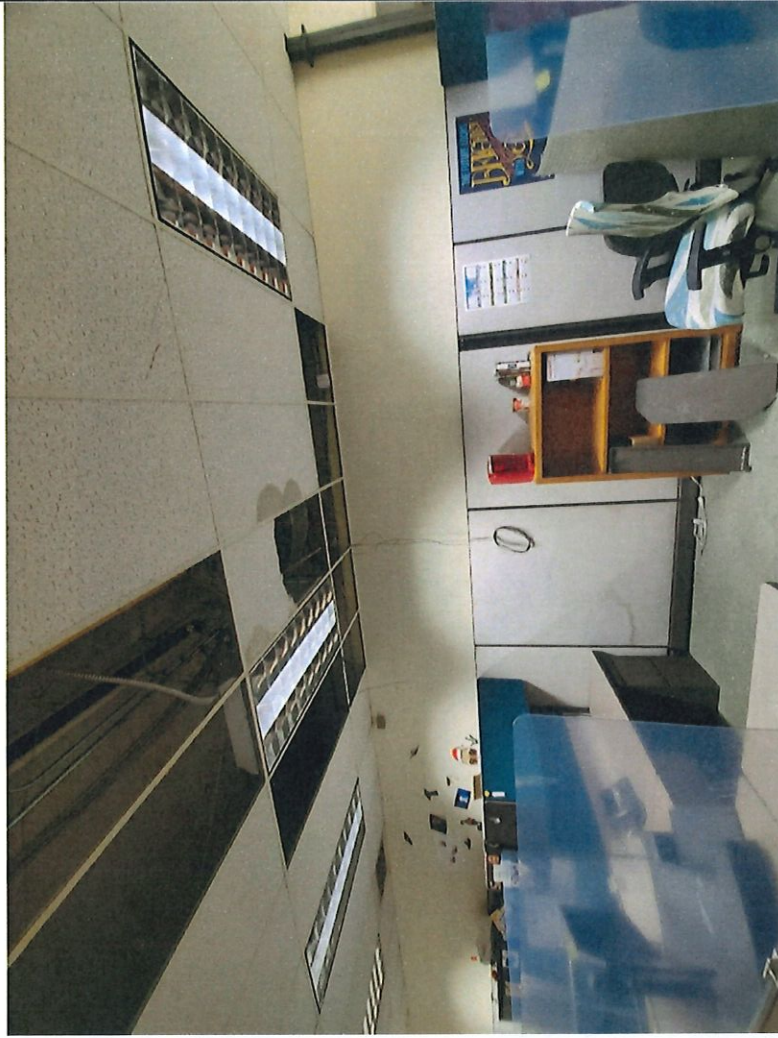
6) Water impacted drop-down ceiling tiles above cubicle office area with visible water-staining on mobile divider walling.

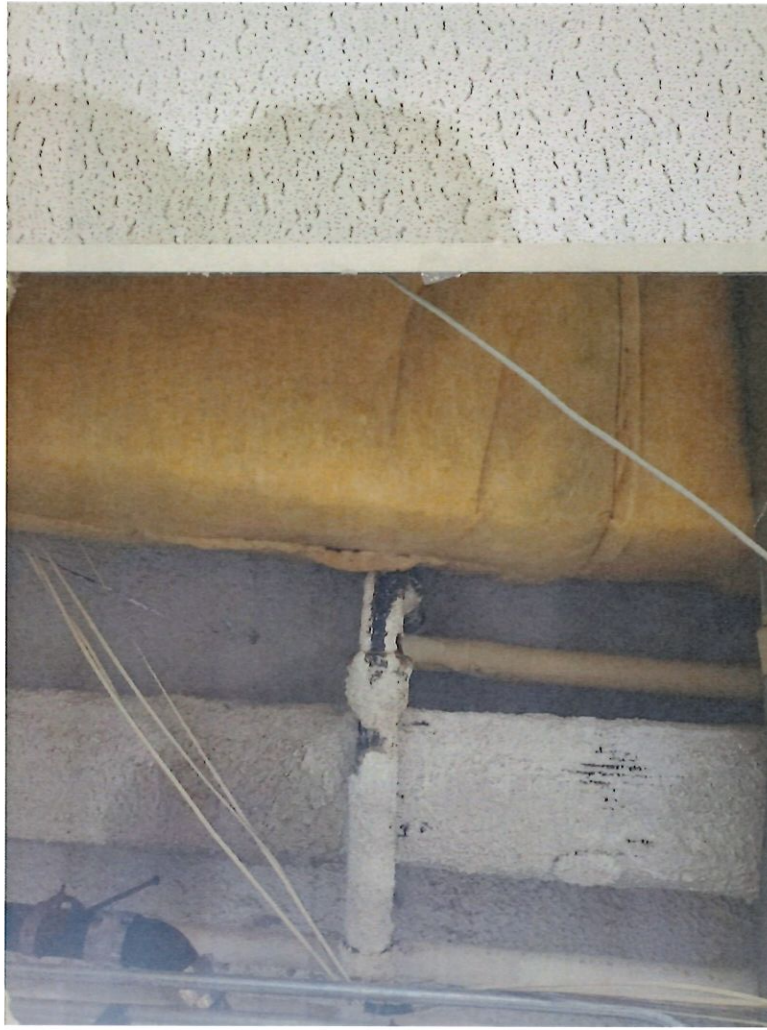
8) Saturated spray-on fireproofing on building material with a piece visibly missing from a section of the exposed plumbing line within a ceiling cavity.
