**DPW PROJECT 18914
LEN B. JORDAN
IDAHO DEPARTMENT OF ADMINISTRATION
BOISE, IDAHO**

**ASBESTOS-CONTAINING BUILDING MATERIAL
SURVEY AND ASSESSMENT REPORT**

NOVEMBER 2018

SUBJECT: DPW PROJECT #18914
LEN B. JORDAN
IDAHO DEPARTMENT OF ADMINISTRATION
BOISE, IDAHO

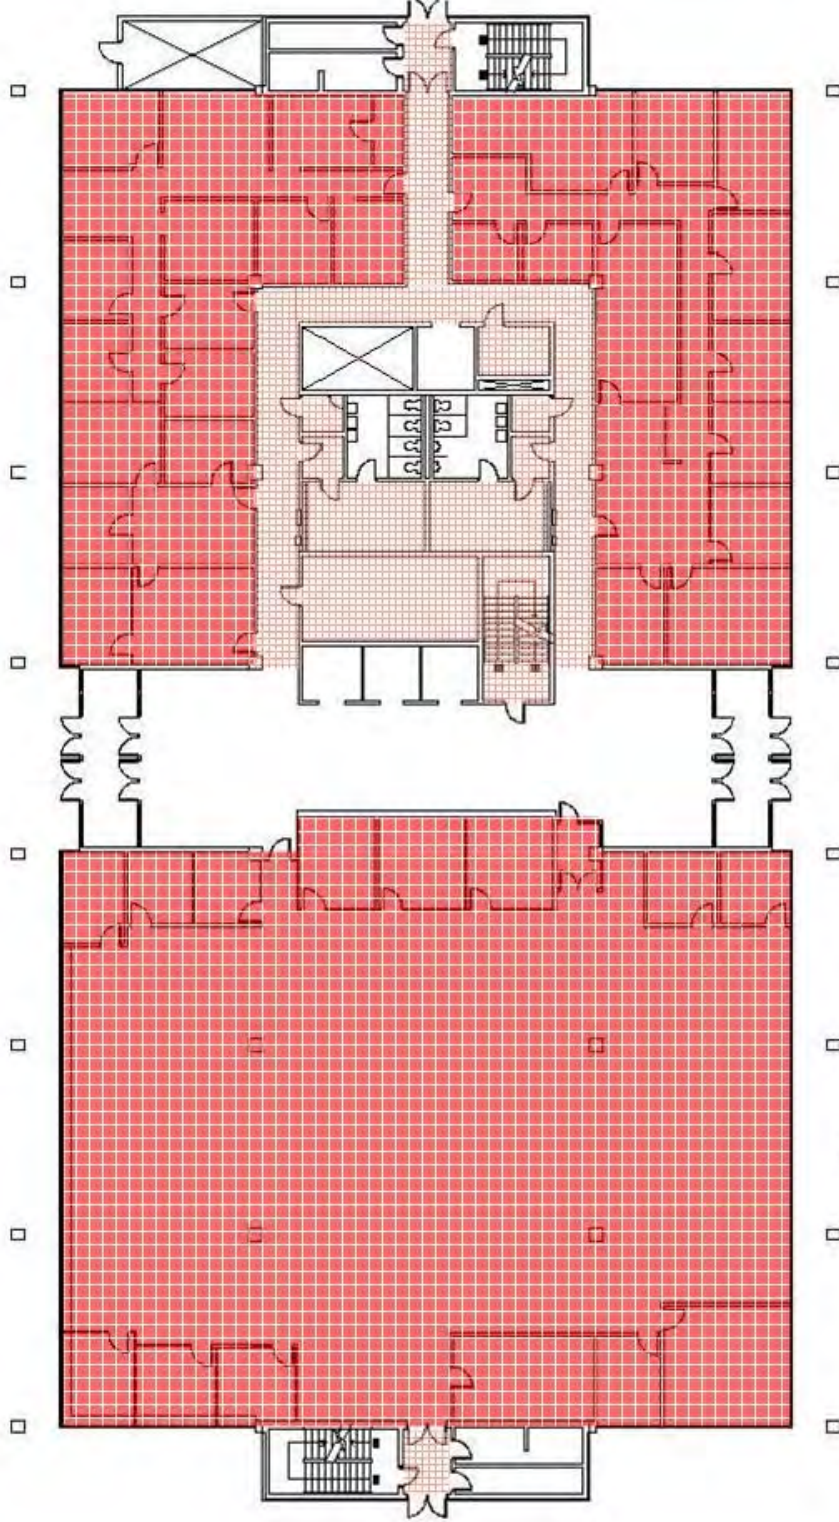
1st Floor

Approximate location of asbestos-containing 12-inch beige vinyl floor tile and black mastic concealed beneath carpeting over concrete substrate.
-

Approximate location of asbestos-containing 12-inch beige vinyl floor tile and black mastic over concrete substrate.

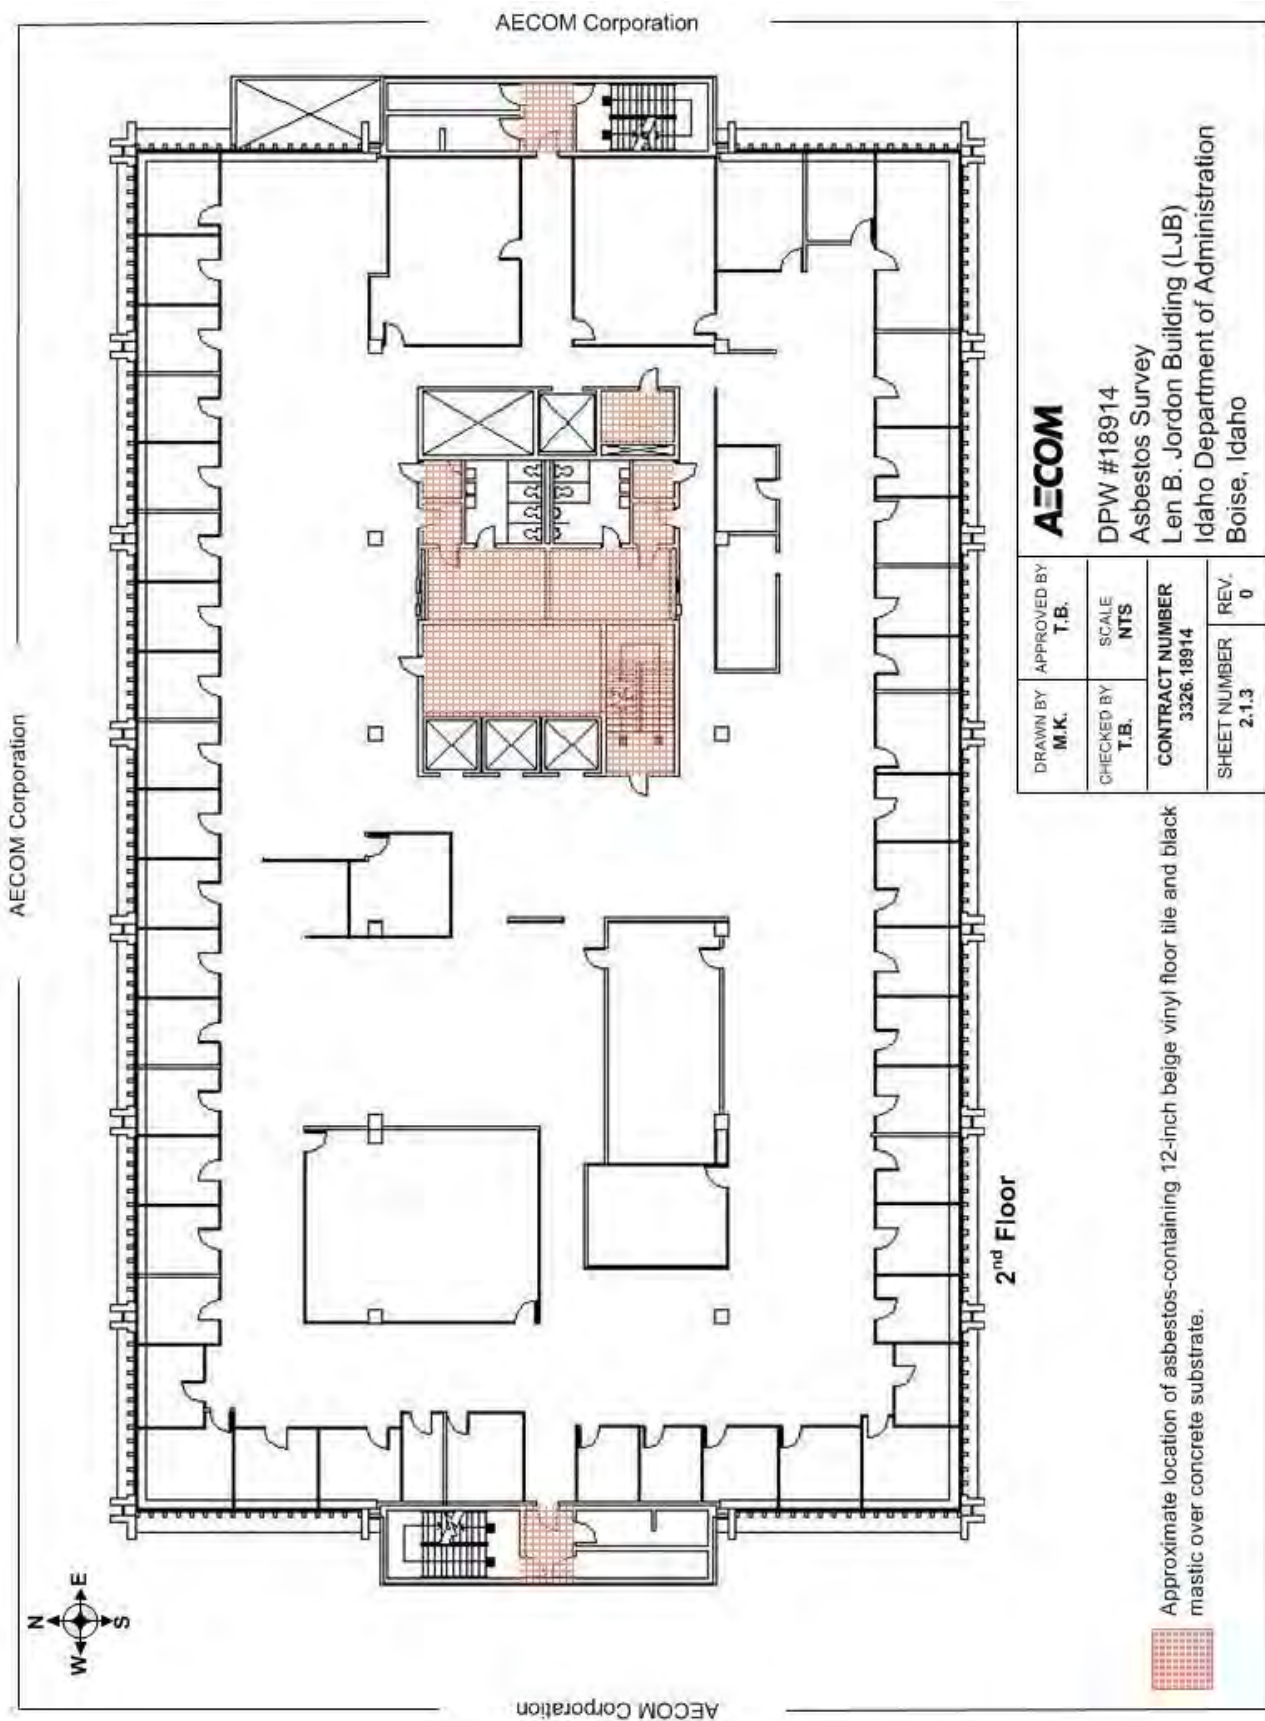
DRAWN BY M.K.	APPROVED BY T.B.	SCALE NTS
CHECKED BY T.B.	CONTRACT NUMBER 3326.18914	
SHEET NUMBER 2.1.3	REV. 0

Approximate location of asbestos-containing 12-inch beige vinyl floor tile and black mastic over concrete substrate.

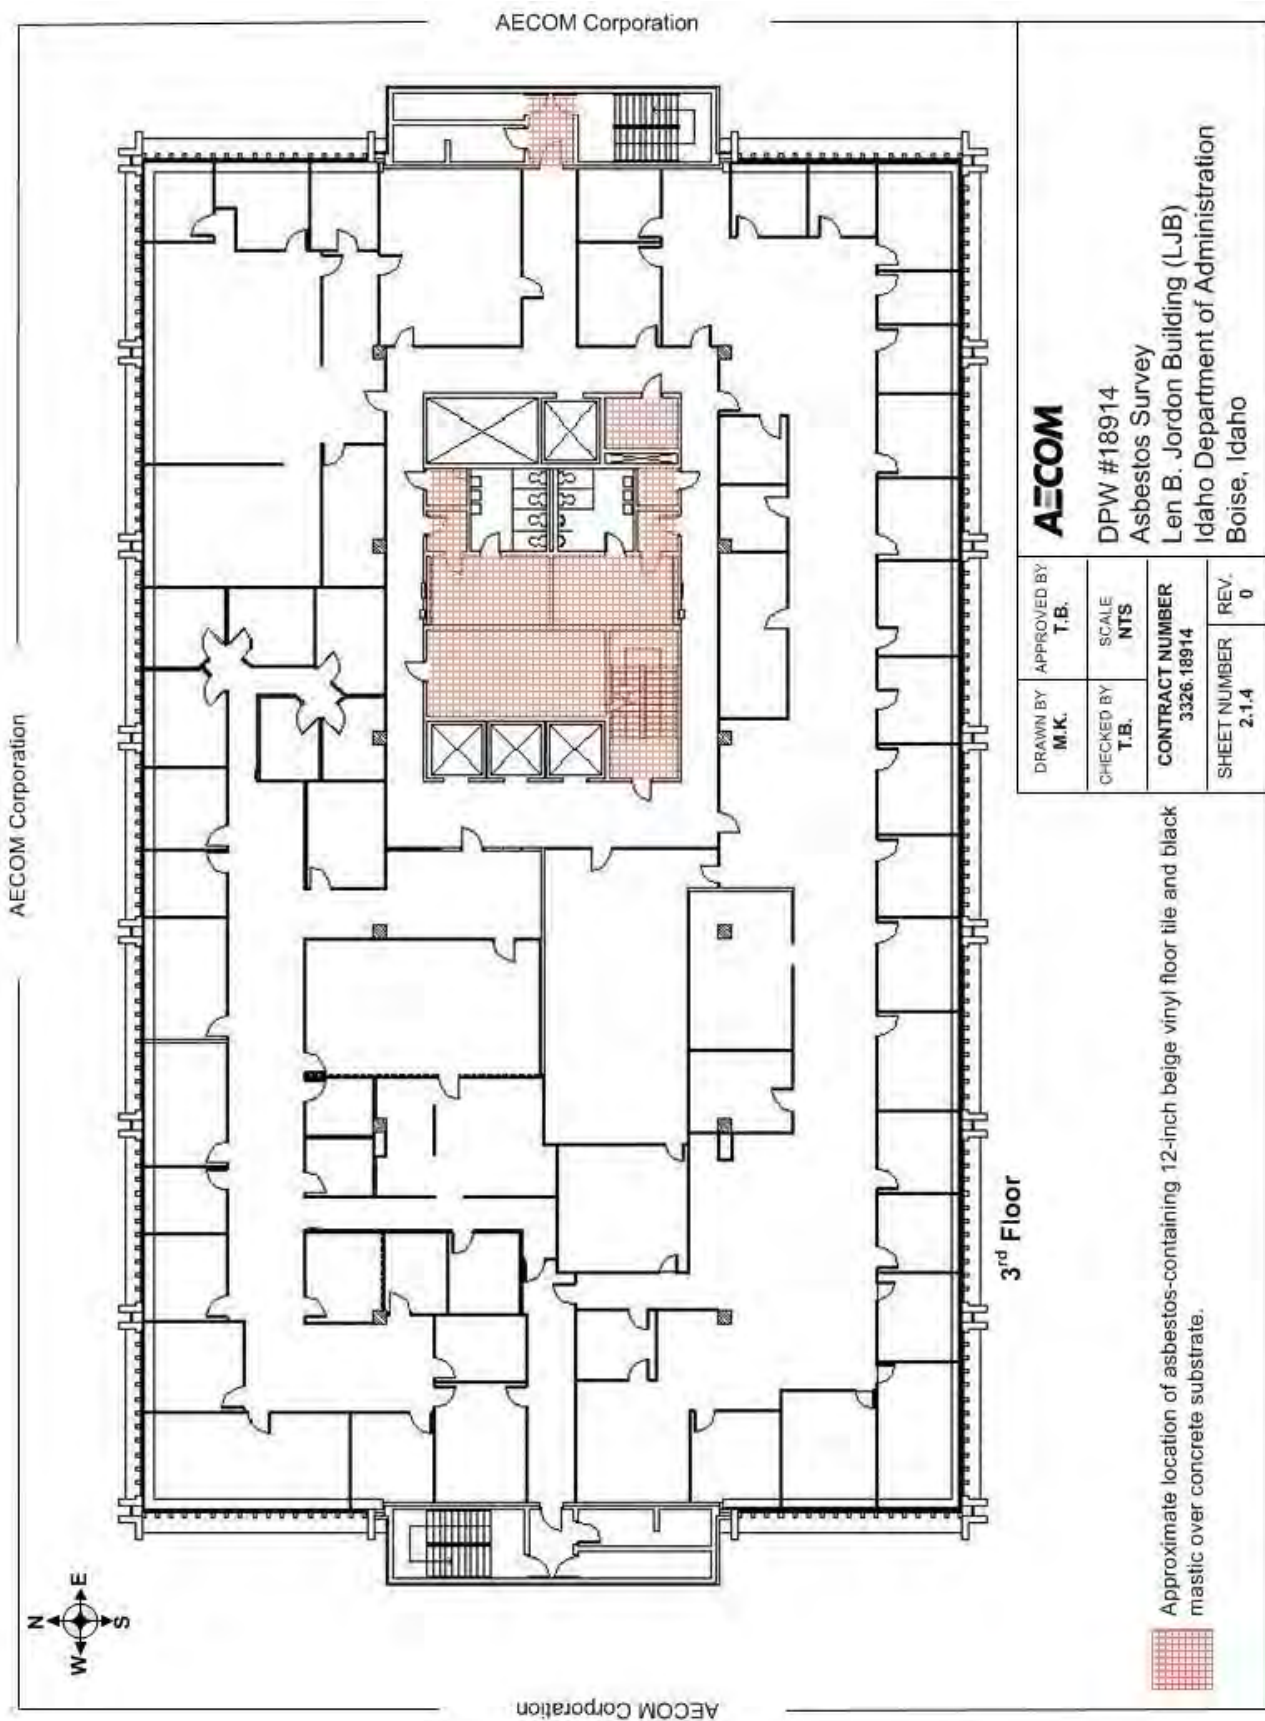
3rd Floor

Approximate location of asbestos-containing 12-inch beige vinyl floor tile and black mastic over concrete substrate.

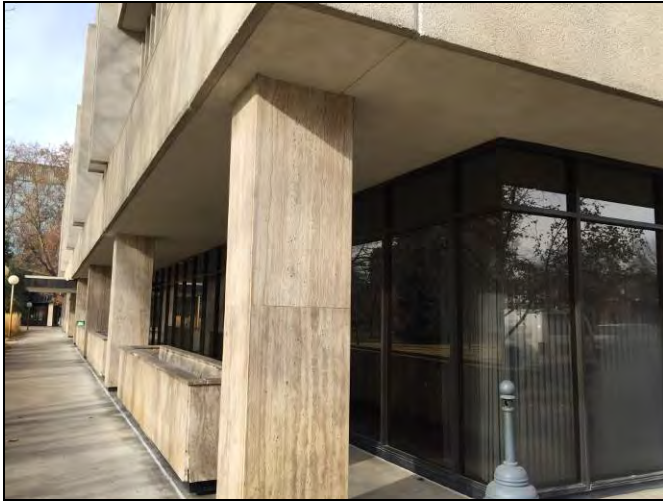
1. **View of the non-asbestos stucco applied to the soffit, pre-cast aggregate exterior walls and the travertine on the columns found on the exterior of LBJ.**

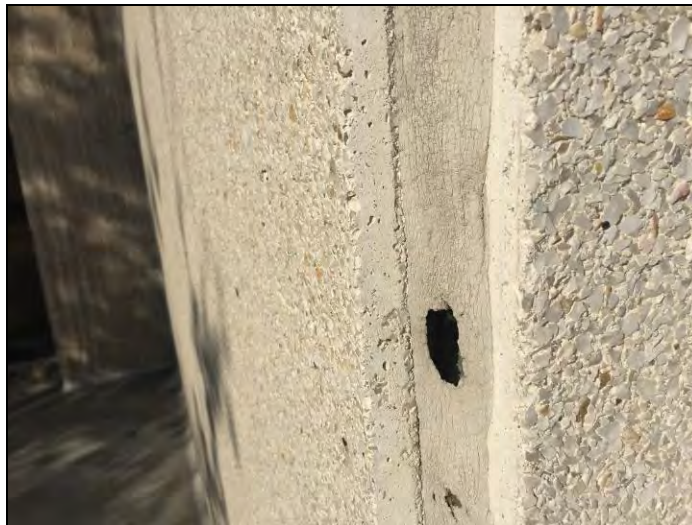
2. **View of the non-asbestos expansion joint caulking found between sections of the pre-cast aggregate exterior walls found around the exterior of LBJ.**

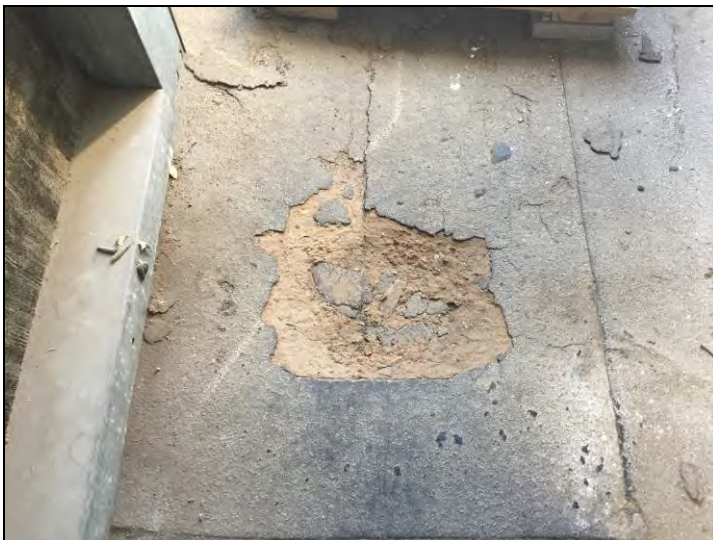
3. **View of the non-asbestos old asphalt roofing found in the penthouse mechanical room.**

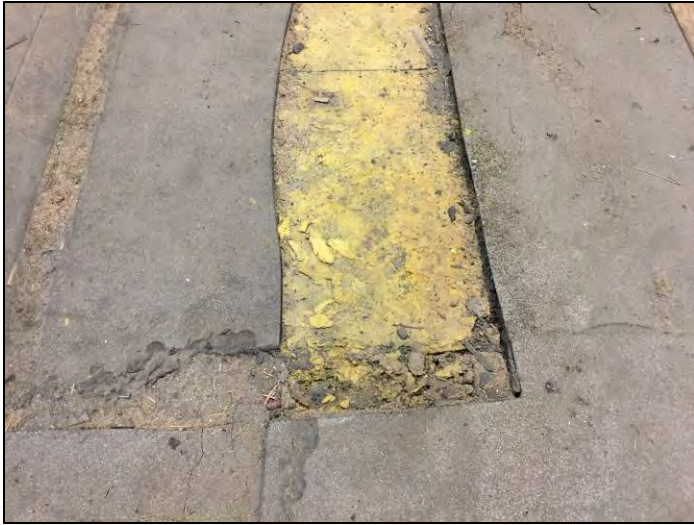
4. View of the non-asbestos yellow rigid fiberglass board found beneath the old asphalt roofing located in the penthouse mechanical room.

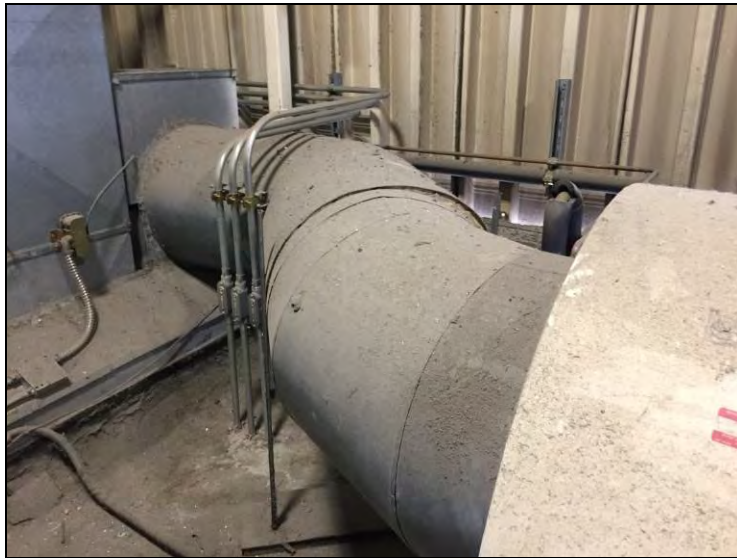
5. View of the non-asbestos dust found on the HVAC ducting and air handling equipment located in the penthouse.

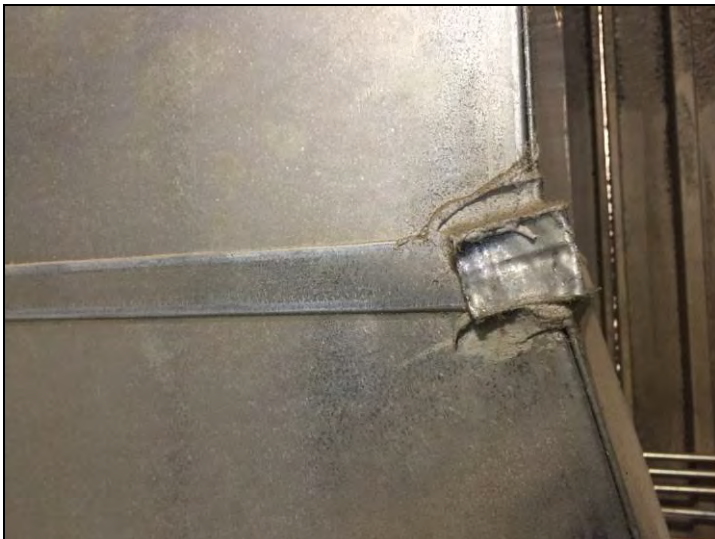
6. View of the non-asbestos grey caulking found on the exterior of the ducting and the air handlers located in the penthouse mechanical room.

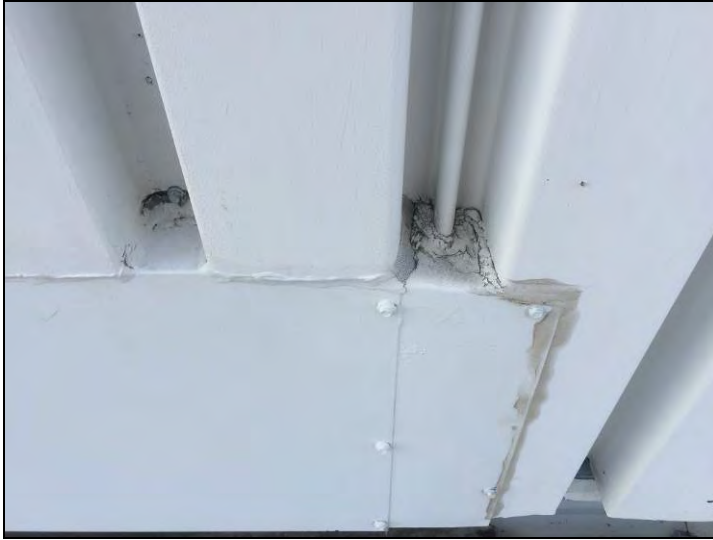
7. View of the non-asbestos grey caulking found on the exterior metal sidewalls of the penthouse mechanical room located on the top of the LBJ Building.

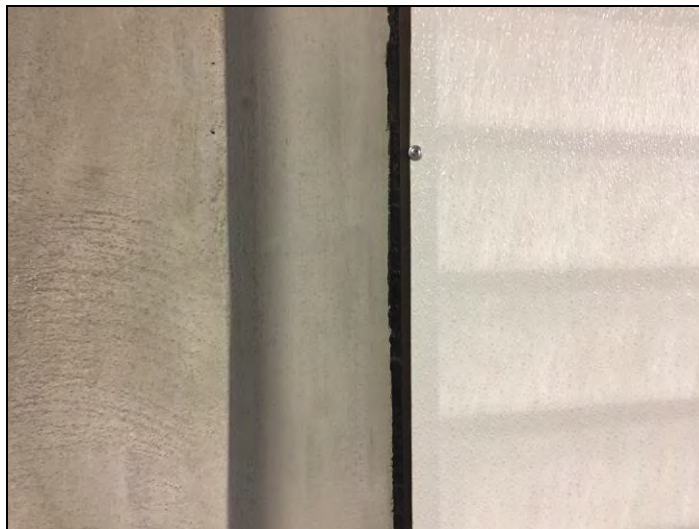
8. View of the non-asbestos stucco wall finish and the black caulking found around the plastic/fiberglass panels used to cover the old vents located within the SE stairwell.

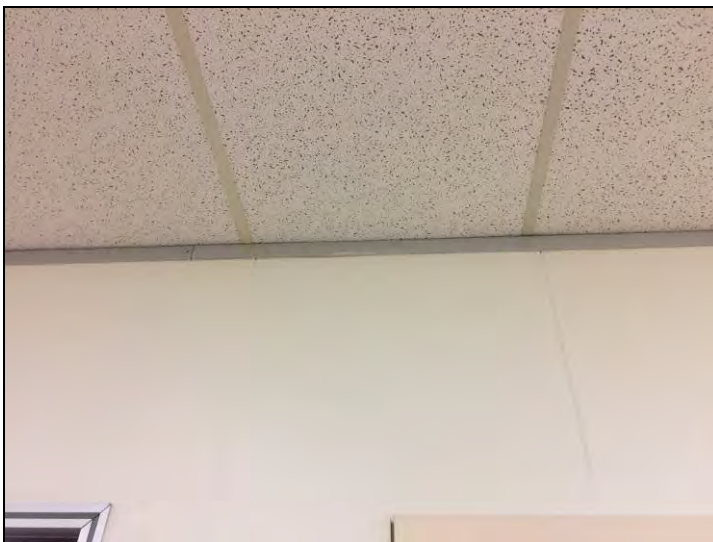
9. View of the non-asbestos 2'x4' ceiling tiles and the pre-fab sheetrock walls found in various locations throughout LBJ the Building.

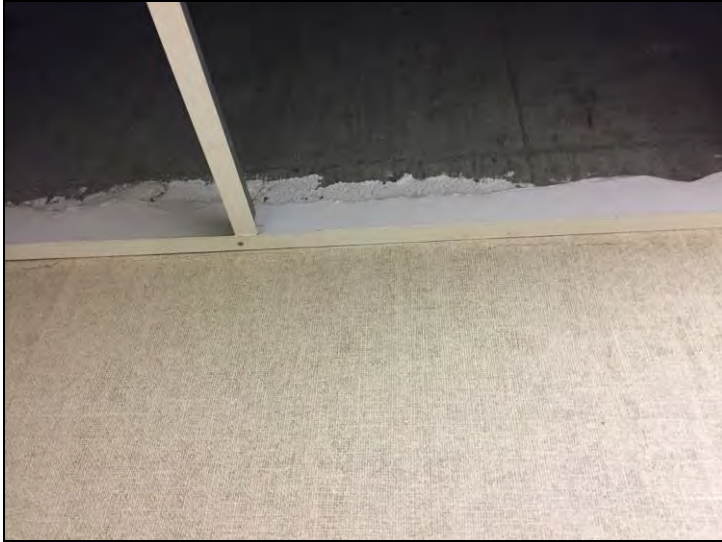
10. View of the non-asbestos plaster finish and vinyl covering found on the plaster and sheetrock walls found in various locations throughout LBJ Building.

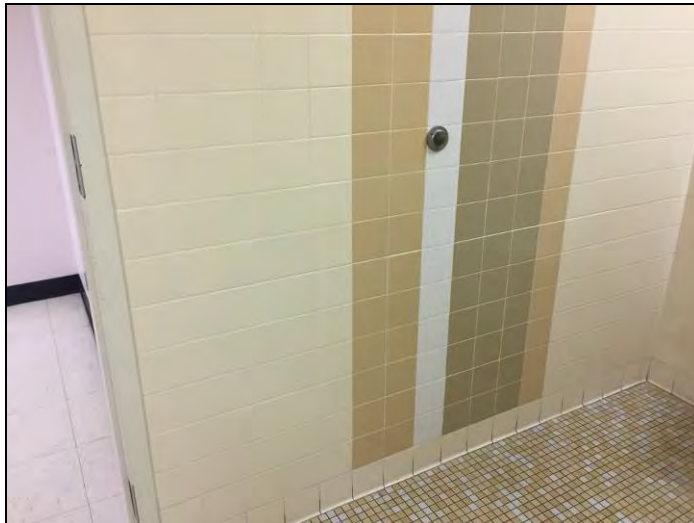
11. View of the non-asbestos ceramic tile grout found within the restrooms' walls within LBJ Building.

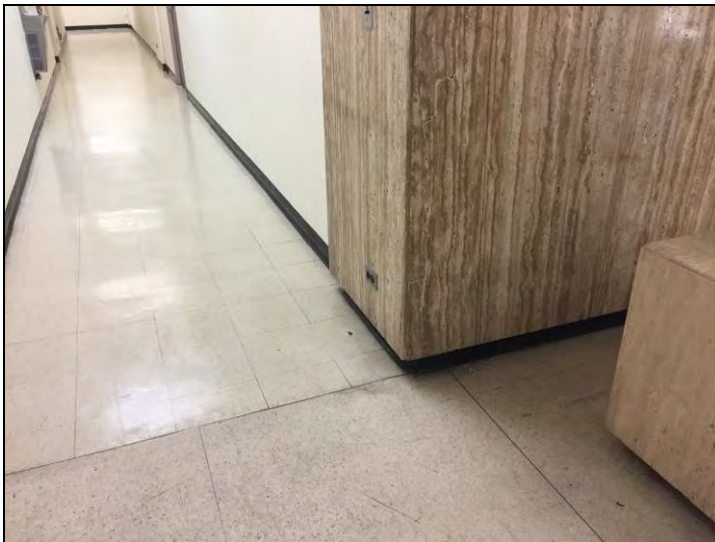
12. View of the new non-asbestos terrazzo flooring and travertine stone wall finish found in main elevator lobby area.

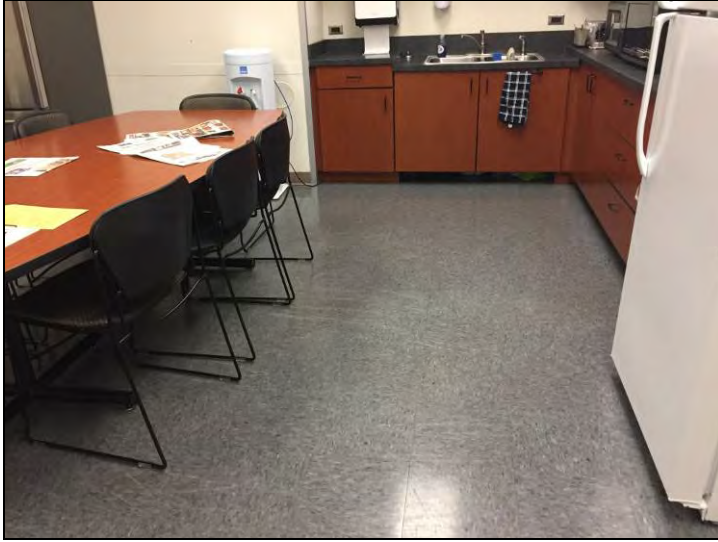
13. View of the new non-asbestos grey sheet vinyl floor tile found in several locations throughout LBJ Building.

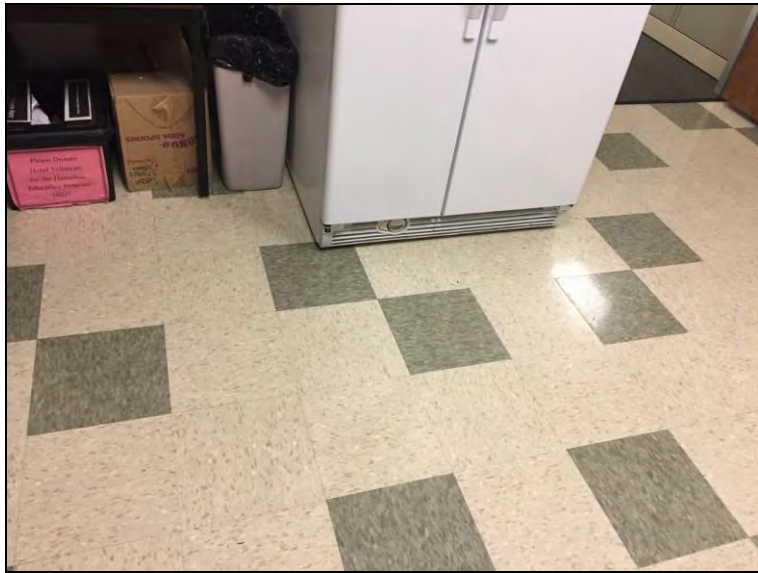
14. View of the new non-asbestos tan and grey vinyl floor tile found in the 2nd floor breakroom.

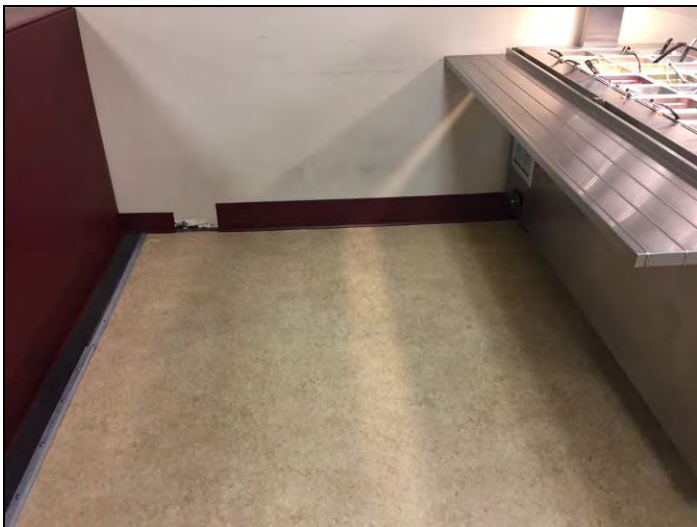
15. View of the non-asbestos gold sheet vinyl flooring found in the basement canteen.

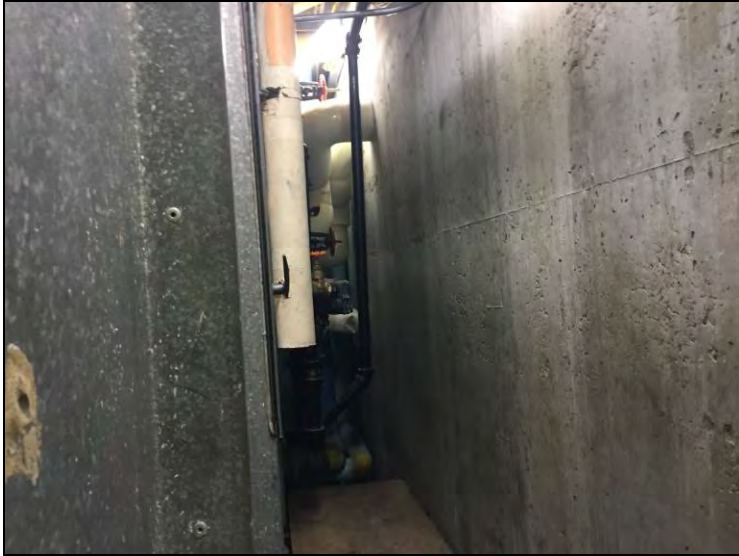
16. View of the non-asbestos TSI fiberglass pipe-run insulation found on the steam, chilled, roof drain and domestic water lines and exhaust from the emergency generator.

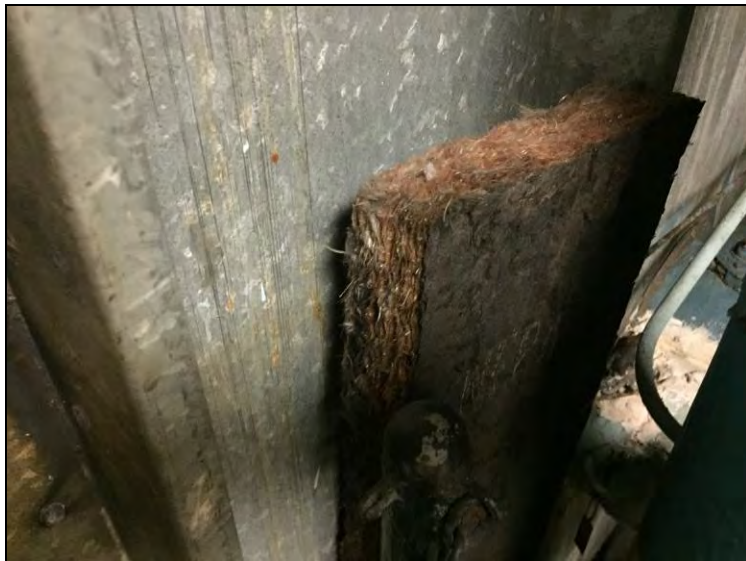
17. View of the non-asbestos black rigid insulation board found on the interior of the HVAC air handlers.

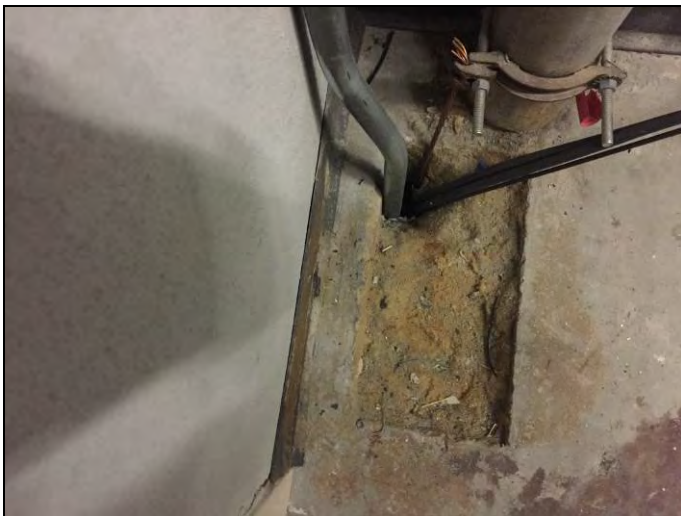
18. View of the non-asbestos foam insulation applied to the pipes and conduits at penetrations through the concrete floors.
