ADDENDUM NO. 2

Project: DPW PROJECT NO. 26336 – **Design Professional RFQ**

Bldg. 00710 Repair Concept

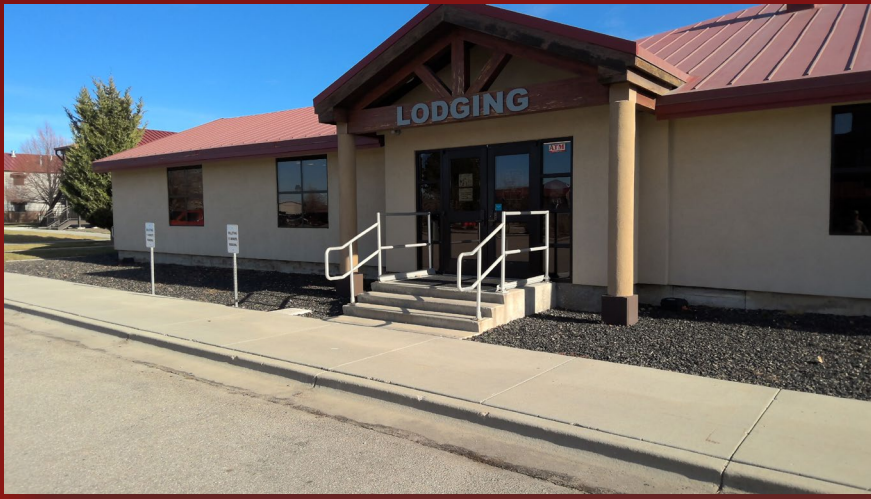
Bldg. 00710 Required Repairs

Bldg. 00710 requires essential repairs and minor modifications to ensure functionality, safety, and accessibility. The scope includes mechanical system repairs, complete restoration of the outdoor decking to include footings, water drainage, joists, decking, trellis refinishing, and ADA access throughout the exterior of the facility.

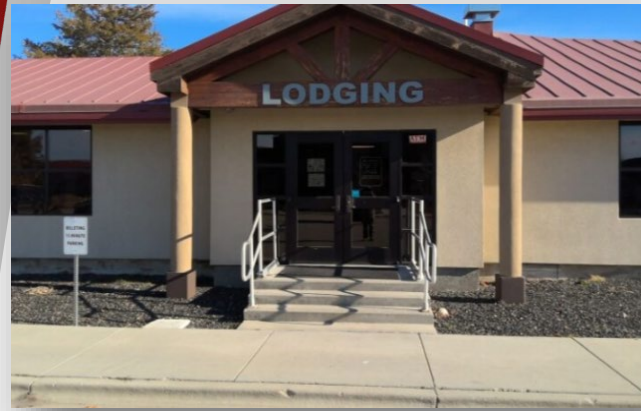
Construct ADA Access

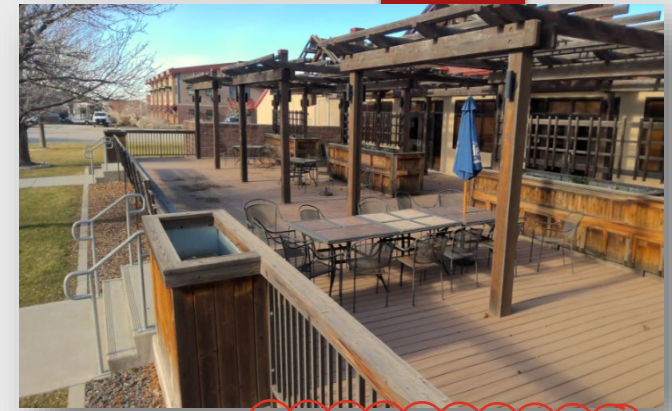
Replace Decking and add ADA Access

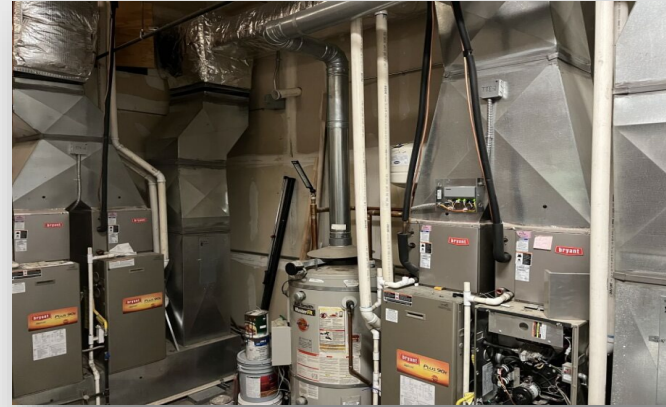
Replace HVAC

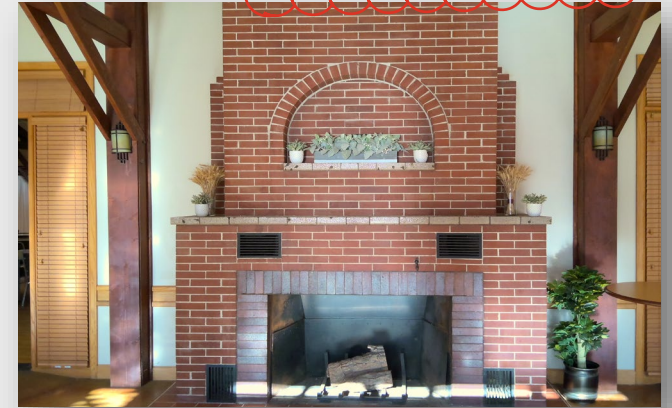
Repair Existing Fireplaces

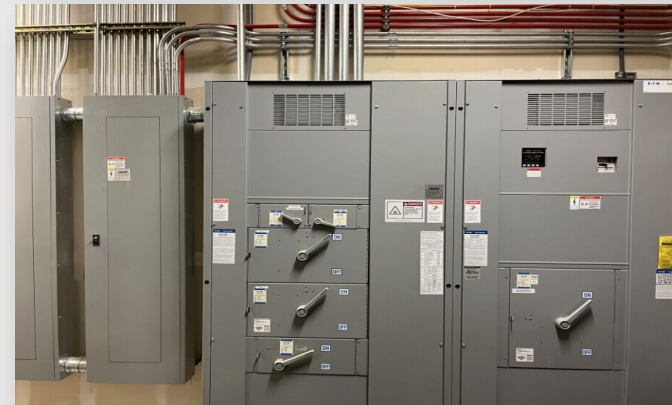
Repair Electrical Loads
