**REQUEST FOR QUALIFICATIONS (RFQ)**

*ure* SUBJECT: DPW PROJECT NO. 27150  
Lewis-Clark State College (LCSC)  
Reid Centennial Hall Life Safety Improvements  
818 6<sup>th</sup> Street, Lewiston, Idaho

**Report of Asbestos and Lead-Based Paint Survey  
DPW Project No. 22-908  
Lewis Clark State College  
Reid Centennial Hall  
Lewiston, Idaho**

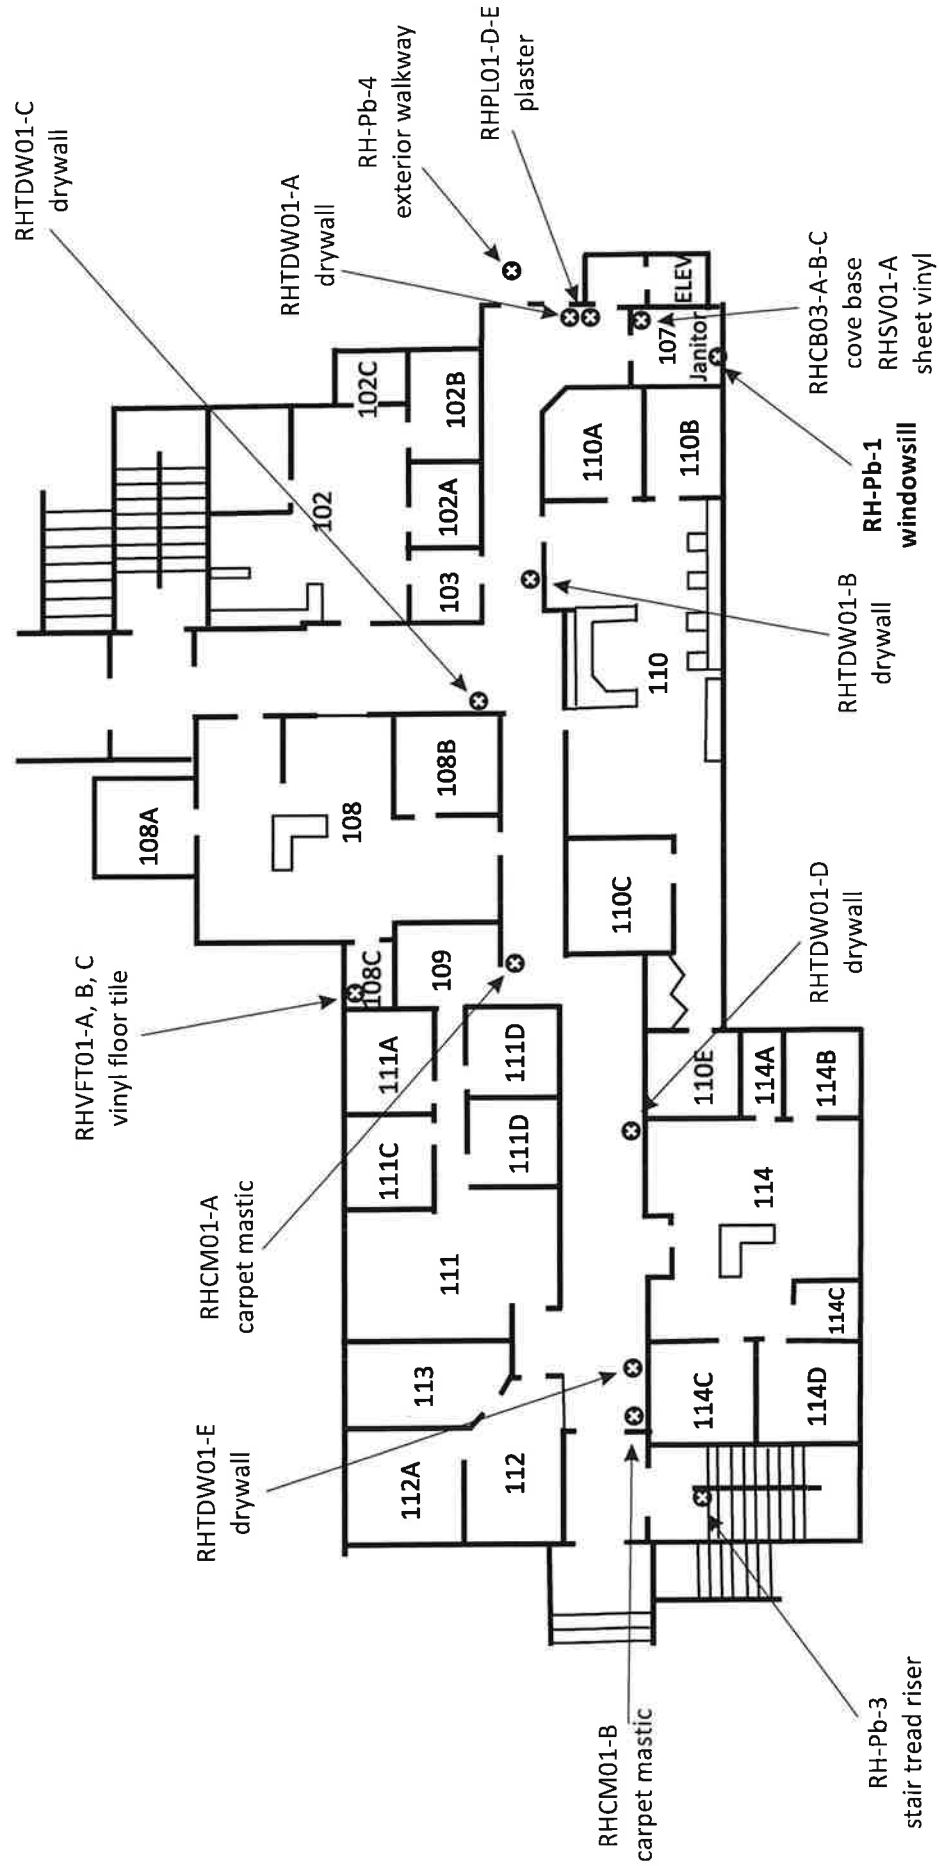
**Figure 2**  
**Asbestos and Lead Sampling Locations**  
**Reid Hall - First Floor**  
**Lewis Clark State College**  
**500 8th Ave., Lewiston, Idaho**  
**October 12, 2021**

No asbestos was identified to be present in any of the suspect building materials tested

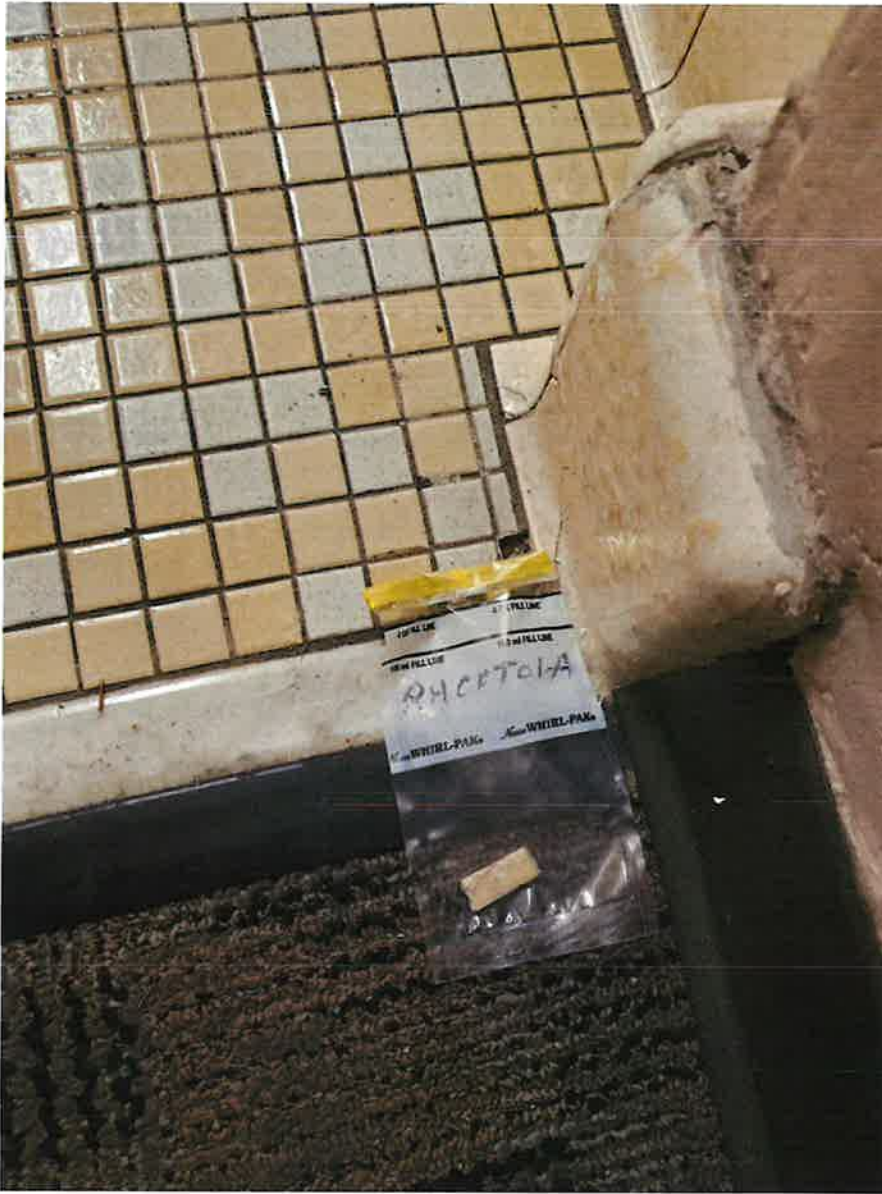
Photo 1: View of the bulk sample collected from the ceramic floor tile and mortar in the men restroom. No asbestos was identified to be present in the ceramic tile or mortar.

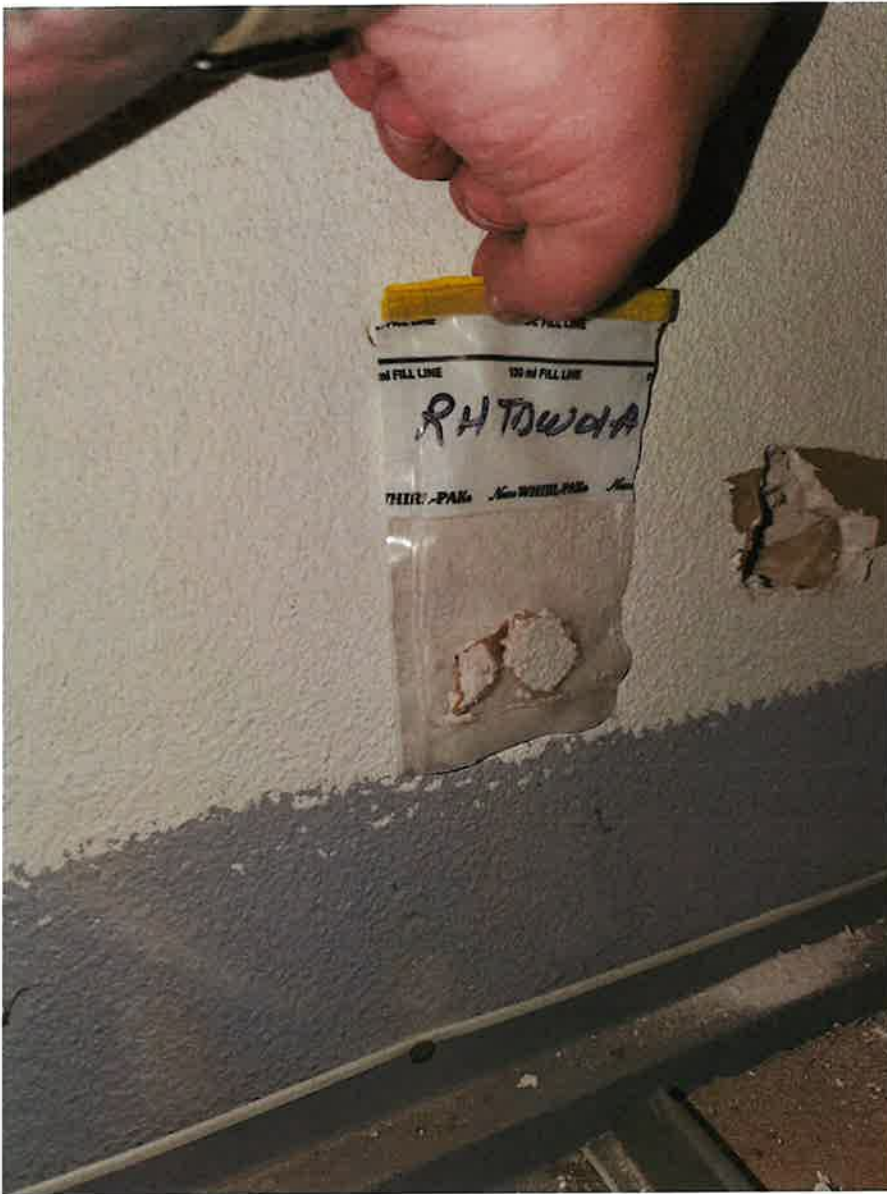
Photo 2: View of the bulk sample collected from the textured drywall in the east main entry to the building. No asbestos was identified to be present in the texture, drywall mud or sheet rock.
