SUBJECT: DPW PROJECT NO. 26250  
Joint Military Science & Veterans Assistance Center  
University of Idaho (UI)  
Moscow, Idaho

# TARGHEE HALL FEASIBILITY STUDY/PROGRAM

August 14, 2024

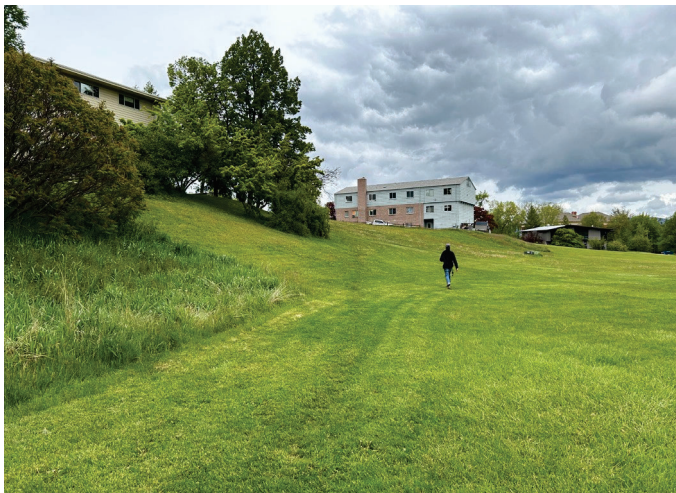
Northwest Transition Slopes to New Greek Row

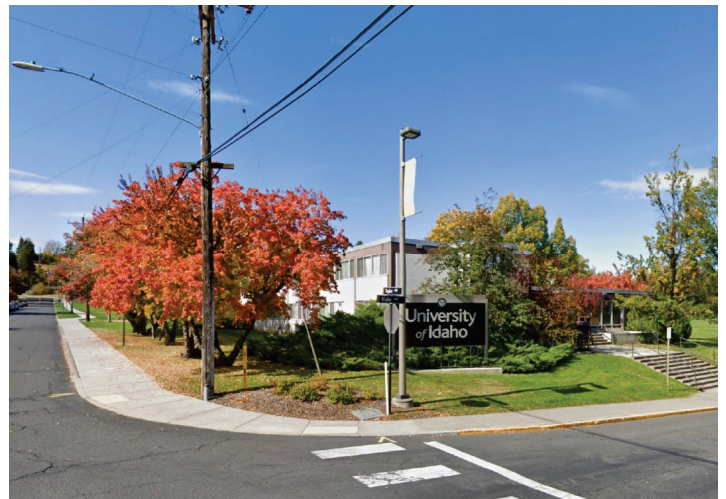
Corner Entrance Sign

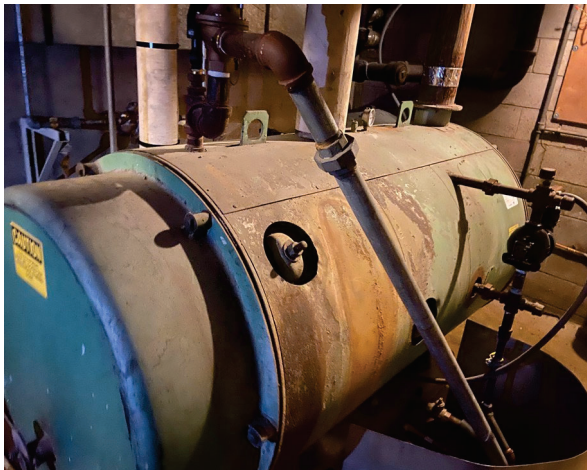
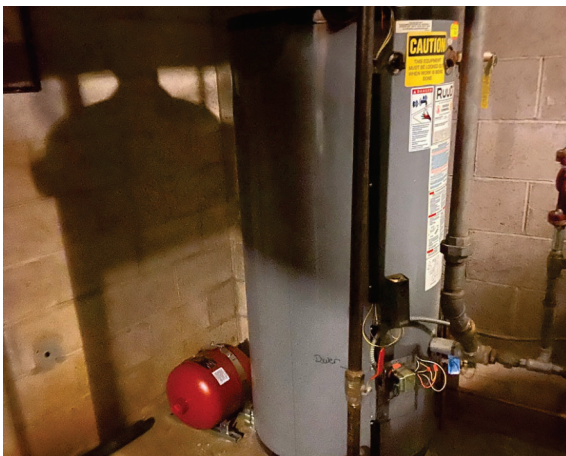
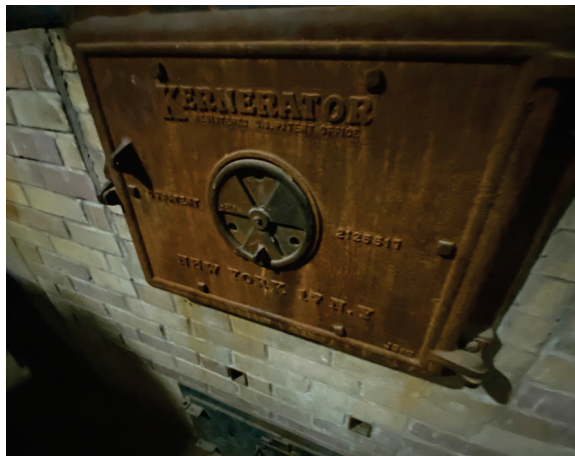
The existing HVAC systems at Targhee Hall are extremely primitive and aged. The entire building is served by a gas fired boiler located in the basement, and passive radiant heater located throughout the building connected by a network of hot water piping. The facility has minimal active ventilation and is limited to restroom exhaust, kitchen exhaust (no longer in service), and an exhaust fan located in the window well of the basement that served what was assumed to be a workout room. It was not clear if this fan is still operational. The dorm rooms all have operable windows to allow for passive ventilation of the facility.

The domestic water heater is located in the boiler room. The water heater is much newer than the domestic piping. It is a gas-fired RUUD model RFD76-200 -I water heater with a 76 gallon storage tank. While the water heater appeared to be in good working order and well maintained, based on the serial number (0394G03349) it is assumed this water heater was manufactured in 1994. Despite its good physical condition, being 30 years old the water heater is likely near the end of its useful life. Both the water heater and boiler flues are routed up to the roof through the existing chimney of the original coal burning furnace.

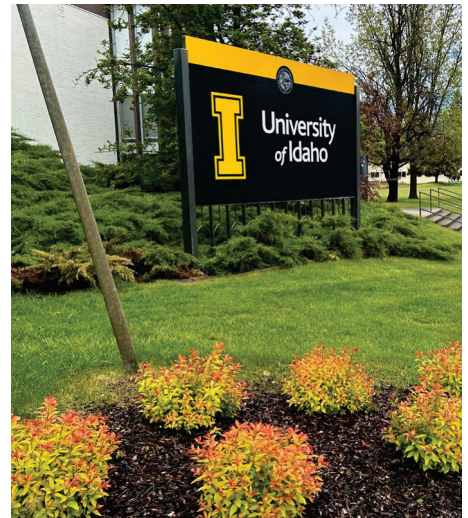
*Further enhance the street presence of the intersection to better welcome students and visitors.*

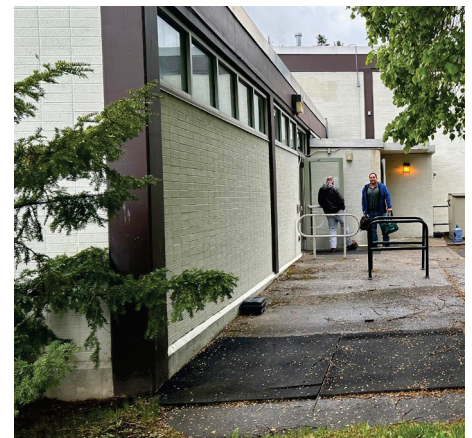
*Demolish most outdated and out of compliance site elements such as asphalt, concrete, stairs, railing, and vegetation in poor condition. Other site elements that do no contribute to final design would also be removed.*

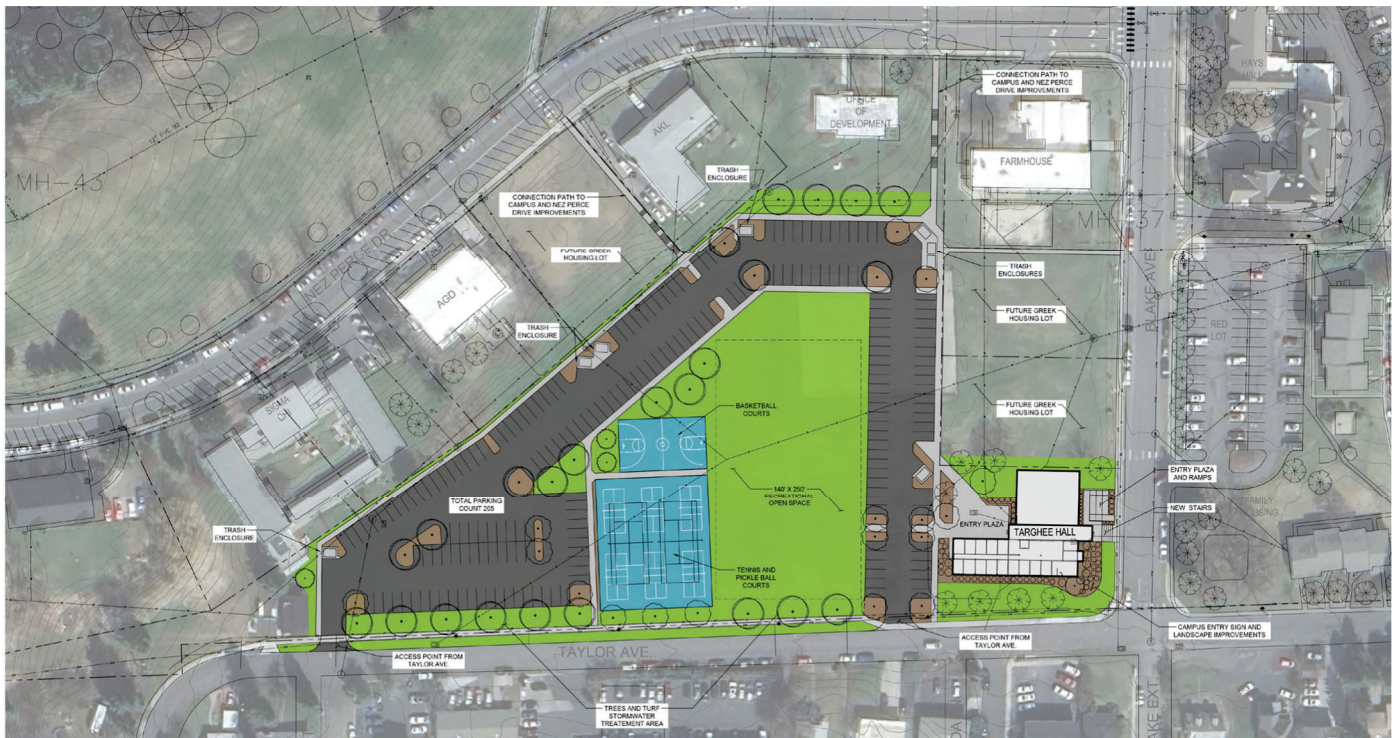
The proposed site design aims to significantly enhance Targhee Hall's functionality and provide resources for students and the new Greek Row, such as sports courts, 200+ parking stalls, and relocating all trash enclosures from Nez Perce Drive. Additionally, the site will improve pedestrian circulation for all students walking through the area to campus. From a wayfinding perspective, the southeast corner sign and building will announce to people driving to the site they have arrived on campus. Outdoor spaces adjacent to Targhee Hall will include plazas and seating that create gathering spaces for the ROTC and Veteran Services programs. The large open lawn in the center of the site will be maintained to allow ample space for the campus recreation department and cadet training.

See Appendix H for larger site plan.

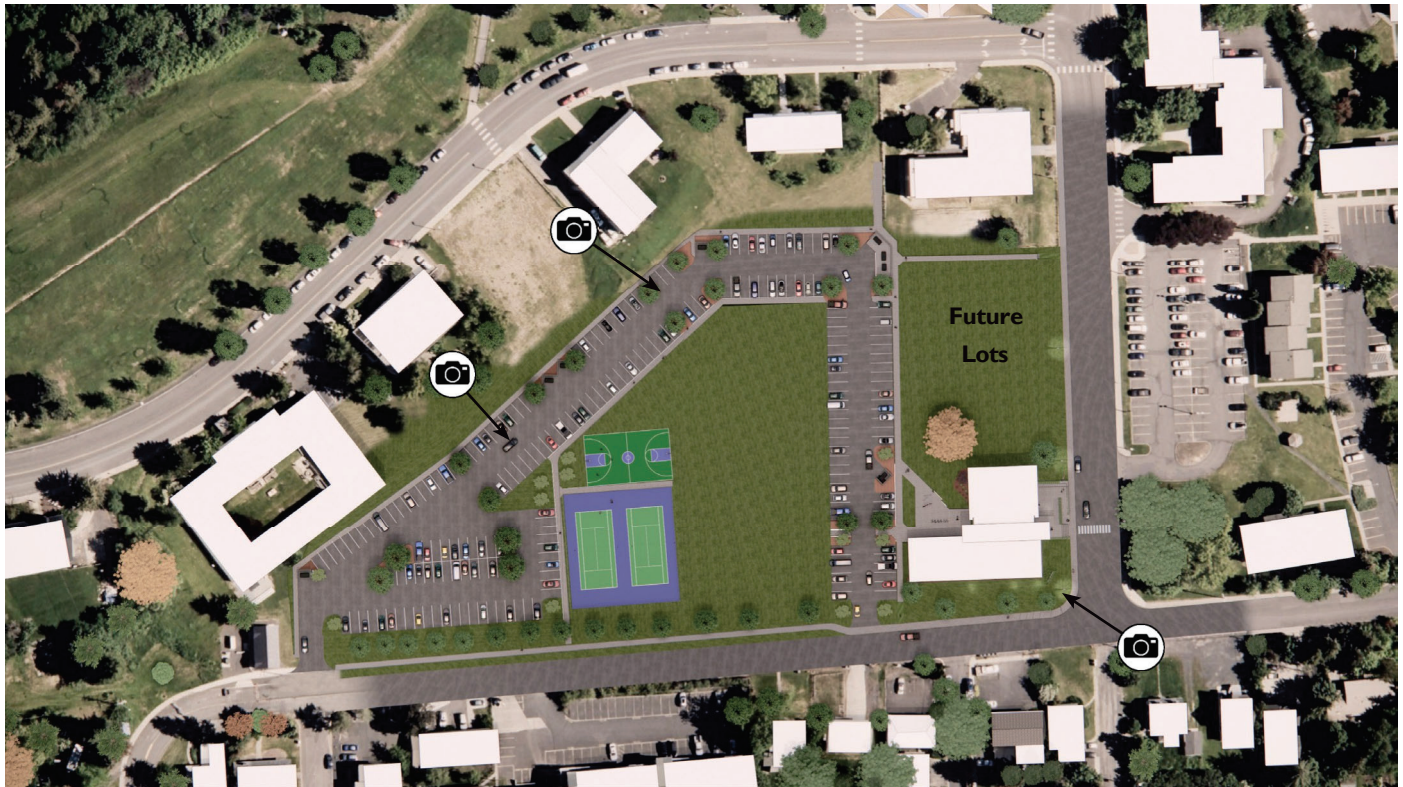
*Site plan rendering of proposed site improvements.*

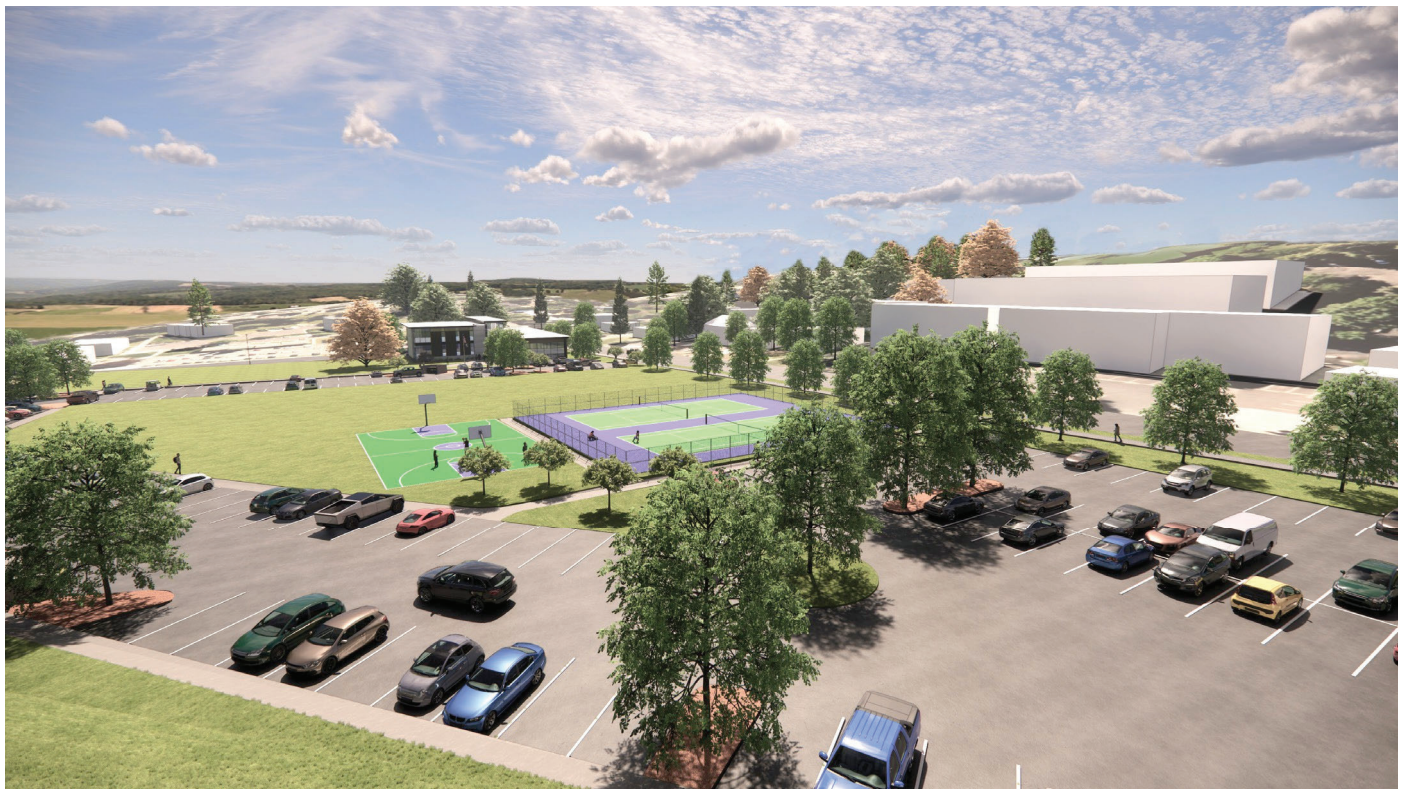
*View from Sigma Chi: The close proximity of courts and parking to new Greek row will better appeal to students where currently parking and other recreational opportunities are further away.*

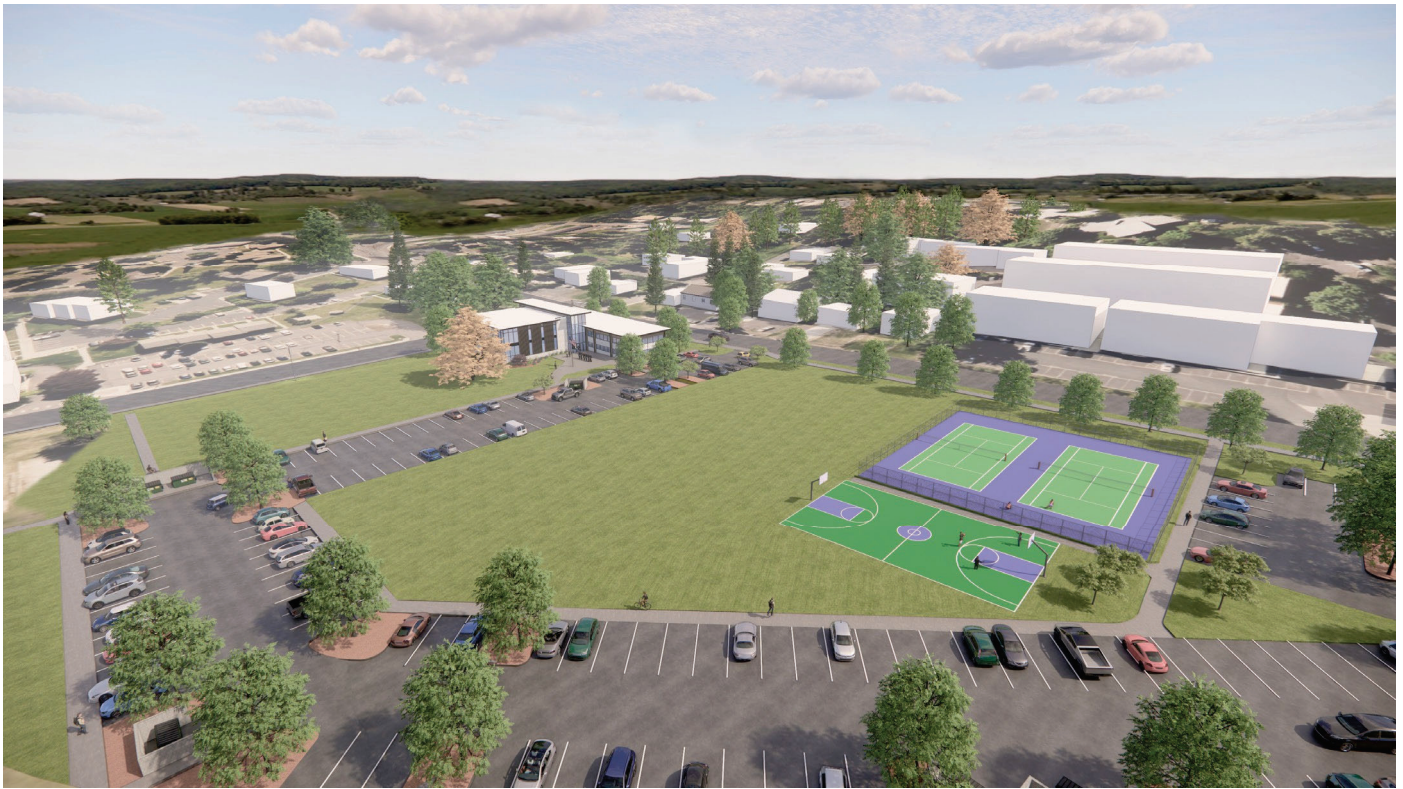
View from Northwest Corner of New Greek Row Hill: Site amenities such as parking, and trash enclosures will help support Nez Pierce Drive.

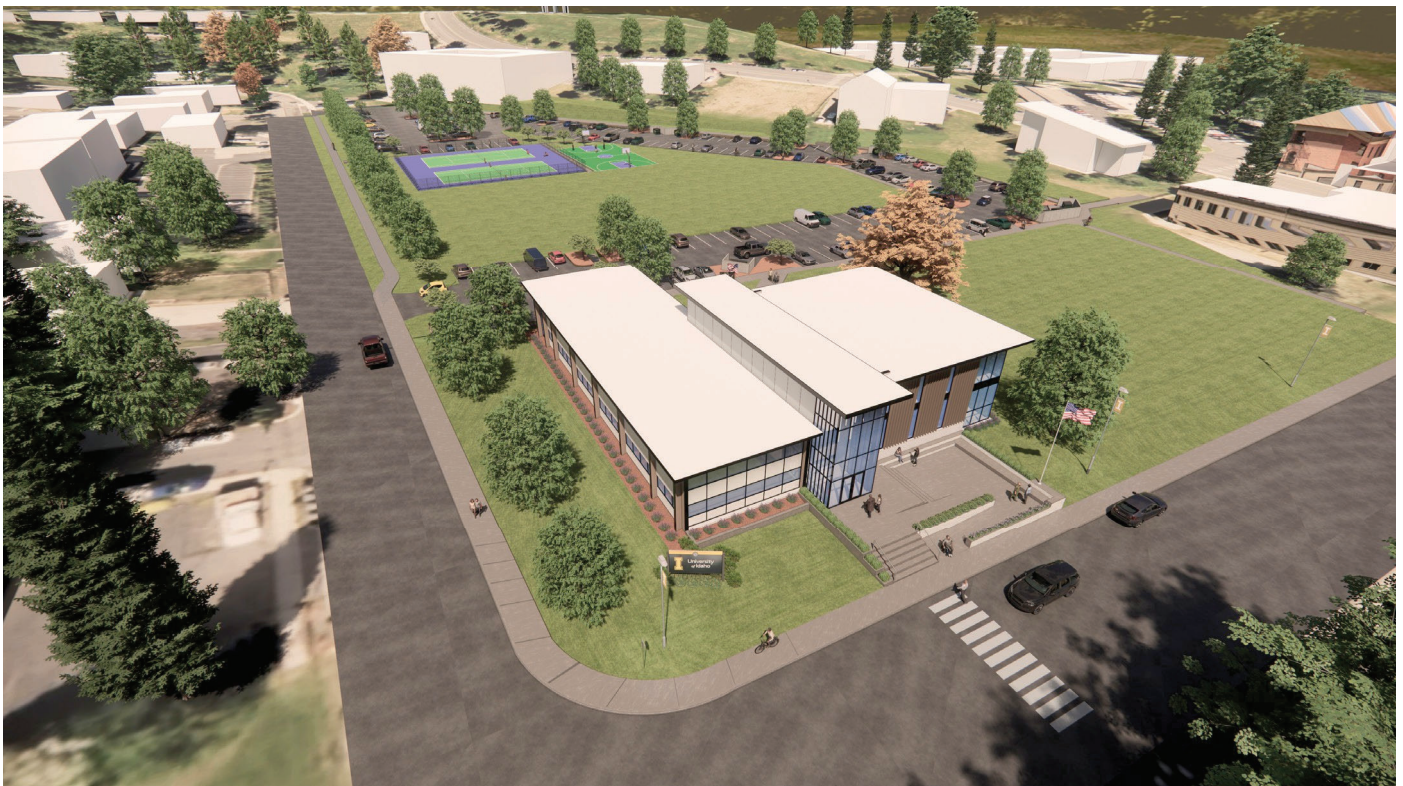
View from Southeast Corner of Blake and Taylor: Entry plaza and corner monument sign upgrades will welcome students and visitors to the campus. These improvements will also serve as a way finding point to better define campus extents.

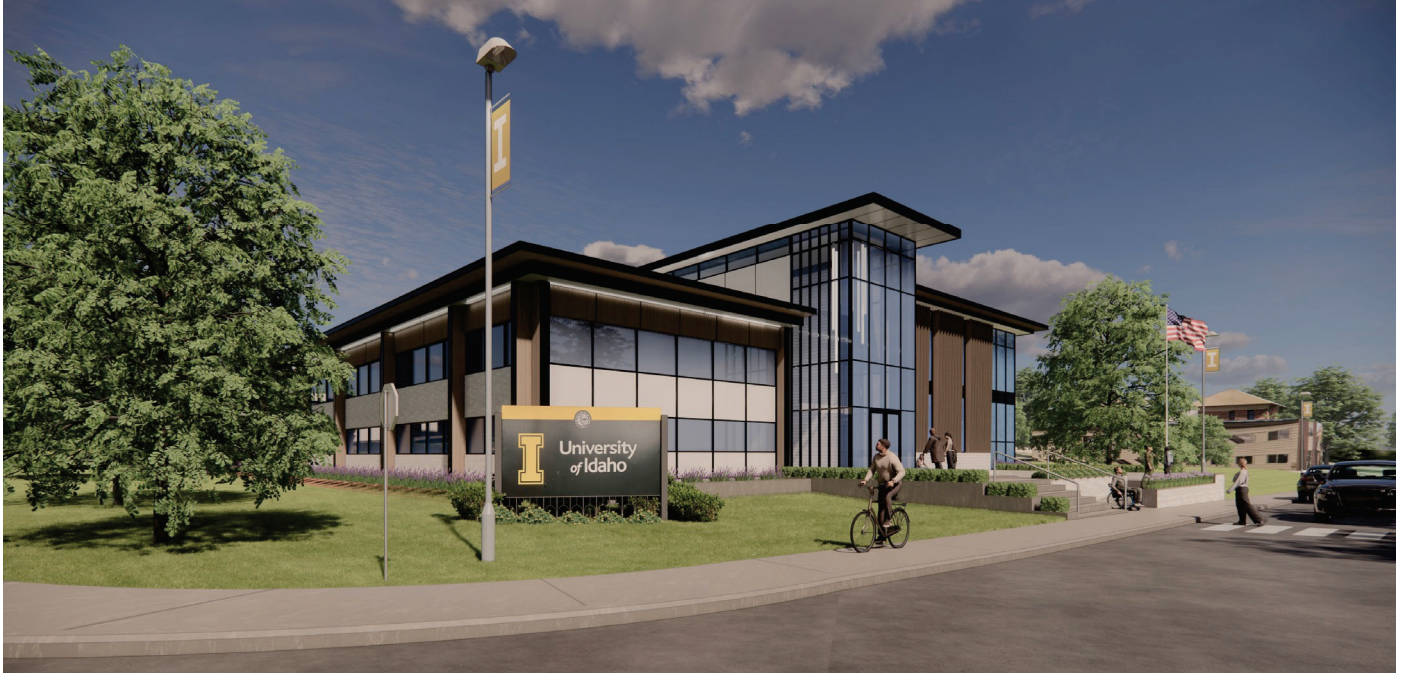
**SE Concept:** Campus entry sign and the east side entry. Floor height above pedestrian path will be accessed through the use of tiered ramping.

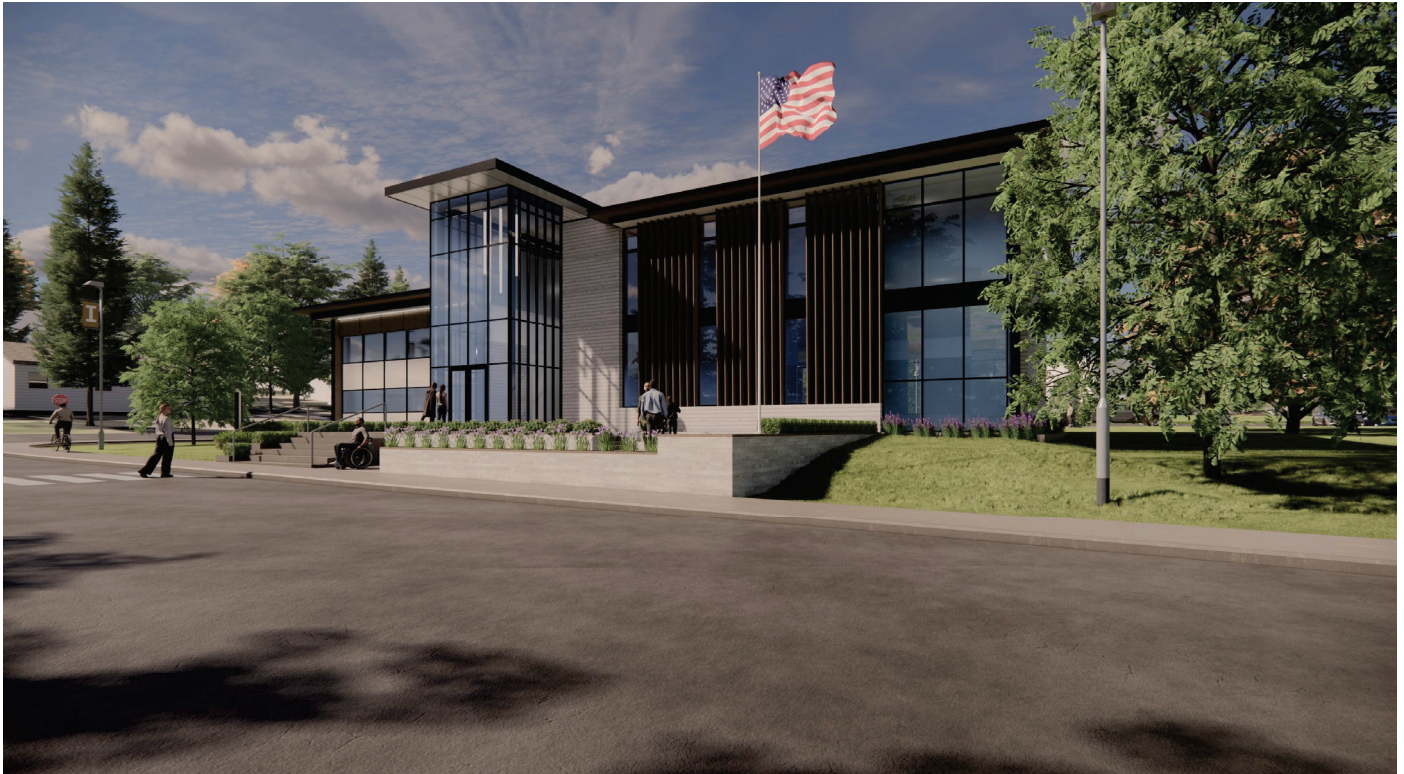
**NE Concept:** East side entry. Floor height above pedestrian path will be accessed through the use of tiered ramping. This provides opportunities for landscaping.

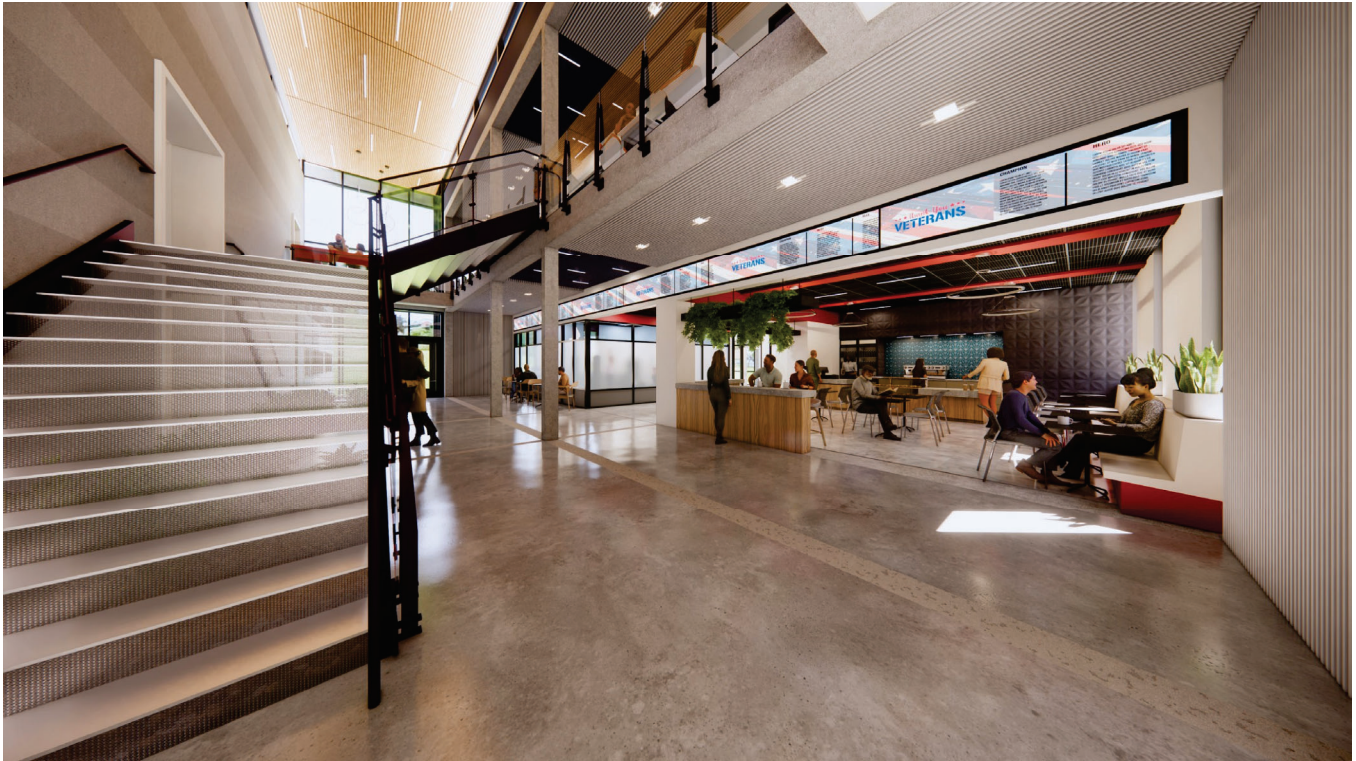
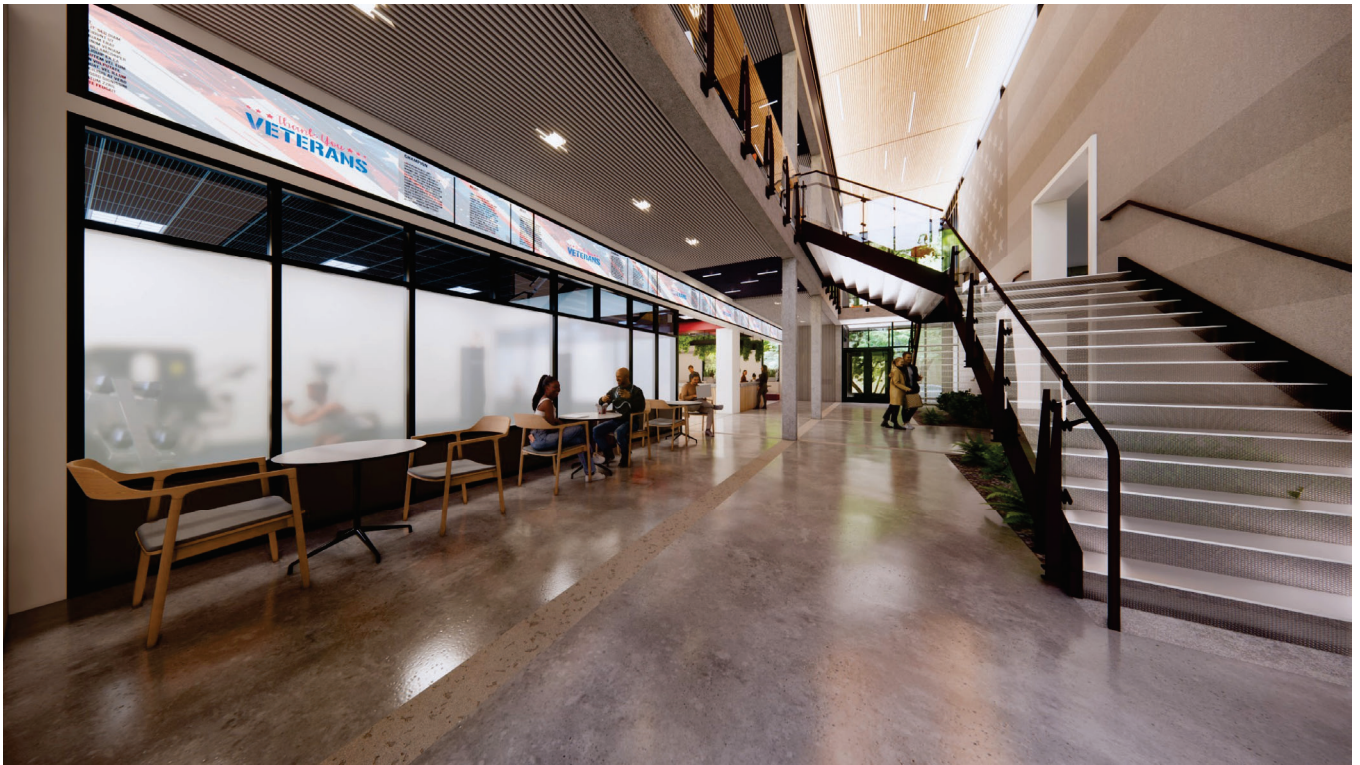
**First Floor:** Both the street-side and courtyard entrances lead into a welcoming lobby featuring a café, study, and gathering areas, which seamlessly connect the existing building to the new addition. This 'Connector' serves as the primary circulation space across multiple floors, highlighting key functions that Architects West aimed to showcase. The space will feature abundant natural daylight, scenic views, and will act as a conduit to all departments and common areas. The first rendering offers a perspective of the experience as you enter the building from the west, with a similar experience at the east entry, though with different functions to the north and south. The rendering's north side provides a glimpse of the Wellness Center, while the south side highlights vertical circulation, including a four-stop, two-sided elevator.

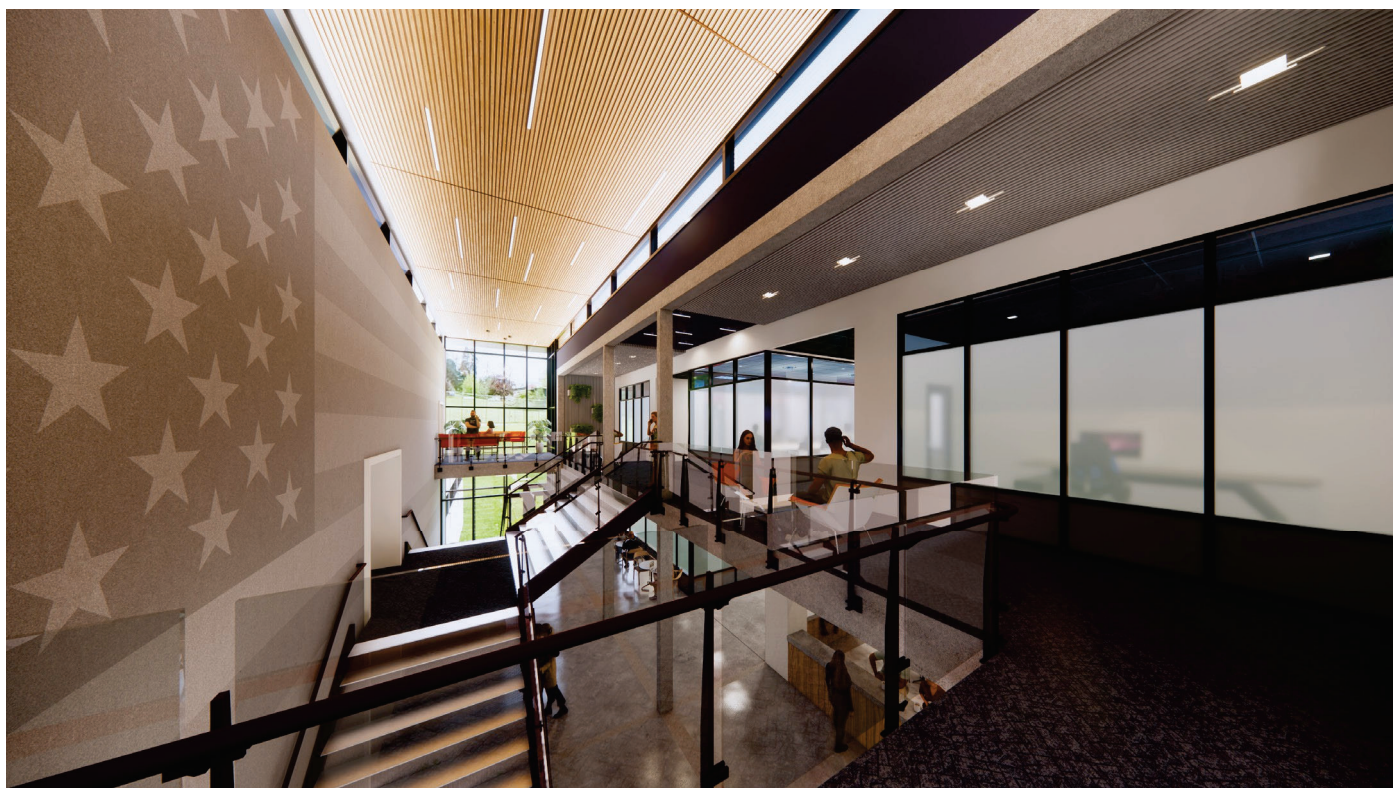
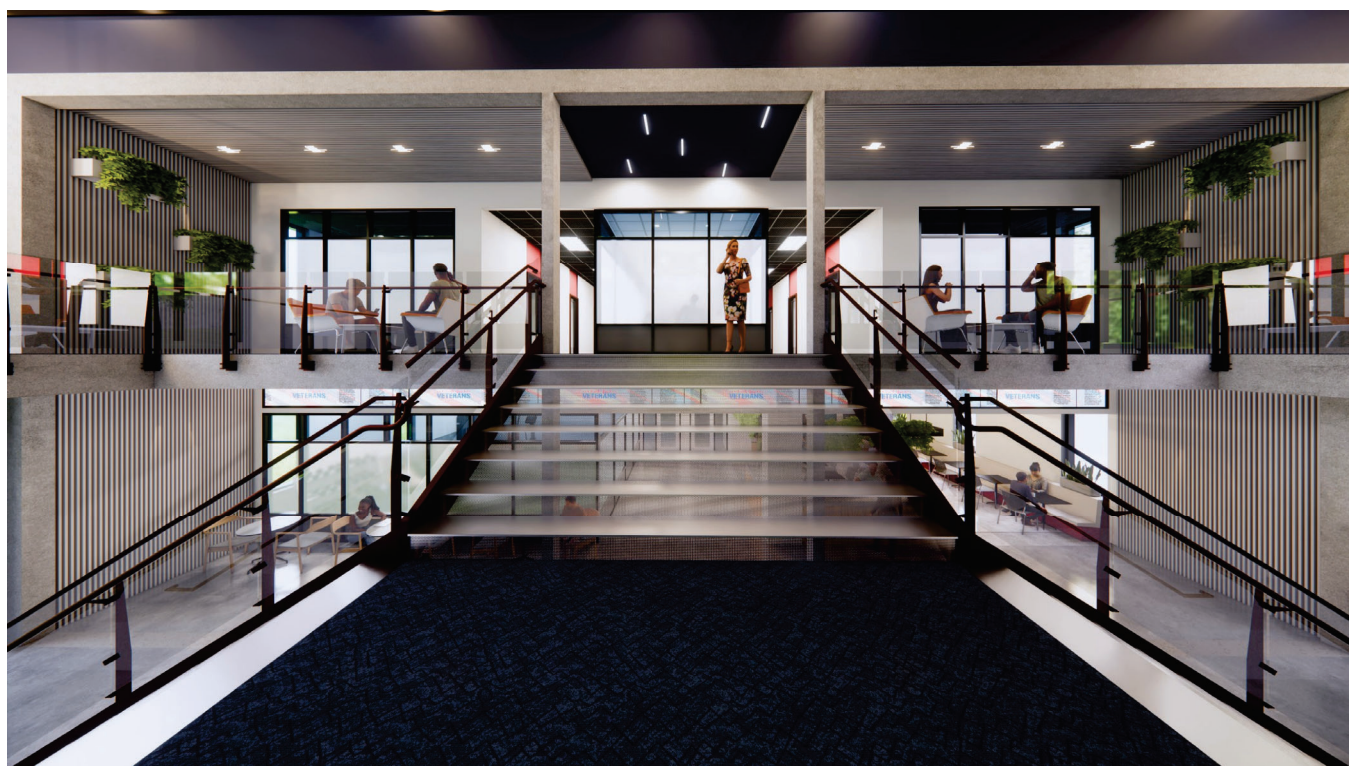
**Second Floor:** The second-floor connector includes open balcony lounges at each end, offering views of the new lobby, flag wall, and grand staircase, creating relaxed spaces that bridge the old and new sections of the building, and facilitate simple and convenient circulation. The second interior rendering illustrates how vertical circulation can be optimized. The floor-to-floor height in the addition is utilized to create visual interest through the stair design, offering opportunities for common areas where students can gather, study, or socialize.
