**DPW PROJECT 18914
LEN B. JORDAN
IDAHO DEPARTMENT OF ADMINISTRATION
BOISE, IDAHO**

**ASBESTOS-CONTAINING BUILDING MATERIAL
SURVEY AND ASSESSMENT REPORT**

NOVEMBER 2018

SUBJECT: DPW PROJECT #18914
LEN B. JORDAN
IDAHO DEPARTMENT OF ADMINISTRATION
BOISE, IDAHO

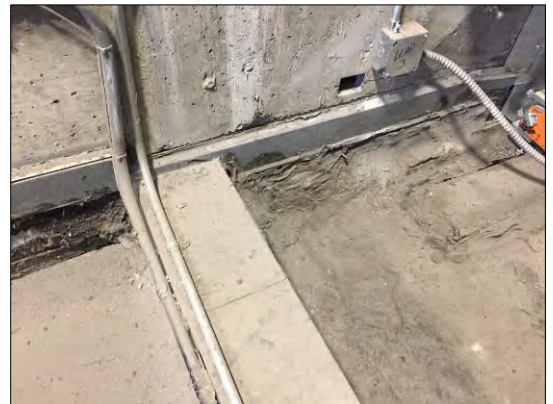
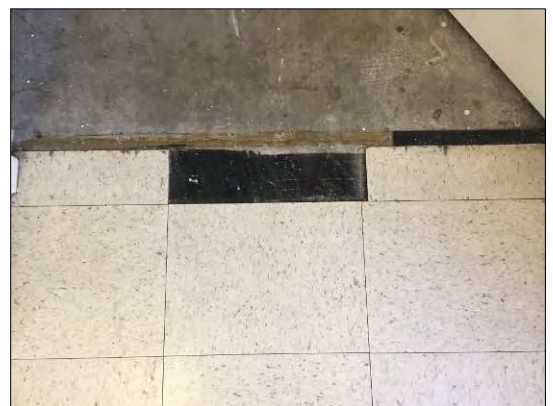
Regulated asbestos-containing materials identified during the inspection include: (1) non-friable black tar-like caulking (7% Chrysotile) found on the floor and around the base of penthouse walls, (2) non-friable beige 12-inch vinyl floor tile (2% Chrysotile) and black floor tile mastic (5% Chrysotile) found in various locations, and (3) friable TSI mudded fitting insulation (15% Chrysotile) found on the steam, chilled and domestic water lines, the roof drain lines, and the emergency generator exhaust stack.

The asbestos-containing materials were found to be in good-to-fair condition and can be managed in place. The non-friable black tar-like caulking and beige 12-inch vinyl floor tile and black floor tile mastic and the friable TSI mudded fitting insulation, if not managed properly, may become damaged and release fibers into the surrounding atmosphere (airborne), which poses a potential health threat to the building occupants and state employees.

Place the asbestos-containing materials in an operation and maintenance program and maintain in-place until the materials can be removed and disposed of properly.

If it is determined at any future point that the asbestos-containing materials are about to become damaged (through deterioration, removal, sanding, grinding, drilling, abrading, etc.), implement an abatement program per 29 CFR 1926.1101 OSHA construction standard.
