SITE ANALYSIS REPORT
FOR
DPW PROJECT NO. 25-063
IDAHO CORRECTIONAL INSTITUTION
IDAHO DEPARTMENT OF CORRECTIONS

OROFINO, IDAHO

January 2025

IDAHO CORRECTIONAL INSTITUTION - OROFINO SITE ANALYSIS REPORT

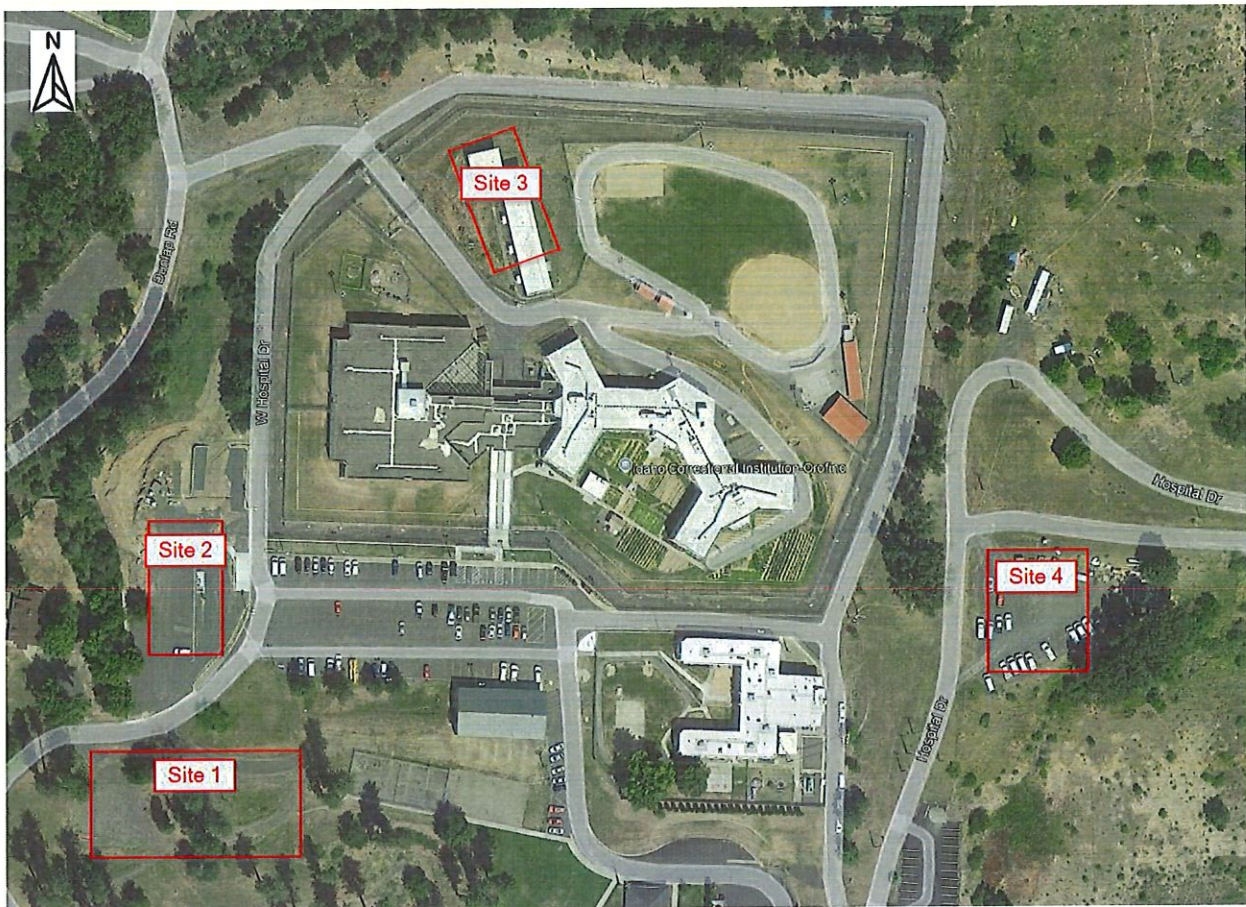
FIGURE 1: SITE LOCATIONS CONSIDERED

Four potential locations were assessed for the new building, as illustrated in Figure 1. The evaluation criteria included site conditions (such as terrain, available space, and existing structures), utility locations, accessibility, parcel ownership, and safety and risk factors. Each site was ranked based on its performance in each evaluation category.

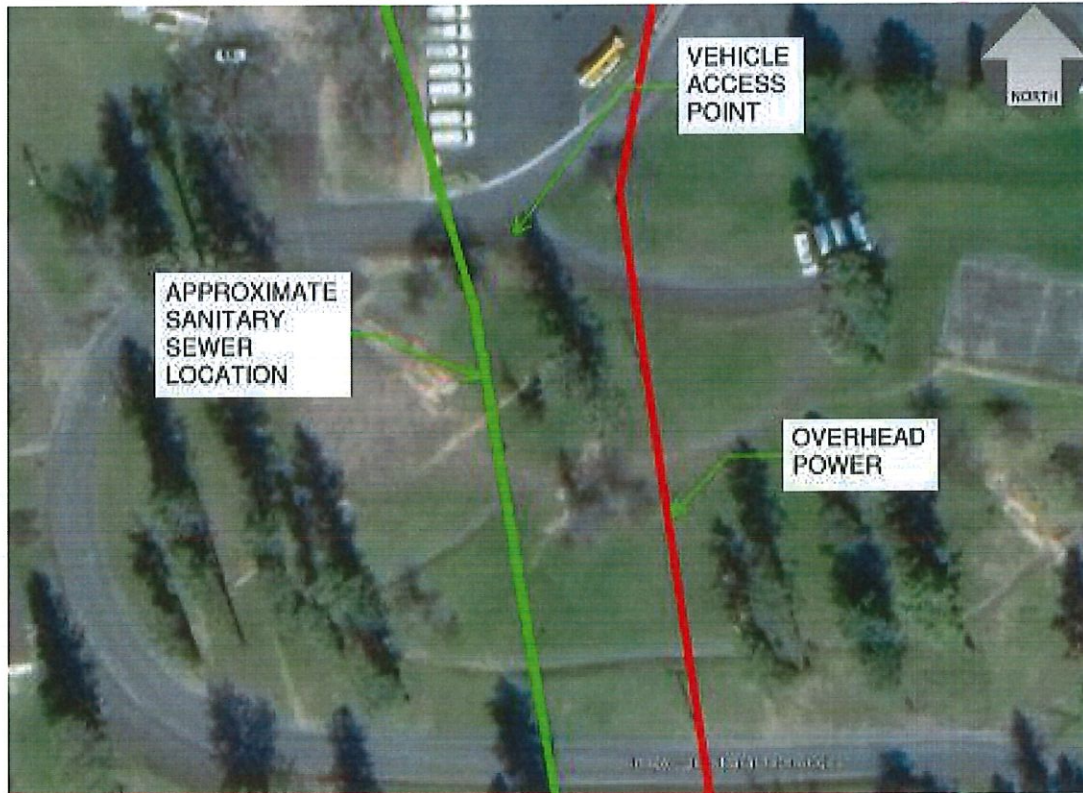
FIGURE 2: SITE 1 ACCESS AND UTILITY LOCATIONS

Site 1 features relatively flat terrain with grass and sparse tree cover. Positioned slightly downhill from the main buildings. The site benefits from existing vehicle access and would require minimal grading. While there are no structures currently on the site, a sanitary sewer main runs through its boundaries and would likely need to be relocated if this location is chosen. Additionally, overhead power lines along the east side of the site could interfere with the proposed building placement and may need to be relocated.

Power: Overhead power lines currently run along the east side of the site and may need to be relocated underground. Preliminary coordination with Avista indicates that the existing power infrastructure is expected to be adequately sized to meet the demands of the new building.

Sewer: The facility's sewer main runs through the middle of Site 1 and will need to be relocated to construct on this site. Once relocated, the new building can connect to the main and it is expected that the existing 6-inch pipe can serve the new building without resizing.

Site 1 has vehicle access on the northwest side and provides sufficient space for ADA parking. However, designated pedestrian access from the main buildings to Site 1 will need to be constructed to ensure ADA compliance and provide a safe walkway for staff to transport food and equipment from the main facility.

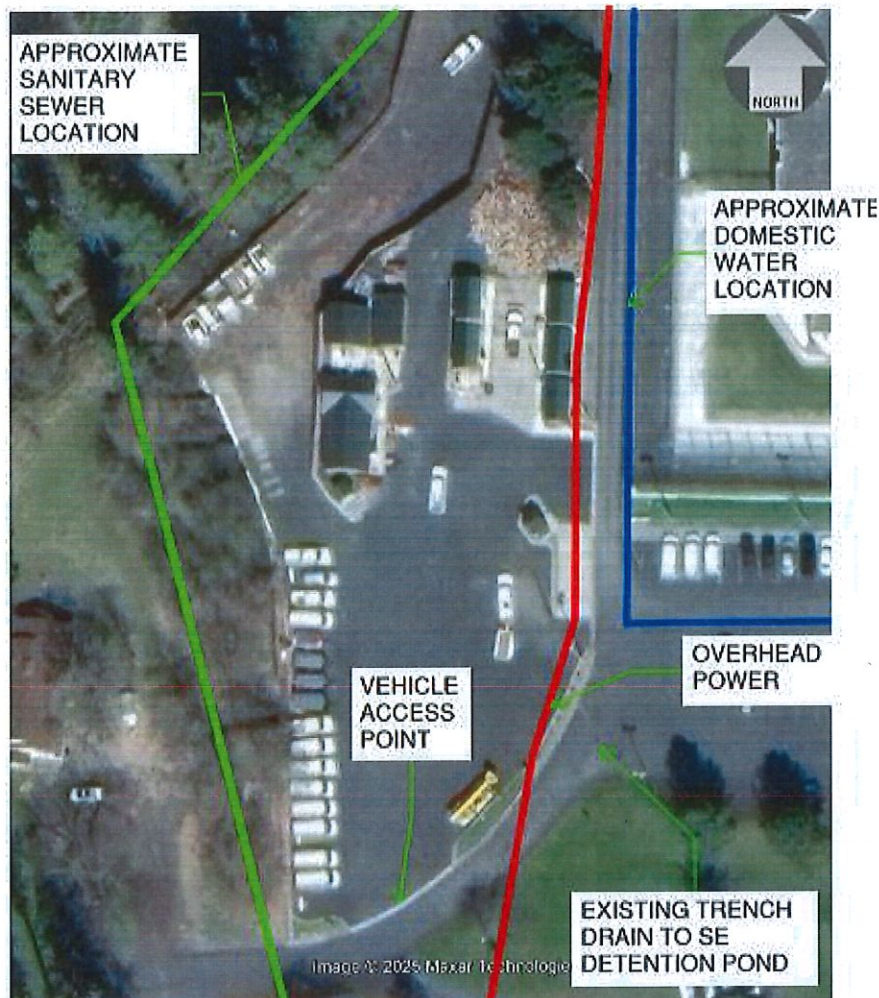
FIGURE 3: SITE 2 ACCESS AND UTILITY LOCATIONS

Site 2 is presently utilized as a gravel parking lot with several outbuildings located at the northern end. The site is at the same approximate elevation as the main facilities, with a gentle slope toward the south. Overhead power lines run along the east side of the lot but are not expected to interfere with the new building. While the building at the north end of the lot might also need to be relocated, prison staff did not view this as a significant restriction. The wash pad location at the central east side will need to be relocated if the new building is located here.

The facility has expressed a desire for food service deliveries from the main ICIO kitchen to be delivered via carts. This site has a direct line of site from the main Administration Building and kitchen deliveries could be walked along the existing sidewalk westerly to the proposed building.

Water: The site can be supplied with water from a water tower located east of the facility, and the additional demand from the new building is not expected to affect the existing water distribution system. Installation of a new fire hydrant may be required. Additionally, a water service from the existing 10-inch main to the east of this location is necessary as well as a fire line for fire suppression infrastructure.

Power: Overhead power lines run along the east side of the site but are not expected to interfere with the new building. Preliminary coordination with Avista indicates that the existing power infrastructure is expected to be adequately sized to meet the demands of the new building.

Storm: Stormwater will need to be collected and managed through the construction of a new detention or retention facility. There is also the possibility for some stormwater to be routed to an existing detention pond southeast of this location. There is an existing trench drain across the access road that leads to existing stormwater detention southeast of the site. This system could be retrofit to include some of the stormwater from the building footprint, but likely a new system could be situated southwest of the building as that is the downstream side of the site.

Sewer: The sewer main for the entire facility runs along the west side of the site and is suitable to provide sewer service to the new building.

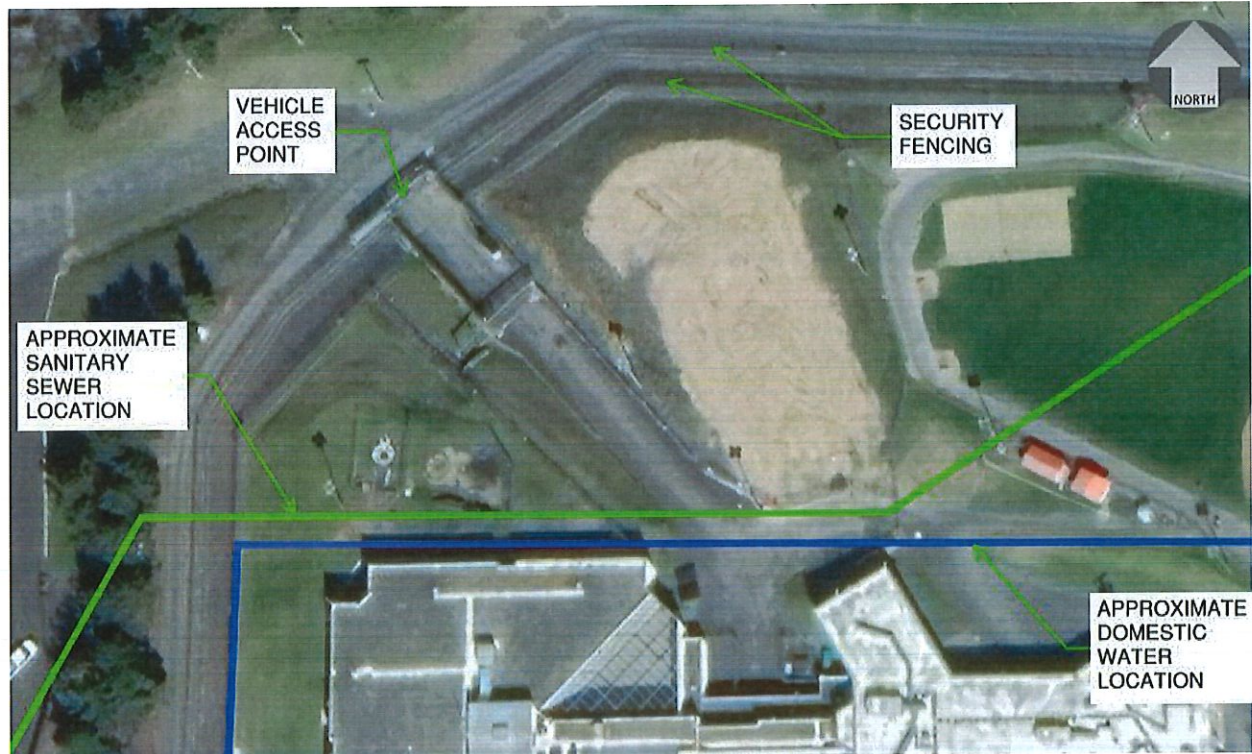
FIGURE 4: SITE 3 ACCESS AND UTILITY LOCATIONS

Site 3 is within the secure facility. The building that was located here was demolished and is seen as the freshly exposed dirt area in figure 4 and the site is currently used as garden space. The site is elevated compared to the main facilities and significantly higher than the road to the north. Developing this site would require extensive grading or the construction of retaining walls. Additionally, accommodating ADA-compliant parking and access could be challenging due to the significant grade variations in the area as well as the secure nature of the perimeter fencing. Construction sequencing and access would be more challenging for this site as well with the need for construction crews to enter and exit the secure facility causing additional construction delays and costs.

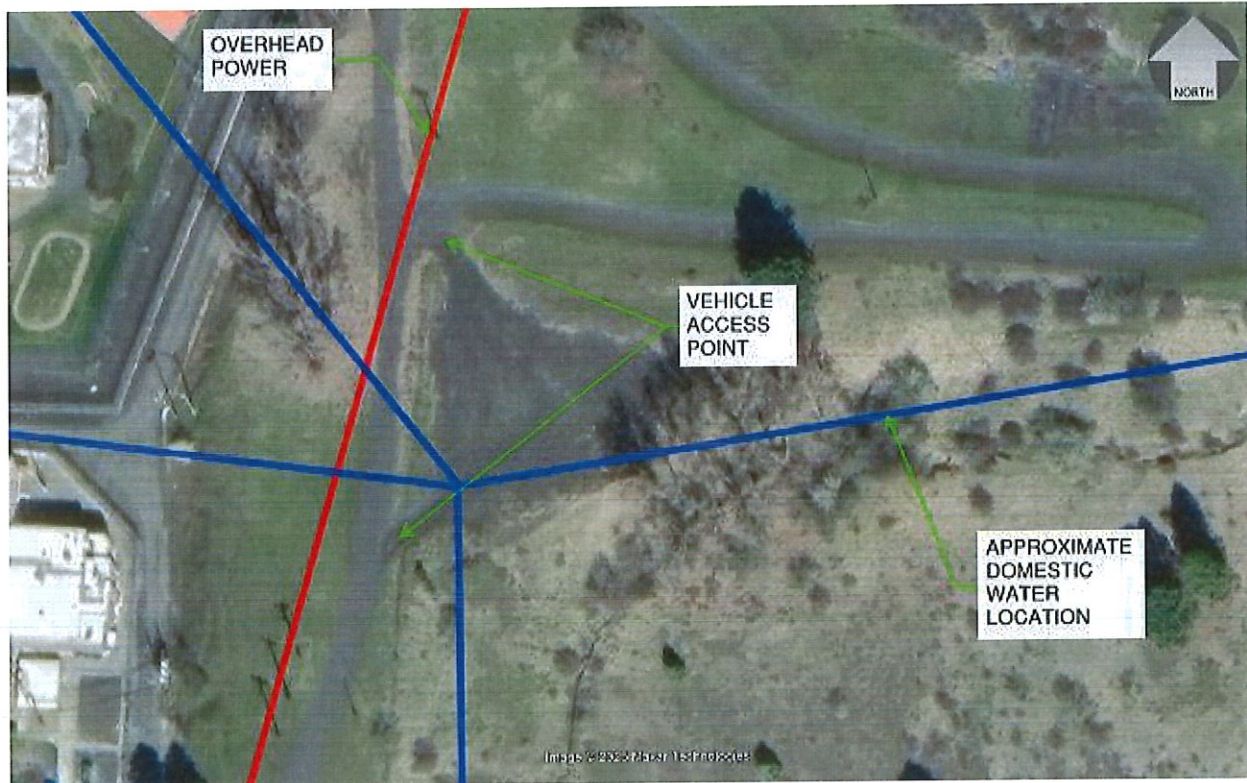
FIGURE 5: SITE 4 ACCESS AND UTILITY LOCATIONS

Site 4 is situated on a gravel lot on the east side of the facility. This site is elevated compared to the main facilities and would require significant grading to establish a suitable footprint for the building and the necessary parking. Additionally, water mains, as indicated in the 1988 water tank plans, run beneath the site and would need to be relocated for construction to proceed or the building footprint would need to accommodate their location along with access roadways or revisions.

standards. Additionally, water mains directly connecting to the water tower run near or under the proposed building footprint. These would need to be relocated if this site is selected.

Power: Overhead power runs along the west side of the site. Preliminary coordination with Avista indicates that the existing power infrastructure is expected to be adequately sized to meet the demands of the new building.

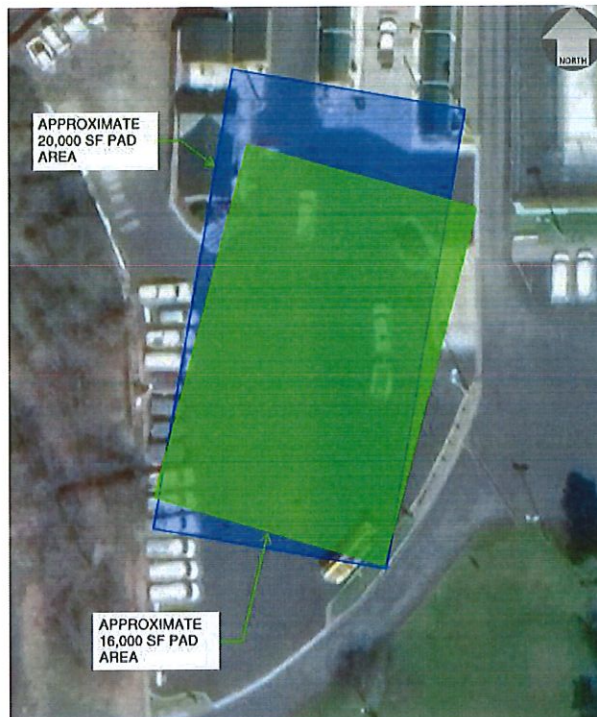
FIGURE 7: SITE 2 BUILDING AREA OPTIONS

Building on site 2 is expected to provide the best results at the lowest cost. Minimal grading will be necessary, existing utilities will not need to be relocated, and the proximity to the main facilities will provide the easiest access for staff and residents moving between buildings. The property boundaries near site 2 will need to be established by a licensed surveyor but no other major concerns have been identified that would detract from the site's merits. In Figure 7, the potential building footprints or pad areas are shown with one at 16,000 square feet and the other at 20,000 square feet. To accommodate existing site features such as retaining walls and modular buildings to the north, the footprint could be altered to fit within the site; the exhibit is meant to show the potential for the two configurations.

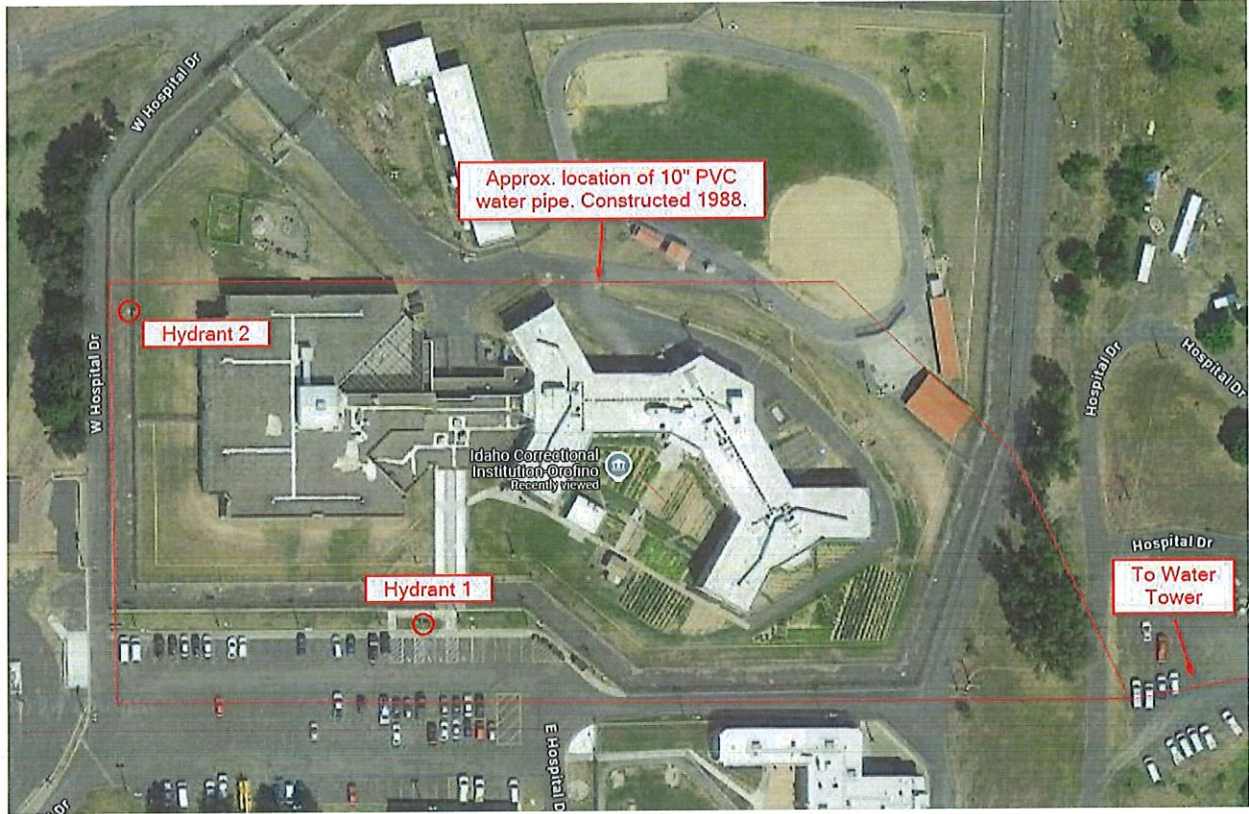
APPROXIMATE HYDRANT AND WATER MAIN LOCATIONS

Test 1		
Flow Hydrant (Hydrant 1)		
Item	Static	Residual
Pitot Reading (psi)	65	50
Flow (gpm)	-	1187
Theoretical Available Fire Flow @ 20 psi (gpm)	2148	
Closed Hydrant (Hydrant 2)		
Item	Static	Residual
Pressure (psi)	65	55
Pressure Drop During Flow (psi)	10

Test 2		
Flow Hydrant (Hydrant 2)		
Item	Static	Residual
Pitot Reading (psi)	65	50
Flow (gpm)	-	1187
Theoretical Available Fire Flow @ 20 psi (gpm)	2148	
Closed Hydrant (Hydrant 1)		
Item	Static	Residual
Pressure (psi)	65	60
Pressure Drop (psi)	5
