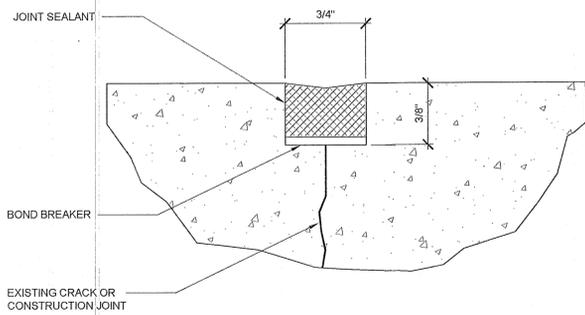
S-9 SCALE: N.T.S.

1
TYPICAL SEALANT DETAIL
AT CRACK OR CONSTRUCTION JOINT

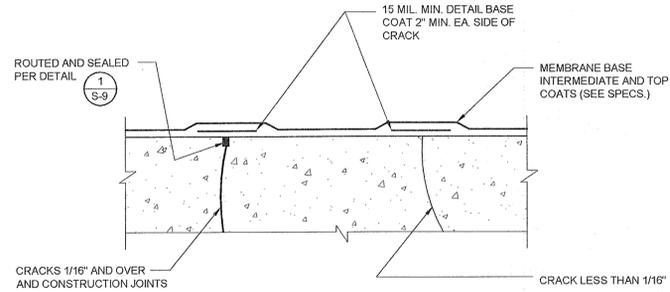
S-9 SCALE: N.T.S.

2
MEMBRANE DETAIL AT CRACKS

NOTE: WHEN JOINT WIDTH VARIES BETWEEN FRONT AND BACK OF TREAD, VARY DEPTH AND / OR SIZE OF BACKER ROD TO MAINTAIN SEALANT PROFILE SHOWN. IF MEMBRANE IS TO BE APPLIED OVER SEALANT JOINT, INSTALL MEMBRANE PER SEALED CRACK DETAIL 2/S-9

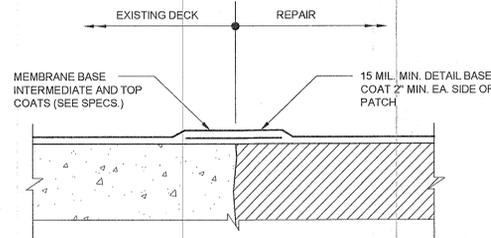
S-9 SCALE: N.T.S.

3A
MEMBRANE DETAIL
AT PATCH EDGES

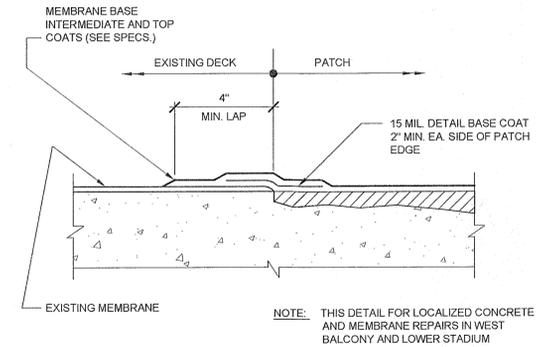
S-9 SCALE: N.T.S.

3B
MEMBRANE DETAIL
AT PATCH EDGES

NOTE: THIS DETAIL FOR LOCALIZED CONCRETE AND MEMBRANE REPAIRS IN WEST BALCONY AND LOWER STADIUM

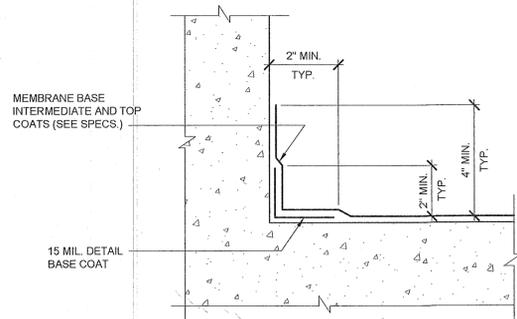
S-9 SCALE: N.T.S.

4
MEMBRANE DETAIL AT CURBS
COLUMNS AND WALLS

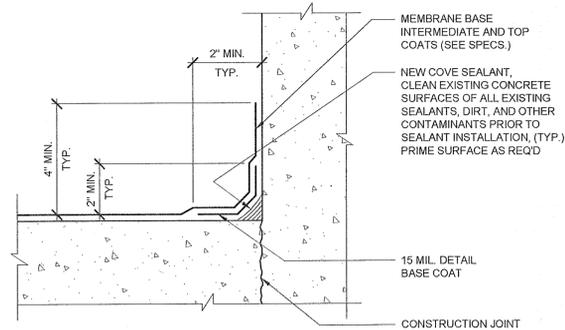
S-9 SCALE: N.T.S.

5
MEMBRANE DETAIL AT RE - ENTRANT
CORNERS AND / OR CONSTRUCTION JOINTS

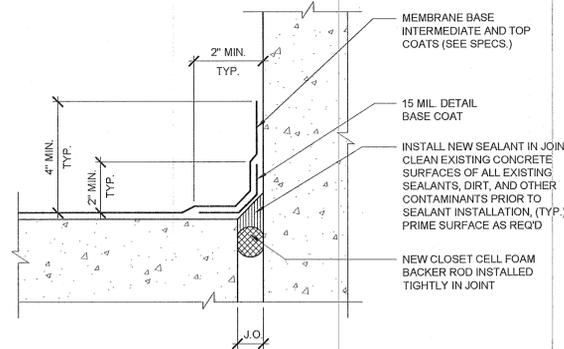
S-9 SCALE: N.T.S.

6
MEMBRANE DETAIL AT PRECAST JOINTS

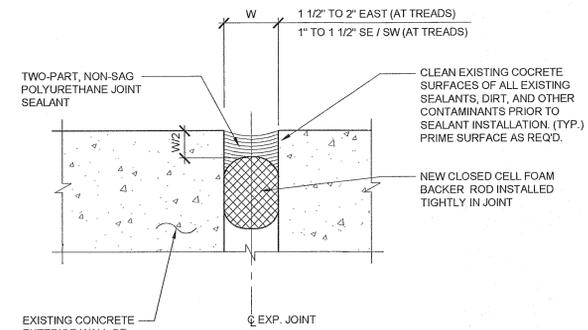
S-9 SCALE: 1\"/>

7
SEALANT DETAIL

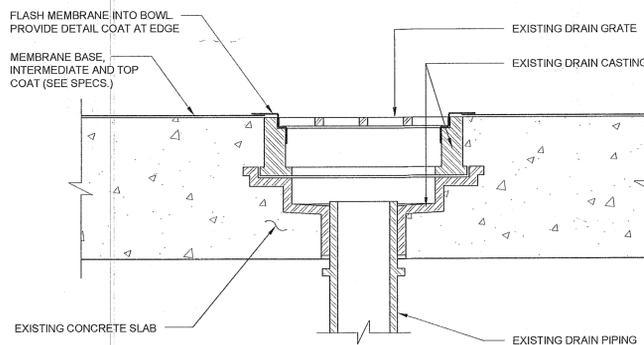
S-9 SCALE: N.T.S.

8
MEMBRANE DETAIL AT SURFACE DRAINS

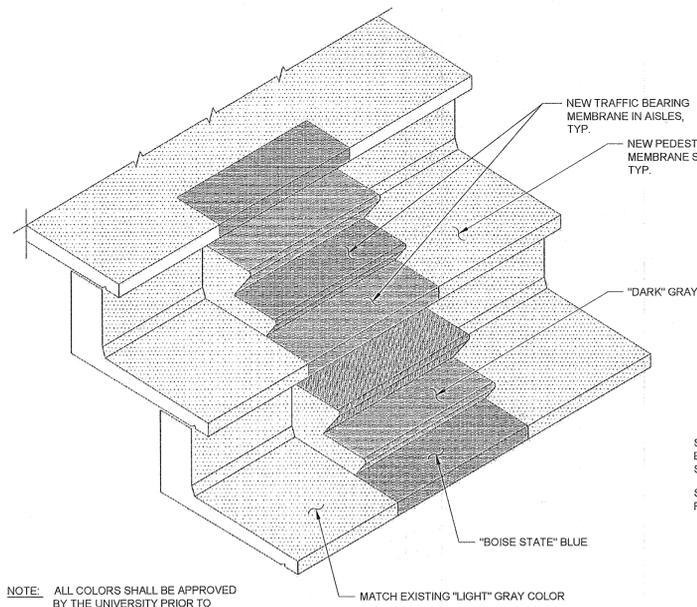
S-9 SCALE: N.T.S.

9
COLOR SCHEME FOR AISLES

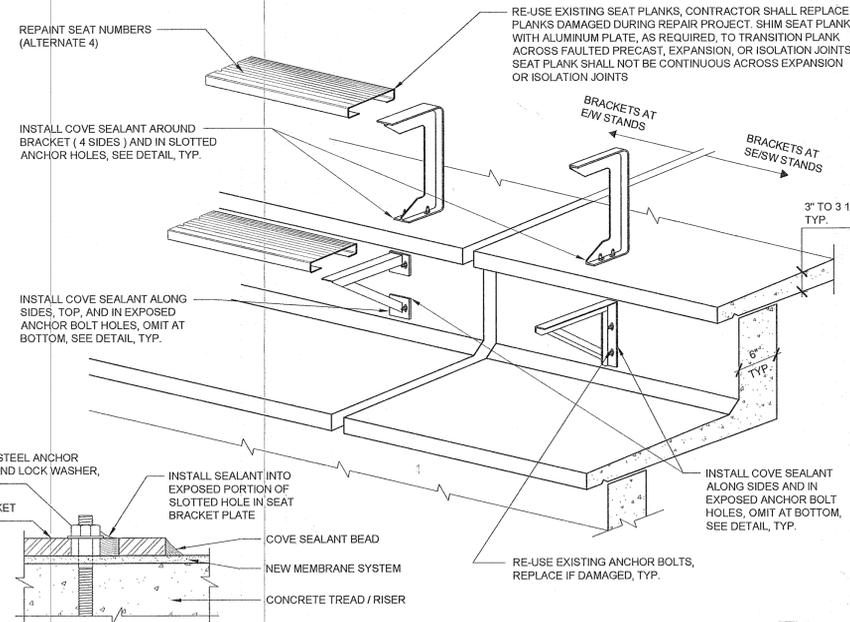
S-9 SCALE: N.T.S.

10
SEALANT DETAIL AT SEAT BRACKETS
