University of Idaho Administration Building

Entry Foyer & Main Stair Renovation
North Entry Mosaic Tile Restoration

Condition Survey

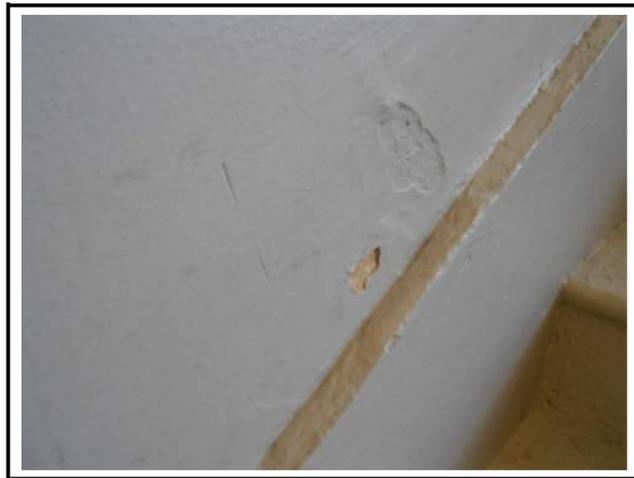
plaster gouges

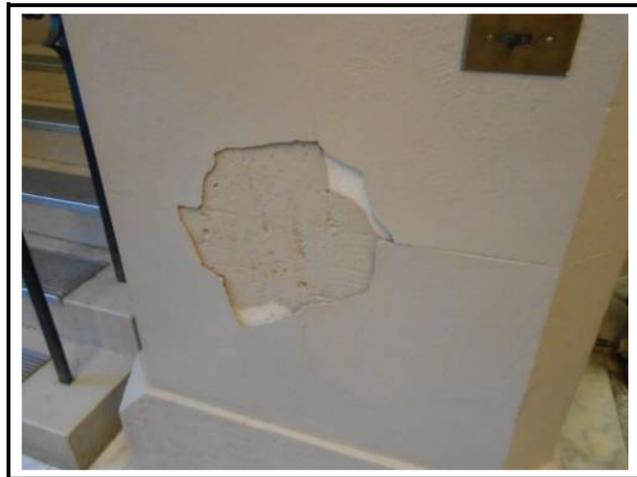
delaminated plaster

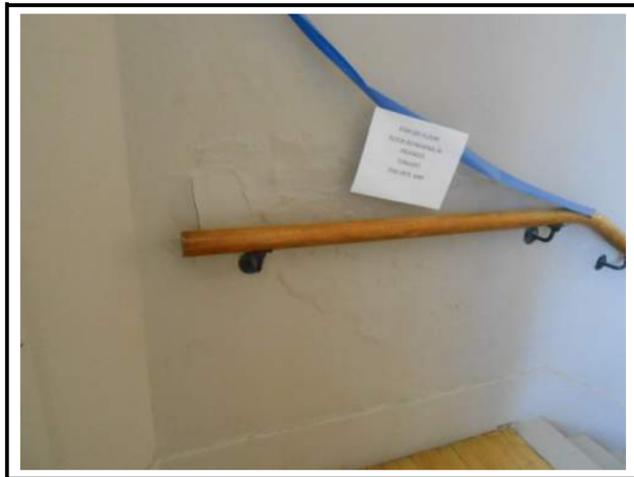
delaminated plaster/paint

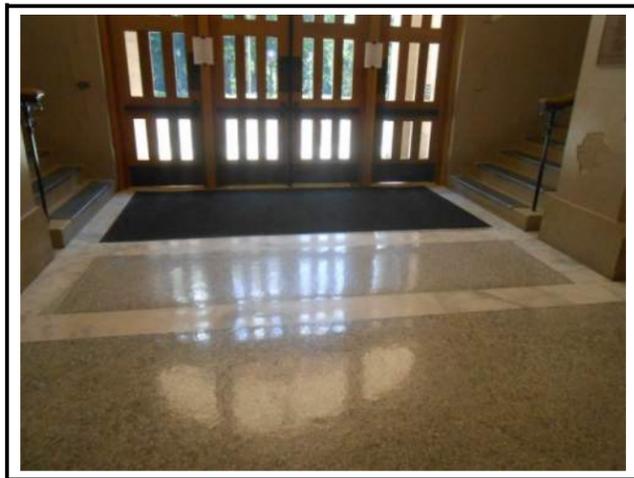
non-original marble floor finish

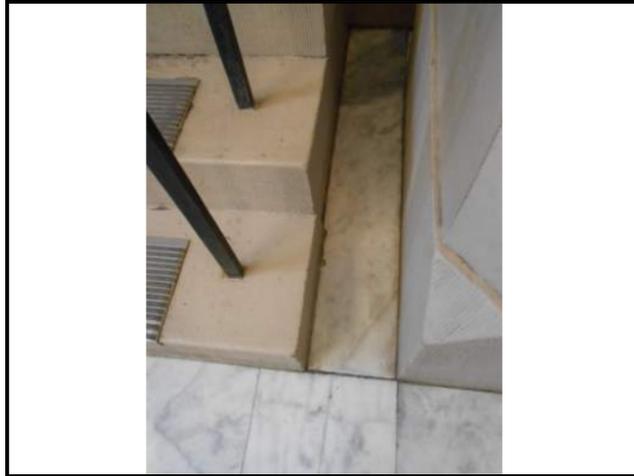
patch in marble flooring

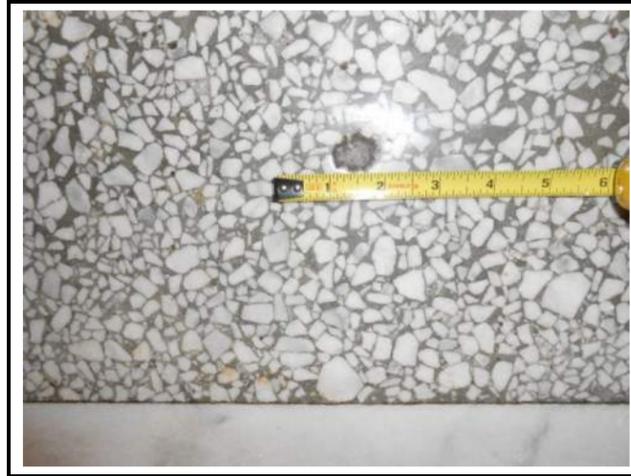
chip in terrazzo flooring

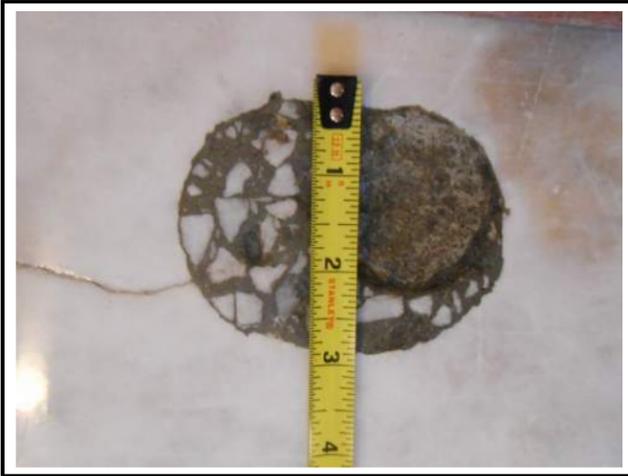
non-original patch in marble flooring

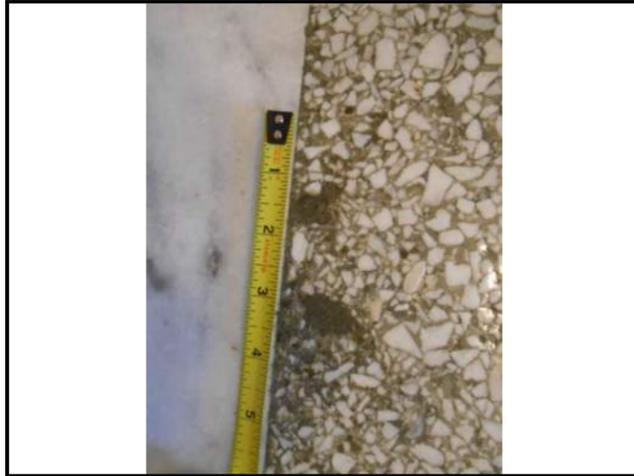
non-original patch in terrazzo flooring

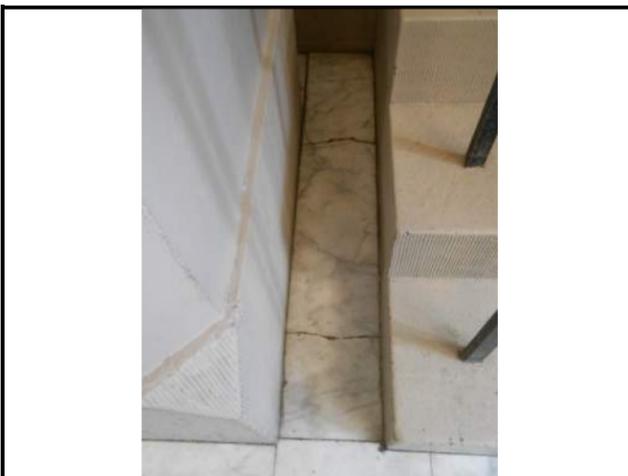
cracks in marble flooring

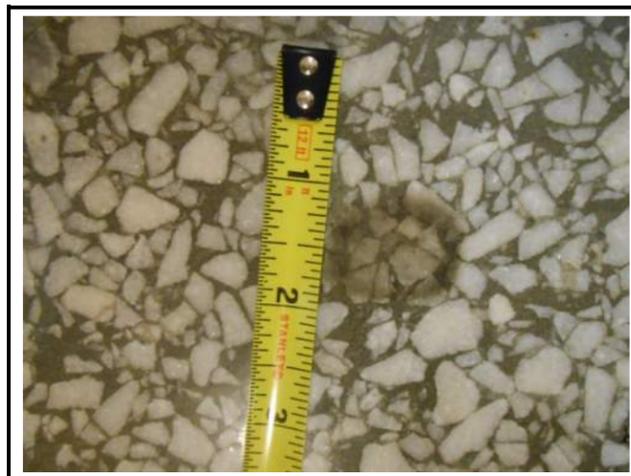
residue on terrazzo flooring

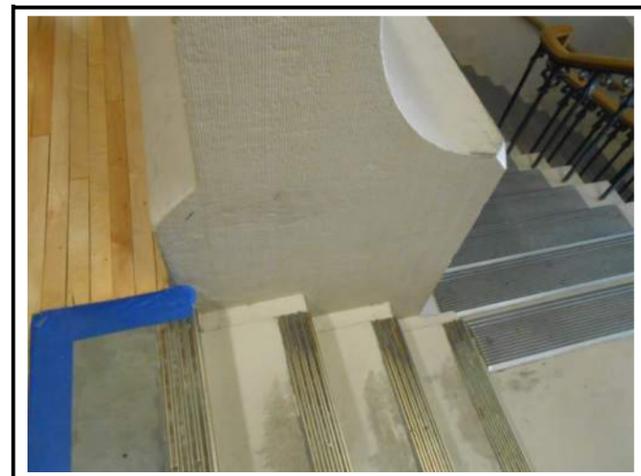
non-original stair nosings

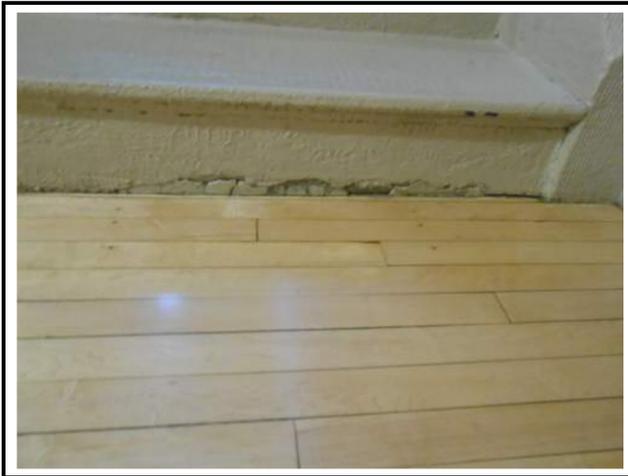
cracked concrete

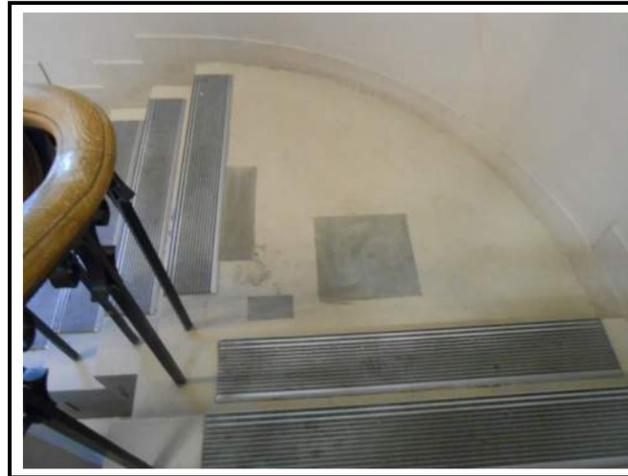
patched concrete

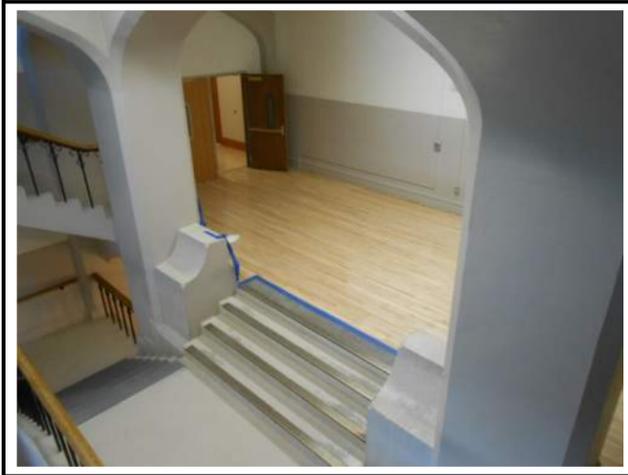
handrail missing at last four stairs to 2nd Floor

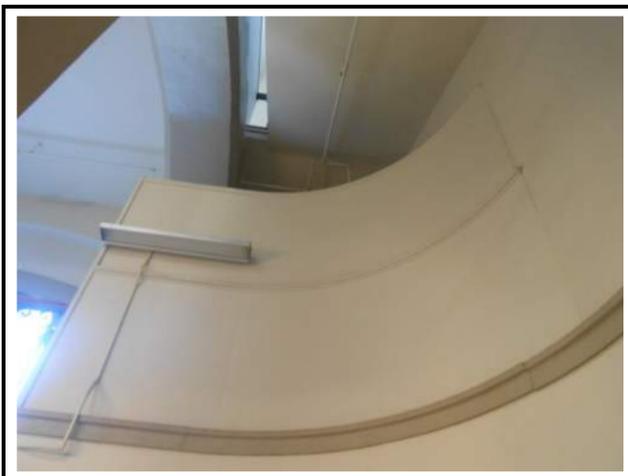
concealed original guardrail at 3rd floor

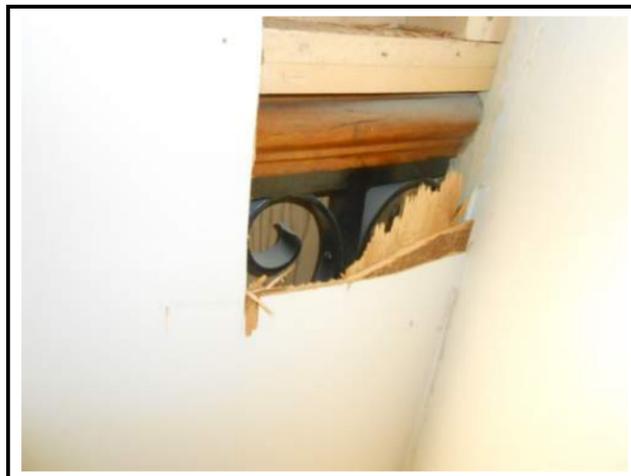
concealed original guardrail at 3rd floor

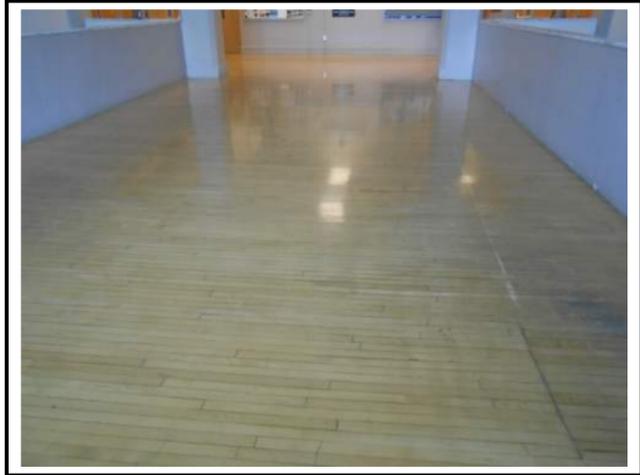
patched wood floor

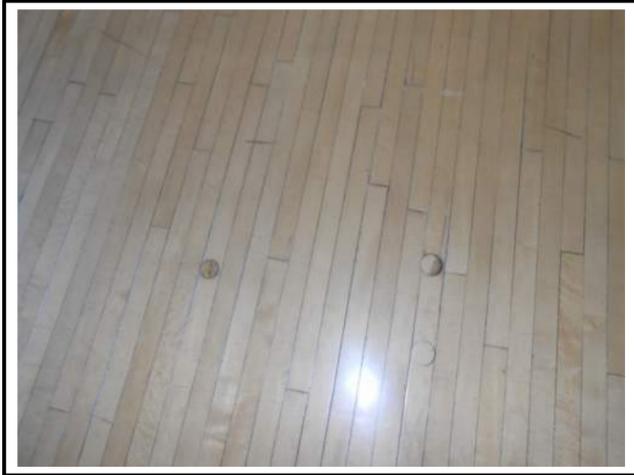
patched wood floor

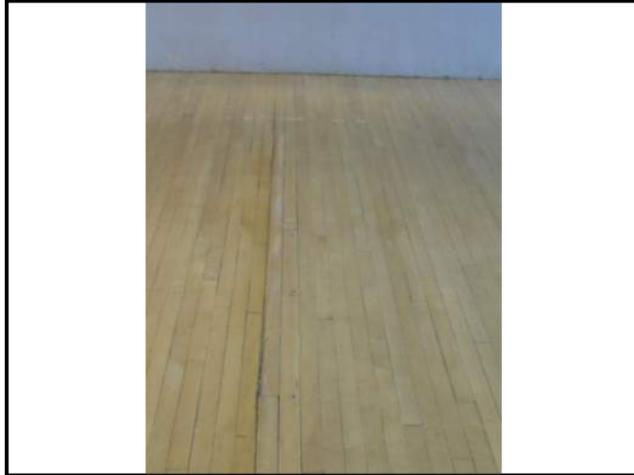
warped and creaky wood floor

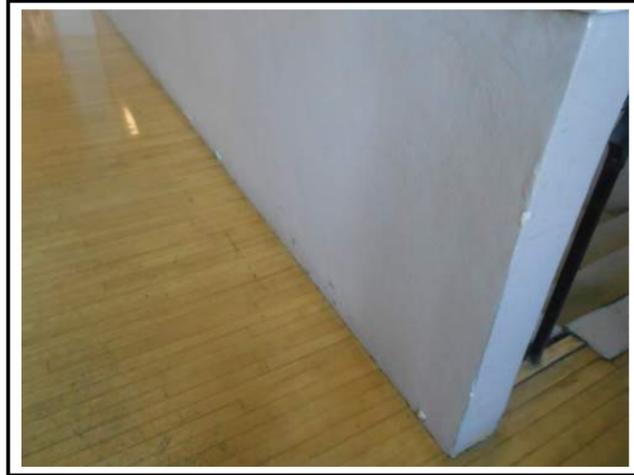
gouges in partial height plaster wall

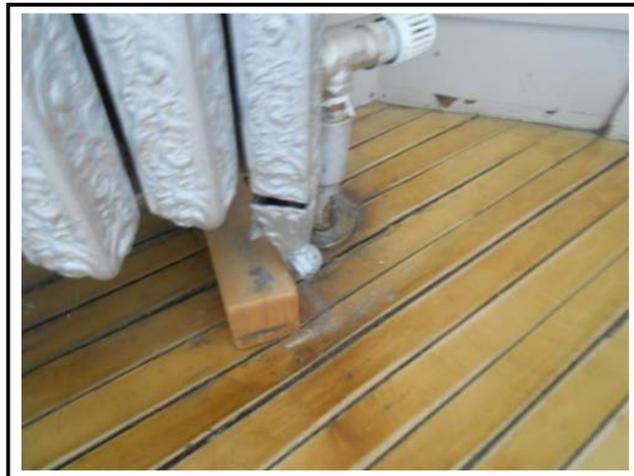
misaligned radiator

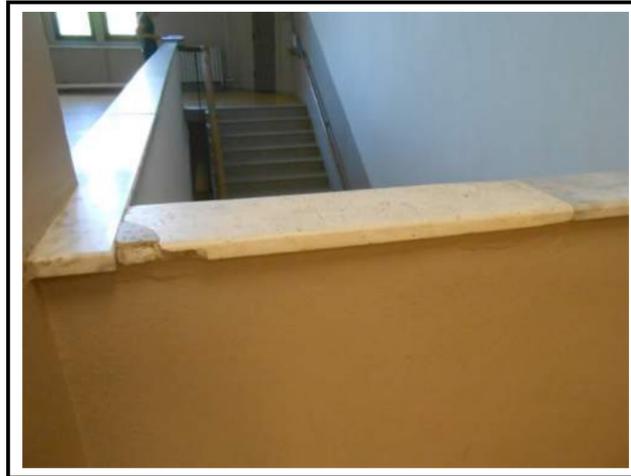
non-original wall cap

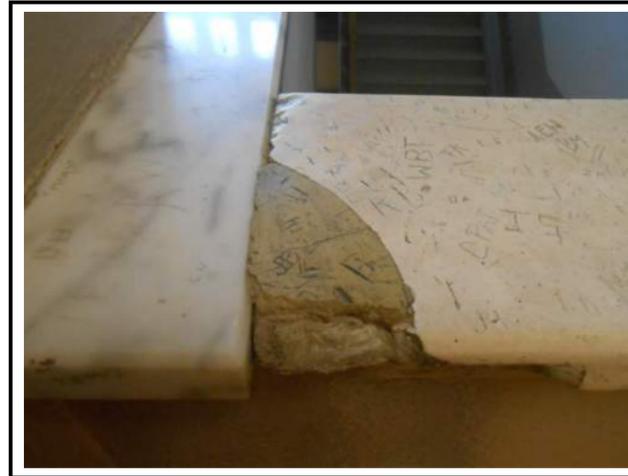
patch in wall cap

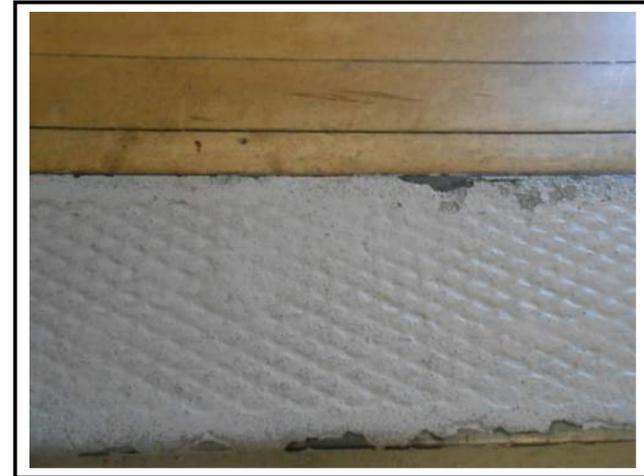
non-original tread coating

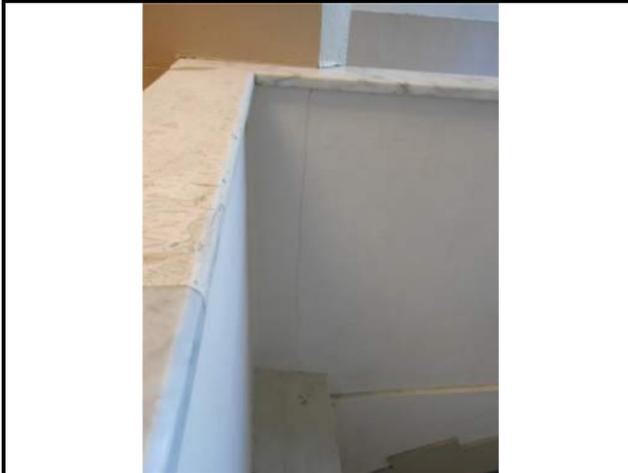
crack in plaster wall

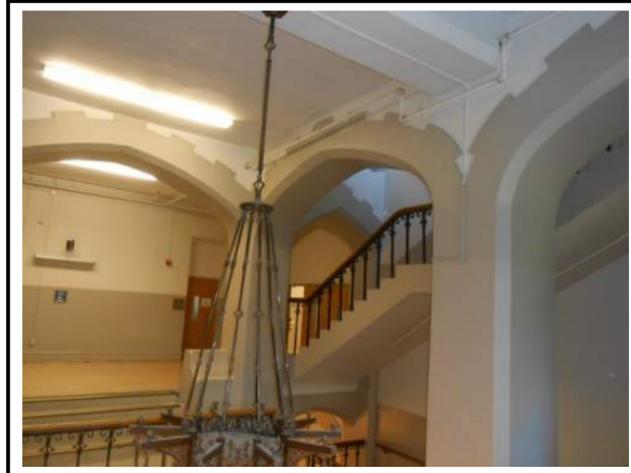
non-historic wall and ceiling mounted light fixtures

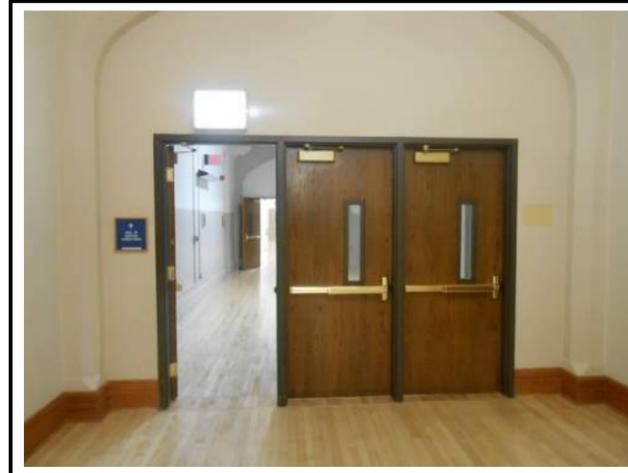
non-historic wall mounted light fixtures

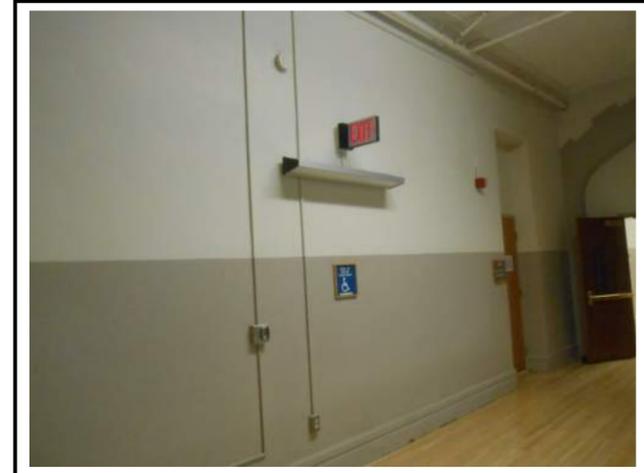
non-historic light fixture

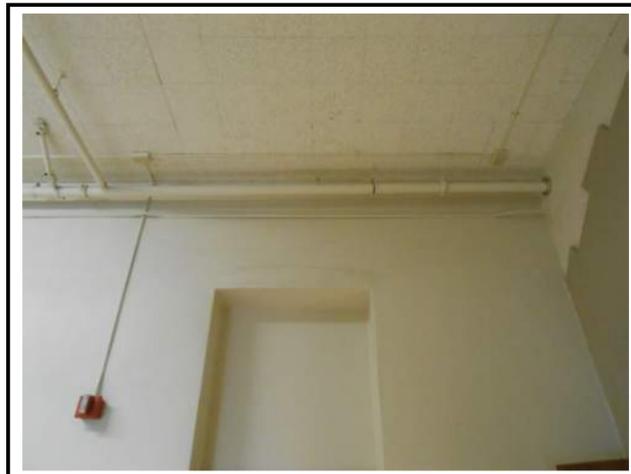
exposed fire sprinkler piping and electrical conduit

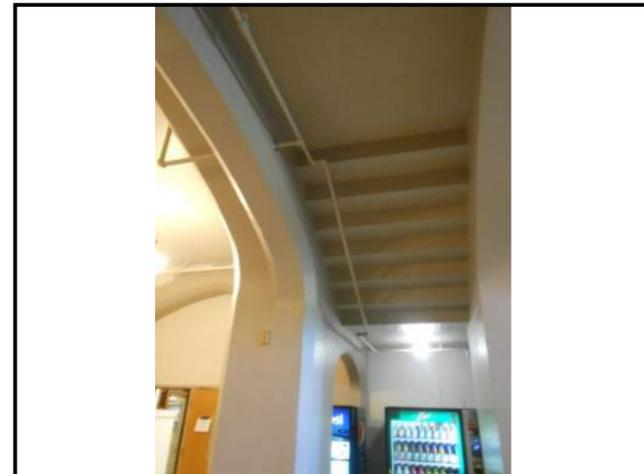
exposed fire sprinkler piping

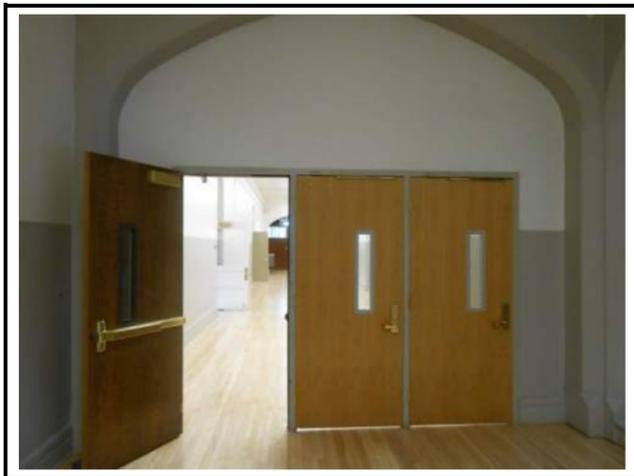
non-original corridor doors

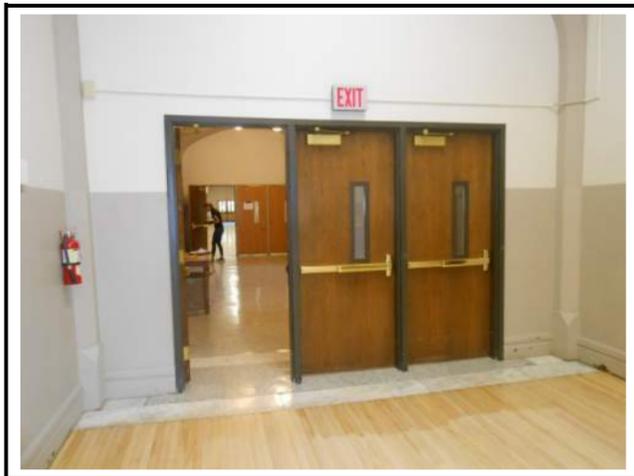
non-original corridor doors

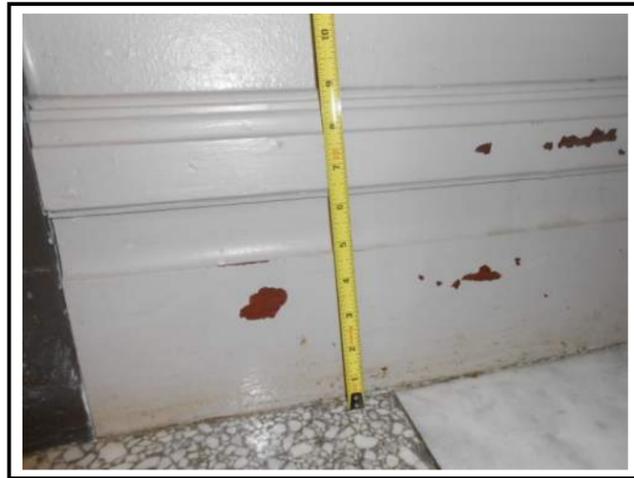
non-original paint on wood base

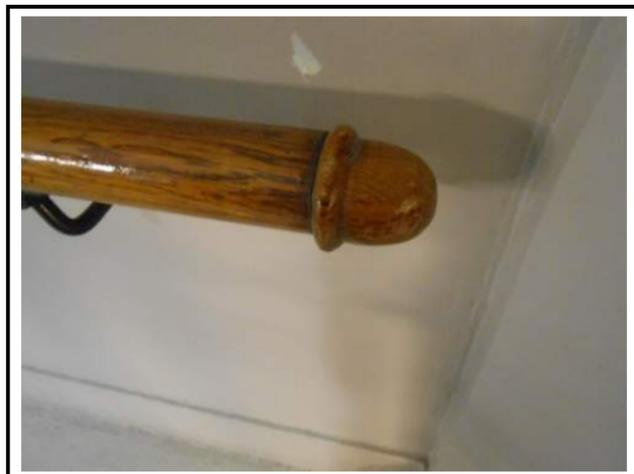
intact acorn at bottom of handrail
